Subject: 2011 Mt. Morris Dam Inspection
Rattlesnake Creek, Waushara County
Field File # 69.04, Key Sequence # 93

**MT. MORRIS DAM
RATTLESNAKE CREEK, WAUSHARA COUNTY**

**2011 DAM SAFETY INSPECTION REPORT
DAM INSPECTION CHECKLIST
PHOTO DOCUMENTATION**

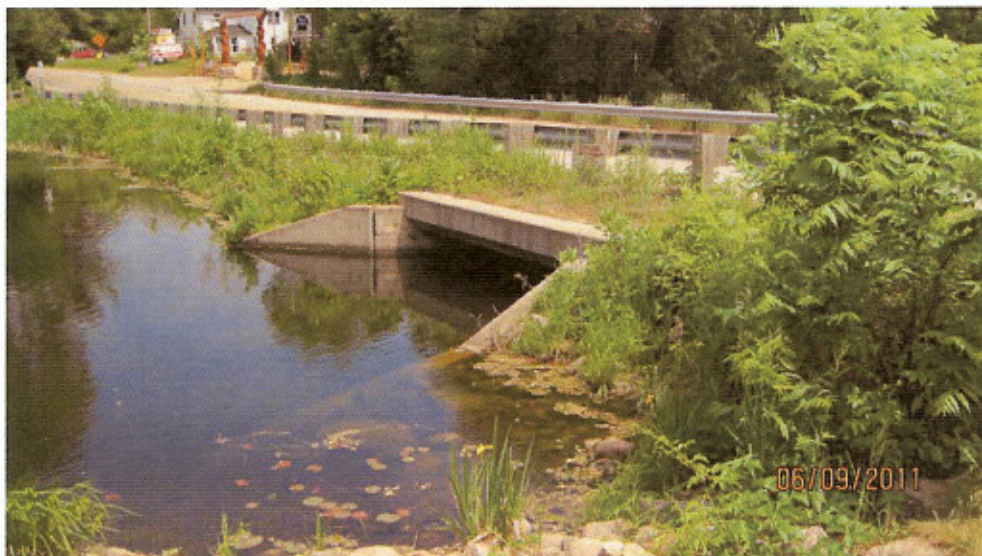
Flume Headwall (0009300609201101)

Numerous warning signs are posted upstream and downstream of the dam and along the flume. It was noted during the inspection the upstream sign at the flume inlet does not conform to current NR 330 standards and a new sign should be placed upstream of the dam that is visible 300 feet upstream. NR 330 also requires signs be posted directing the portage route around the dam.

- 1) The dam warning sign at the headwall of the flume should be updated to current NR 330 standards. The dam warning sign should be posted high enough to avoid vegetation growth blocking it and be visible for 300 feet upstream. Portage signs should also be installed to direct traffic around the dam.
- 2) The security fence wire mesh welds should be coated with a corrosion inhibiting coating to prevent further corrosion.

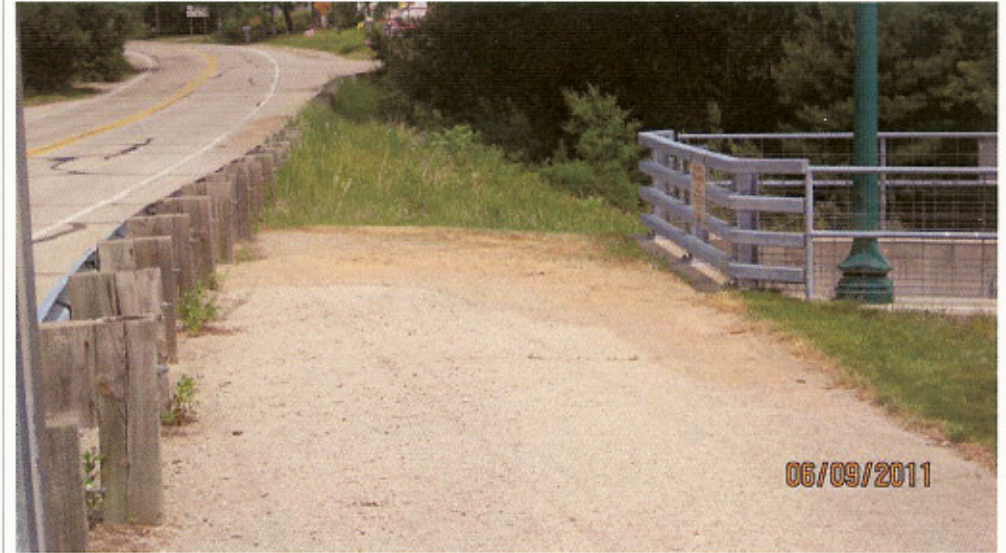
D/S Embankment / Flume (0009300609201106)

The downstream embankment slope has thick brush and small trees that should be cut to the toe of the embankment. Portions of the powerhouse/millhouse property are mowed regularly and in good condition.

No embankment erosion or instabilities were observed during the inspection, however, the thick brush cover made a thorough inspection impossible. It is recommended that

the embankment be re-inspected after the brush on the embankment is cut to ensure no areas of concern exist.

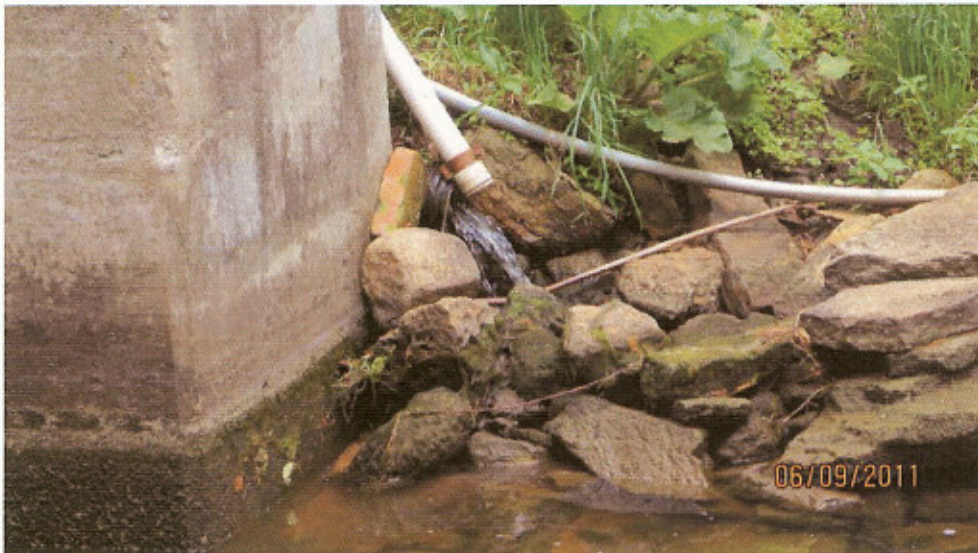
D/S Left Side Toe Drain (0009300609201121)

One area of concern from the previous annual inspection on October 16, 2010, includes a toe drain located along the left side of the flume outlet along the powerhouse foundation. During the previous inspection, it was noted there was a blockage in the toe drain outfall which presumably resulted in a backup of flow and a discharge out into the embankment from the perforated drain tile that resulted in some erosion of the embankment above the drain along the powerhouse foundation. It is believed pressure within the drain forced flow out the drain slots resulting in a piping failure along the drain with some erosion. Photos of the affected area are shown in the report from last year and this year. A comparison of the two photos does not indicate a noticeable increase in the eroded depression area. The eroded embankment area location should be noted and repaired.

During this inspection, a moderate amount of flow of roughly $\frac{1}{3}$ to $\frac{1}{2}$ of the 4-Inch diameter toe drain pipe was observed discharging. Flow was clear and free of obvious sediment materials. The toe drain is inspected during the annual owners inspection for flow rate in gallons per minute and clarity/sediment. It is recommended the toe drain be inspected regularly to assure this problem does not reoccur.

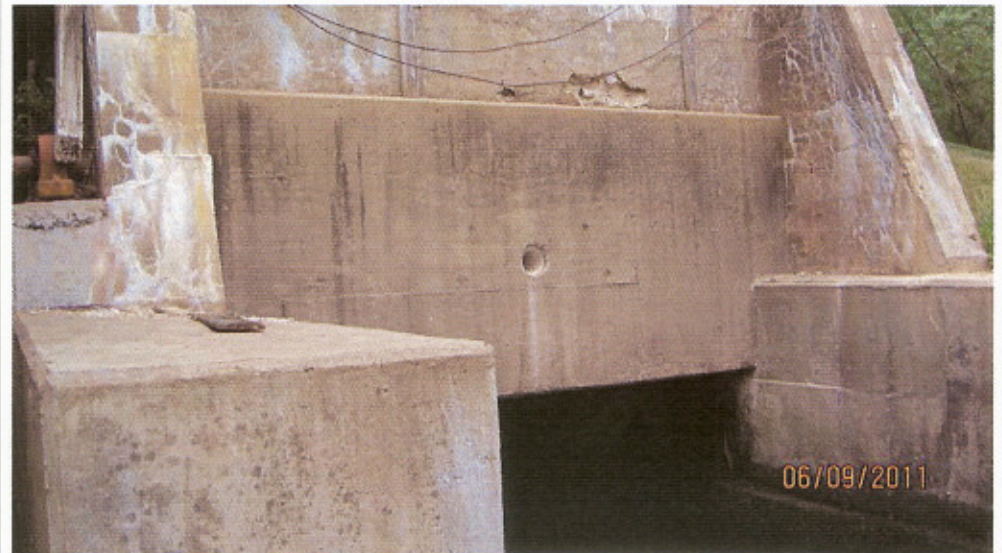
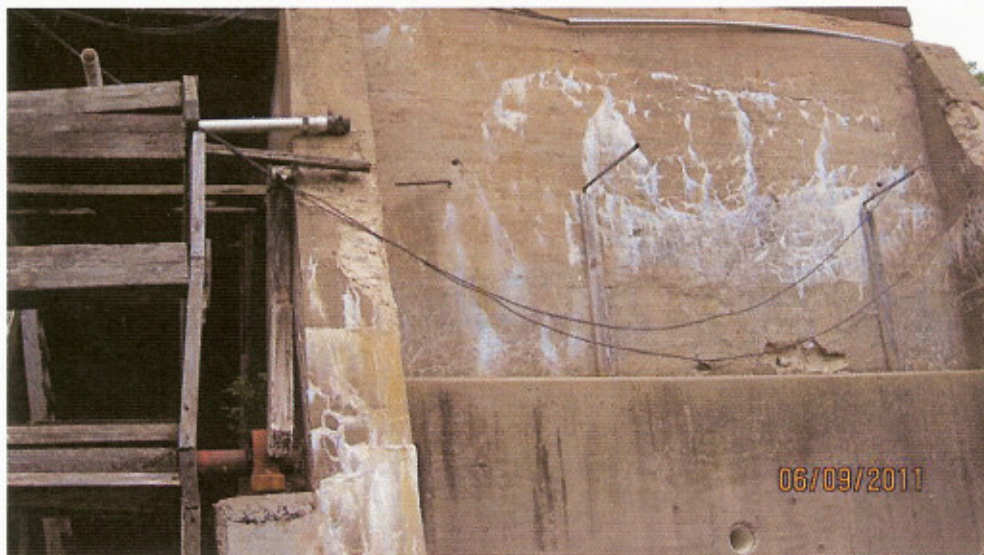
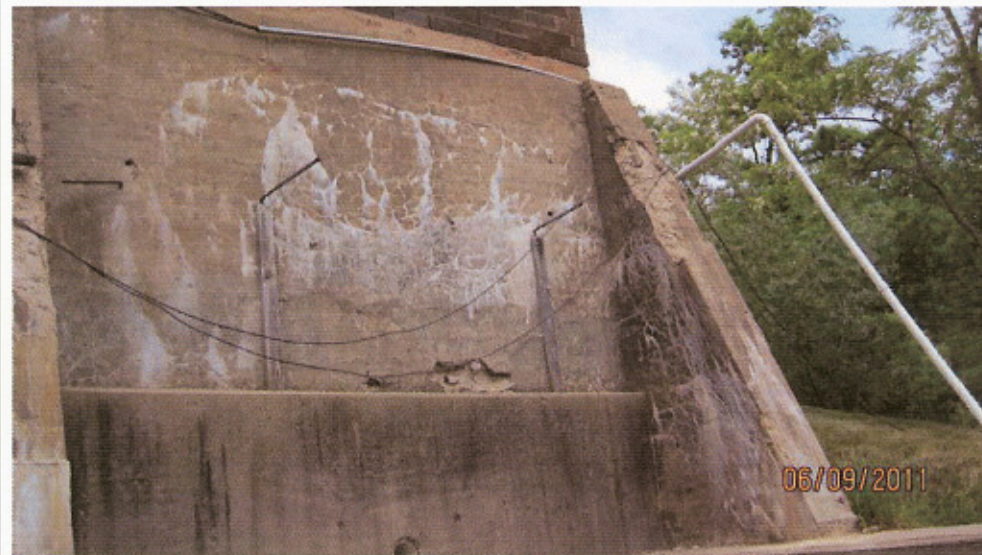
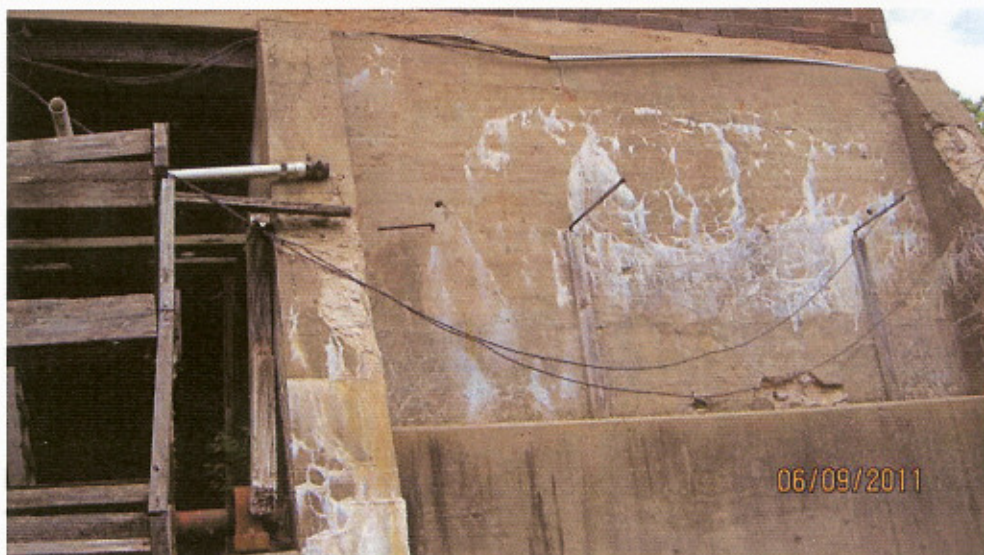
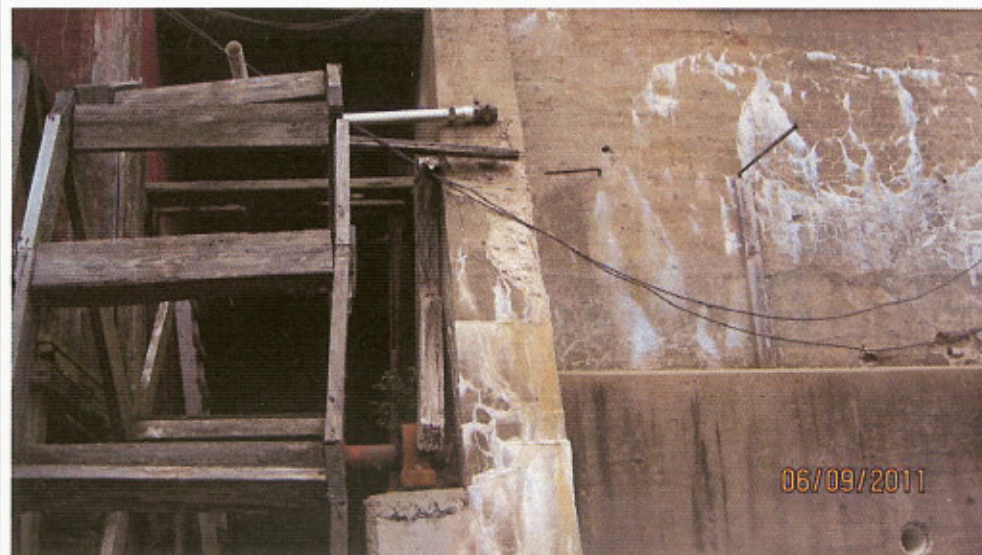
The rear powerhouse foundation wall and bulkheads have some concrete deterioration above the flume. The 1995 flume reconstruction was designed to be independent of the powerhouse. Concrete repairs should made to the powerhouse foundation walls and support structures should hydroelectric generation ever be reconsidered.

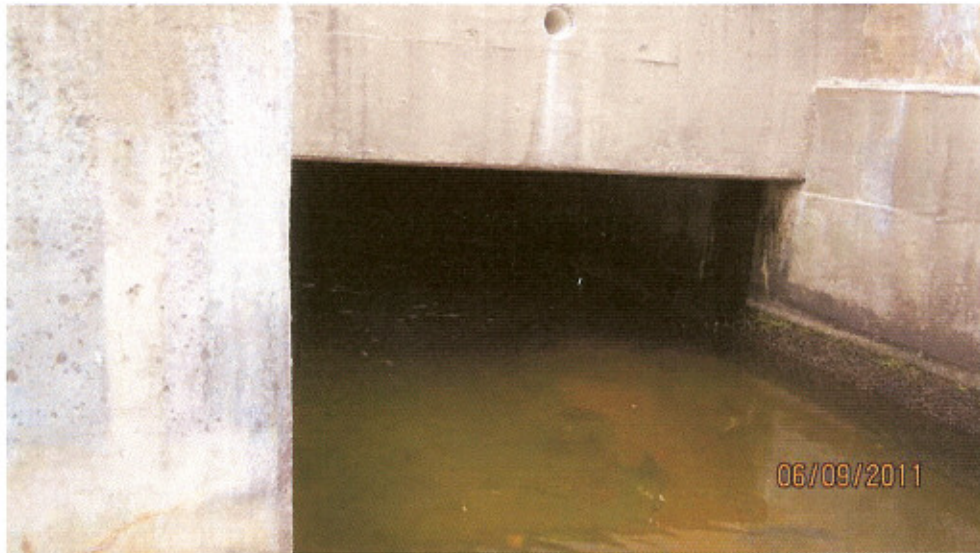
Tailwater Slab (0009300609201132)

Flow was briefly shut off during the inspection to allow examination of the outlet area. The tailwater slab within the powerhouse appears to prevent outlet erosion under normal flow conditions. No scour or undermining of the slab was observed during the inspection.

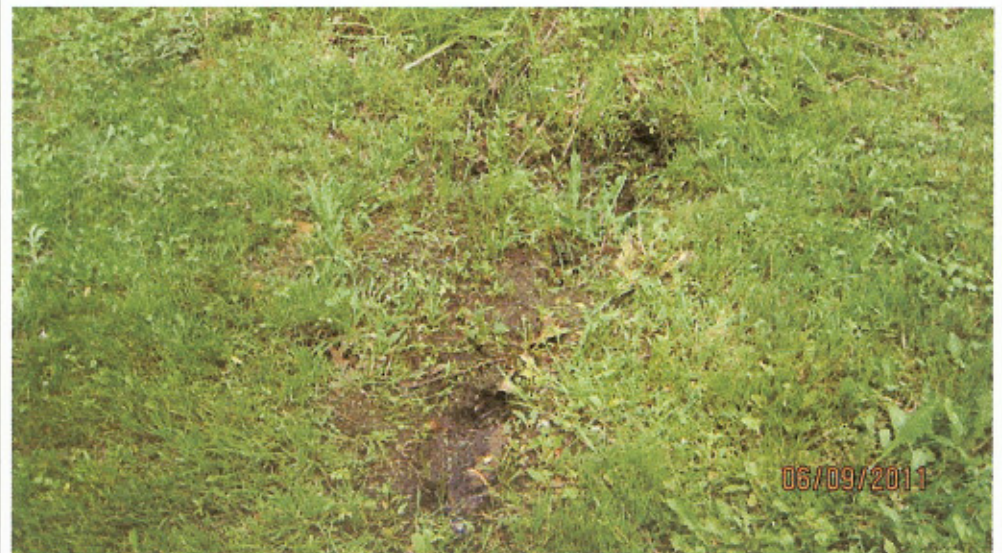
Minor Seepage Area D/S Left Side (0009300609201143)

Several wet areas with cattails were noted beyond the toe of the downstream primary embankment which appear to be natural low areas with no flowing water. One very small area of seepage was noted near the left side downstream flume abutment. Seepage flow was barely noticeable and appeared clear, however this area should be monitored for future changes.

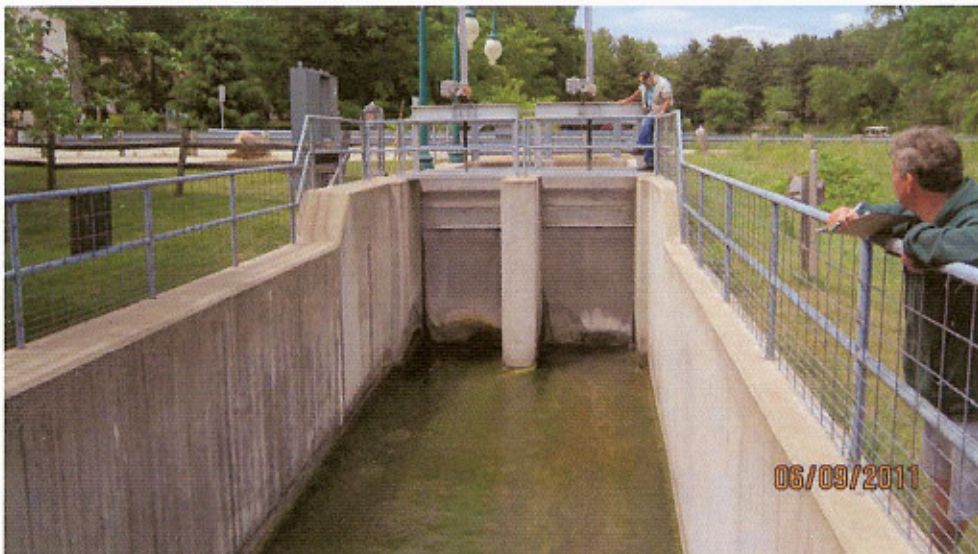
Slide Gates - Upstream (0009300609201154)

The flow within the flume is regulated by two, side by side, 5-foot wide by 9-foot high, electrically and manually-operated, bottom-opening vertical slide gates. Stop log slots are provided on both upstream sides of the slide gates to control water flow for repair or servicing of the gates. The gates are bottom operated by two electrically and manually operated screw jack hoists. The gates were operated and are in good working order.
