Initial Seismic Vulnerability Assessment of Trashigang District Hospital Trashigang, Bhutan

December 21, 2013

GEOHAZARDS

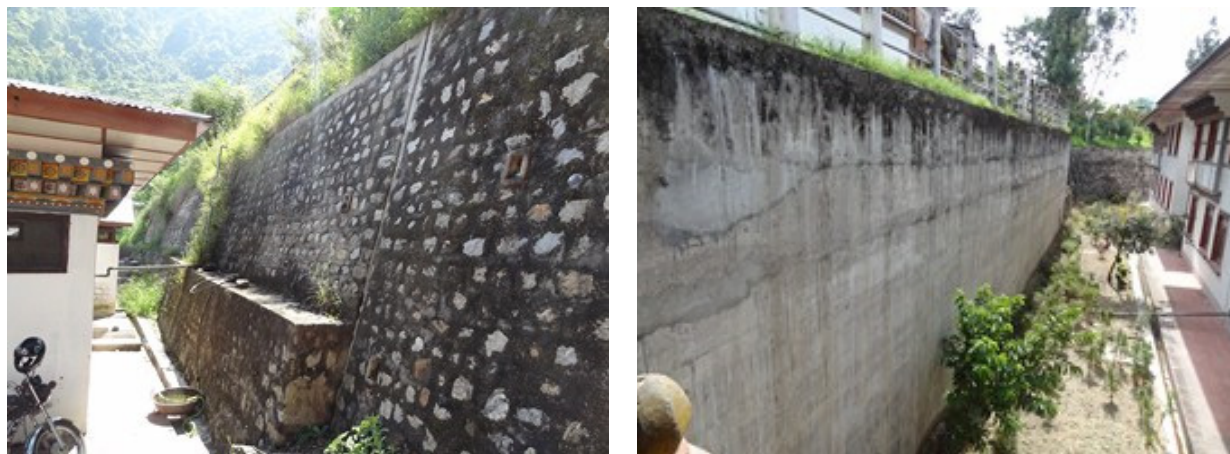
Figure 5. Stone masonry retaining wall behind supporting buildings located upslope from the main hospital (left); reinforced concrete retaining wall behind the main hospital building (right)

Most retaining walls are stone masonry gravity walls, though a large reinforced concrete wall holds up the slope behind the main hospital building. At the time both the original and new hospital buildings were built, common retaining wall design practice considered gravity loads only (albeit for saturated soil conditions), and not seismic loads. As a result, the hospital's retaining walls could be vulnerable to earthquake damage. The large reinforced concrete retaining wall behind the hospital has rotated toward the hospital slightly and is likely to rotate further during earthquake shaking (Figure 5).

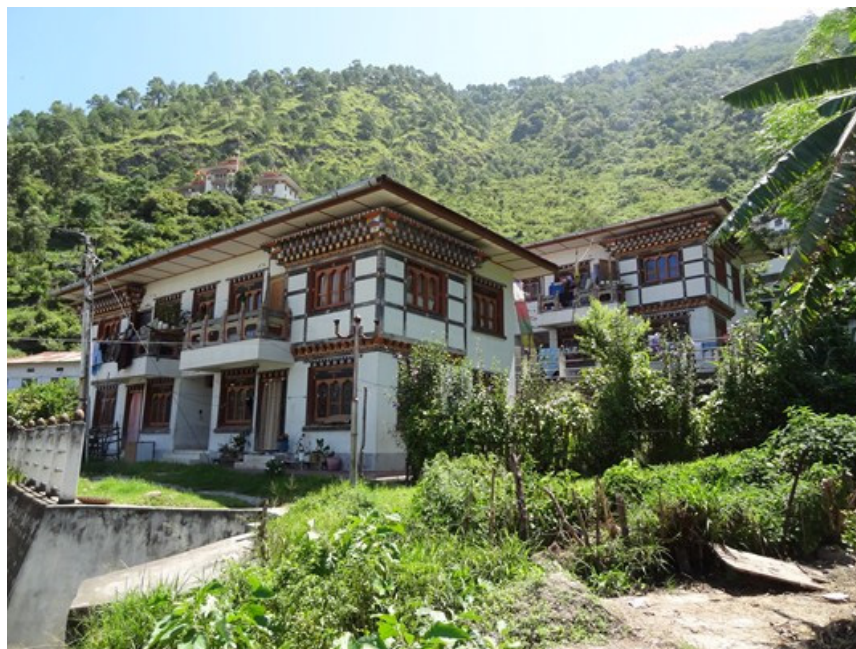
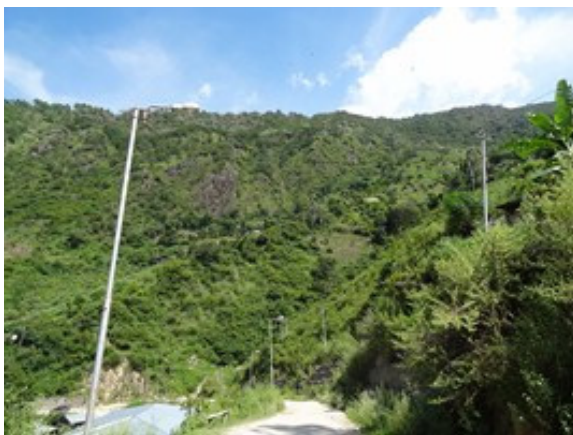
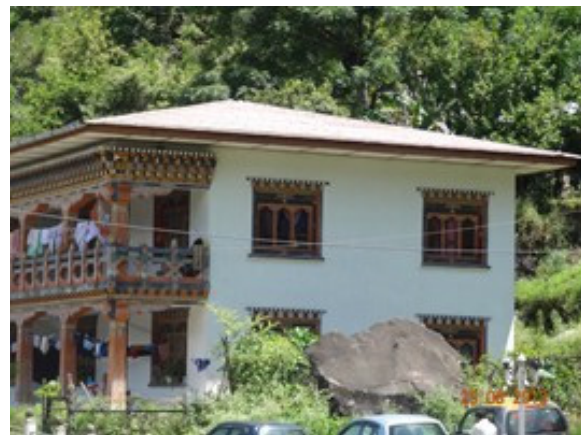
Figure 6. Hospital staff quarters with courthouse in background (above), steep slope and cliff above the courthouse (below left), large boulder next to staff quarters below court house (below right)

The landslide hazard for Trashigang is qualitatively described in a recently published geotechnical study of Trashigang town³. The Trashigang District Hospital is not specifically addressed in that geotechnical study, however, the report provides some important information for the preliminary evaluation of landslide hazards in the hospital study area. The primary landslide hazard considerations presented in the report include the presence of crystalline bedrock with three primary discontinuity orientations unfavorably dipping subparallel to the north-facing slopes of Trashigang town. This bedrock condition is principally susceptible to rockfalls and rock slides. Numerous rockfall scars are visible in the steep slopes above the hospital.

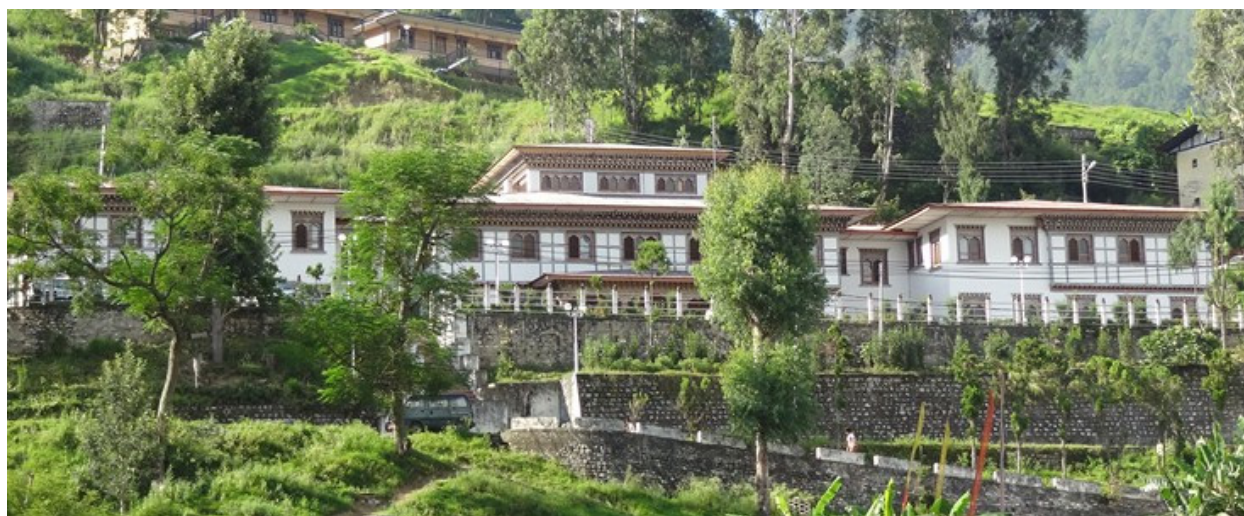
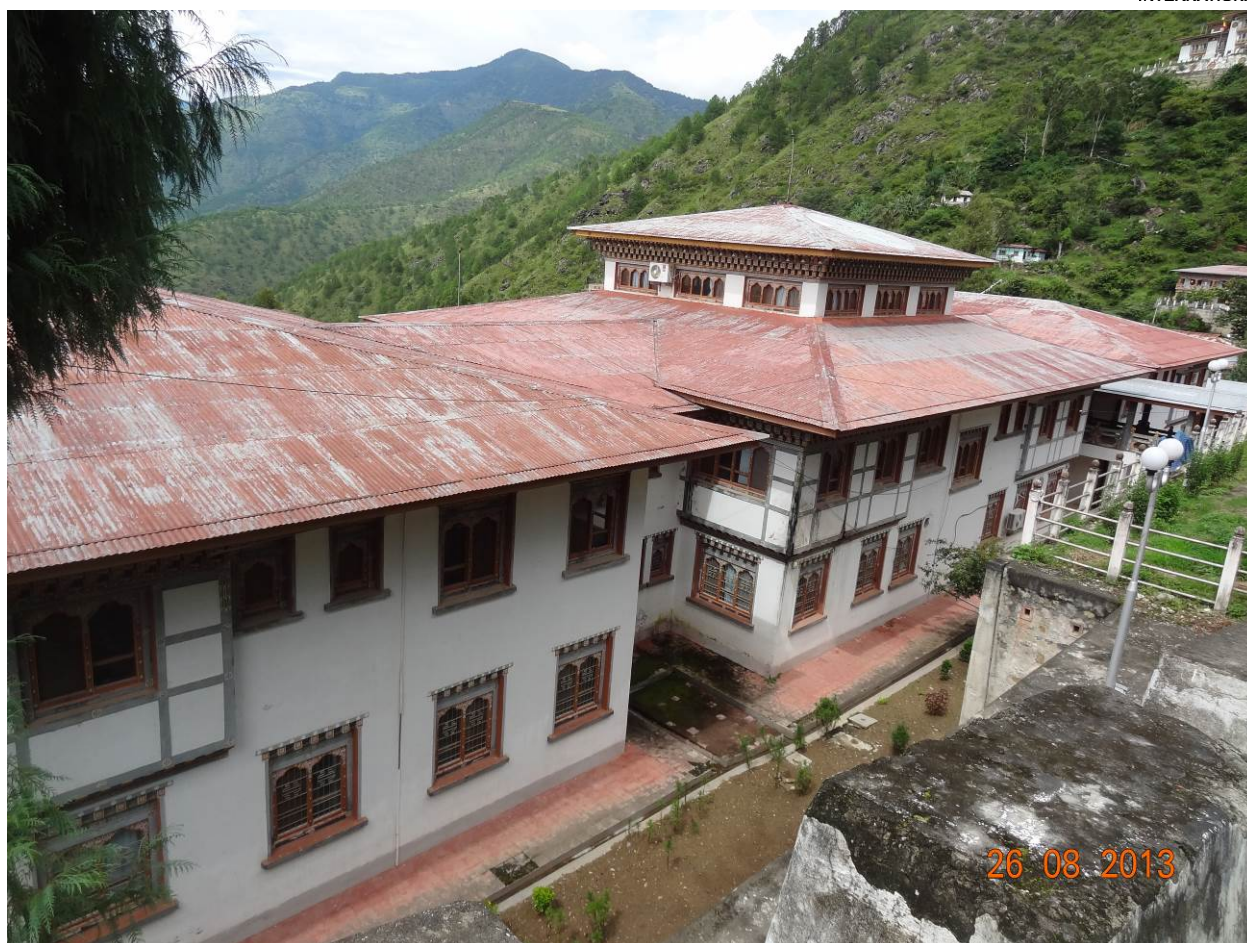
Figure 8. Front exterior view of Main Hospital building

Figure 9. Rear view of Main Hospital building

The building, as a whole, does not have significant vertical irregularities and appears unlikely to collapse or partially collapse in strong shaking. Damage may be greater in the second floor conference room due to dynamic amplification, with partial collapse of this upper structure possible in the very strong shaking

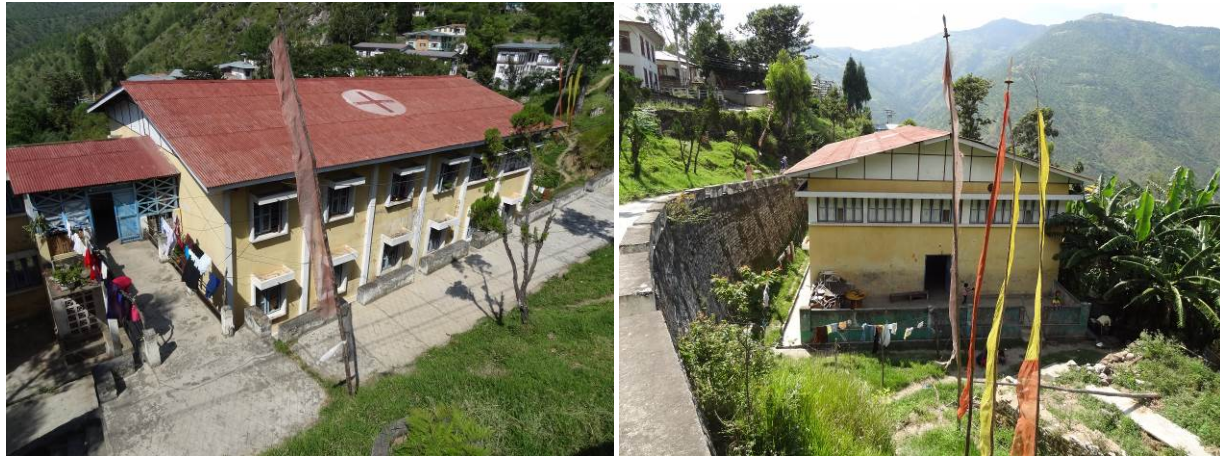
The Old Hospital building, shown in Figure 11, is the original hospital built with Government of India funding in 1975. The ground floor is now used as a tuberculosis ward, while the first floor is being used currently to house hospital support staff and their families. The building is a ground-plus-one-storey reinforced concrete frame building. No structural drawings are available. Based on its age, which predates India's IS 13920, India's ductile reinforced concrete seismic design code, the building is almost certainly a nonductile frame. The building has several additional vulnerabilities. There does not appear to be a beam at the top of the first storey columns in the longitudinal (long dimension) direction, meaning that the frame is incomplete. In the transverse (short dimension) direction, short, thin columns at the top of the first storey at the north end of the building are vulnerable to shear failure. The multiple seismic vulnerabilities of this building put it at risk of collapse during strong shaking.

Figure 11. Front view (left) and side view (right) of the Old Hospital building

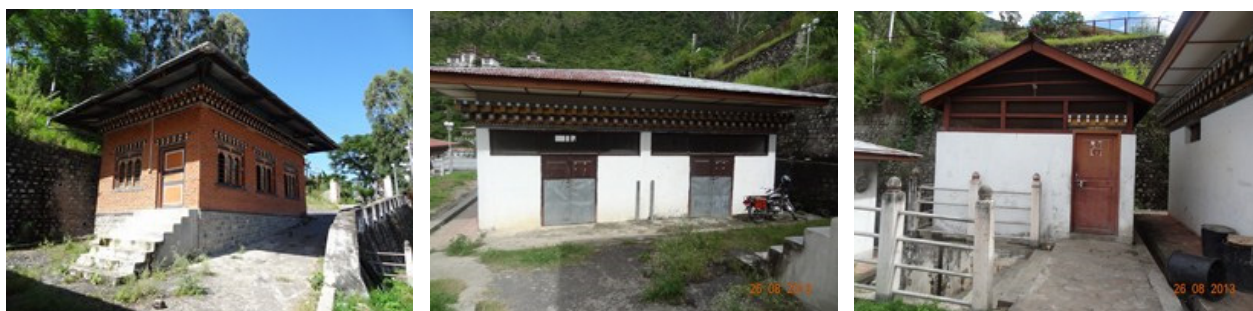
These smaller support buildings are all small plan brick masonry buildings. Several have significant vulnerabilities. The Prayer Hall has one solid wall and three walls with numerous openings that create narrow piers. Though there is a seismic band at the roof, there is no reinforcing in the narrow piers where damage is likely to occur. The Prayer Hall is likely to be badly damaged in a strong earthquake. The Laundry building has short piers on one side, making it vulnerable to earthquake damage, as Figure 14 shows. The Incinerator building does not appear to have a seismic band; this constructed building is significantly different than the Incinerator building shown on the drawings. The team considered these three buildings to be more seismically vulnerable than the other buildings of the same construction type at the site. The Kitchen and Bath buildings, shown in Figure 15, should have a seismic band according to the drawings.

Figure 14. Prayer Hall (left), Laundry (center) and Incinerator (right)

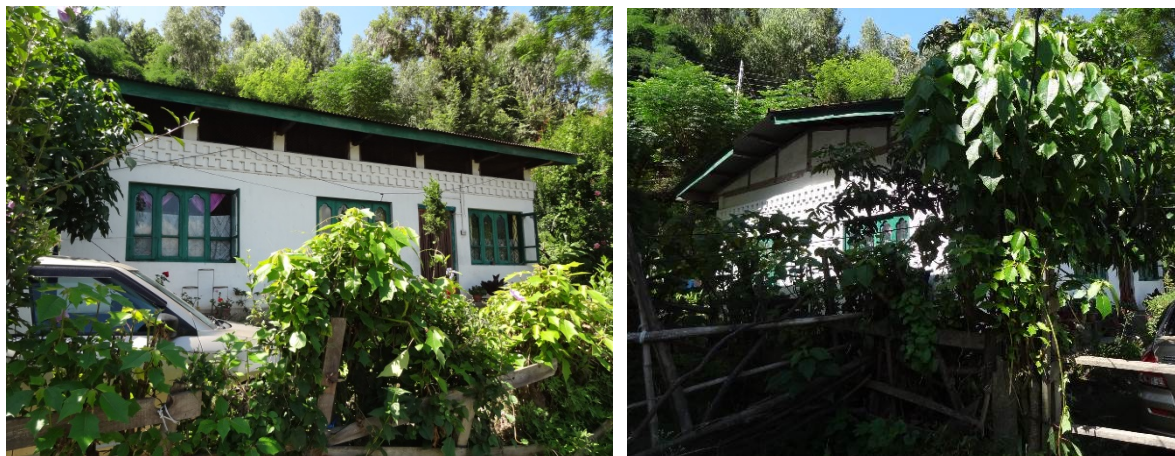
have shown that unreinforced masonry gables are vulnerable to damage, and parts of them can easily fall outward during shaking.

Figure 18. Bungalow type staff quarters showing masonry gable (left); view from uphill (right)

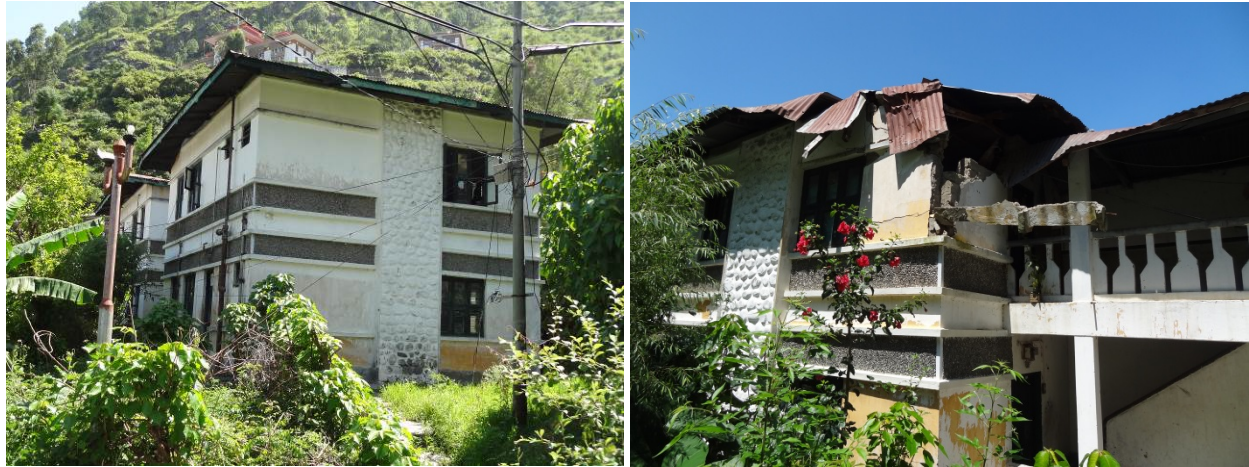
The hospital has one older fourplex, which appears to be a similar age as the bungalows described earlier. This ground-plus-one-storey building, shown in Figure 21, appears to be unreinforced stone masonry. Staff quarters of similar age with what appears to be the same design are found at the Jigme Dorji Wangchuck National Referral Hospital in Thimphu. A falling tree damaged one unit, and the building is scheduled for demolition.

Figure 21. Older fourplex staff quarters (left); damage caused by fallen tree (right)

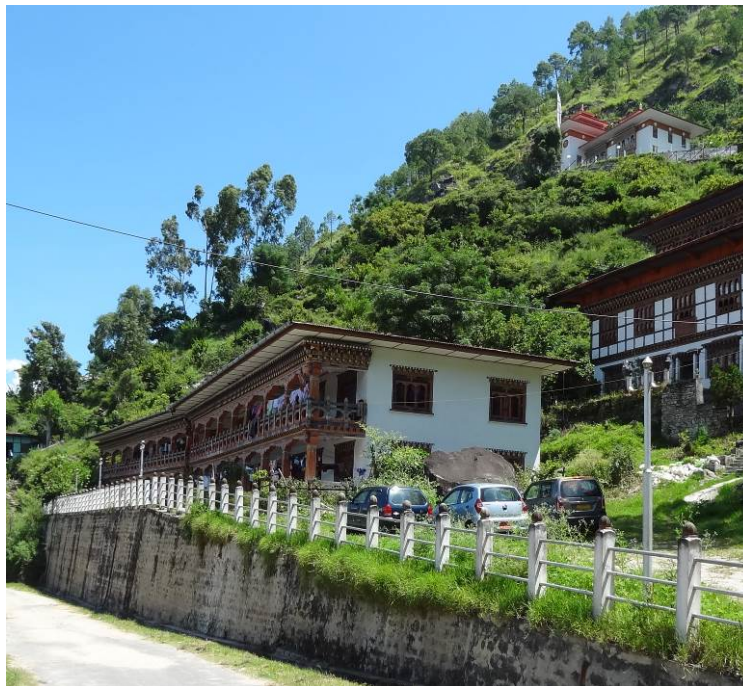
The hospital has two large staff quarters for non-medical staff, which are reinforced concrete frame buildings with brick infill constructed along with the new hospital in 2002-2004. These quarters are above the road that runs behind much of the hospital site. The architectural drawings refer to these as “Type 100” staff quarters. Figure 22 shows the very large boulder sitting next to one building, which indicates that rockfalls may be a significant hazard for these buildings. According to local engineers, boulders fell from the cliffs above the courthouse building in the upper right corner of the photo during the 2009 Mongar earthquake.

Figure 22. Support staff quarters with large boulder (located alongside building); courthouse is building at upper right

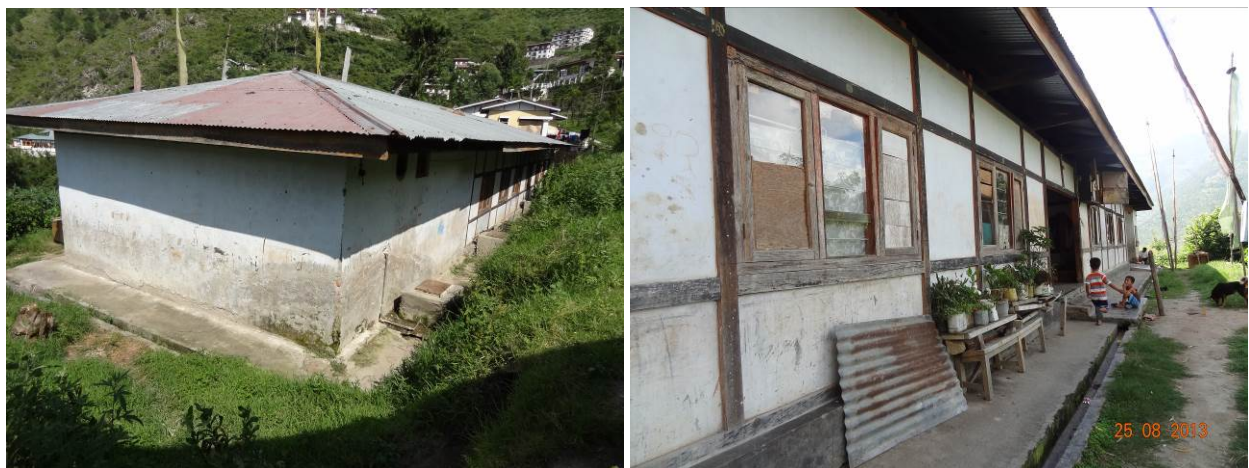
The old hospital's outpatient department building, built in the 1970s, has been converted to staff quarters. This building is primarily ekra (timber frame with panels of plastered ekra reed lattice), with one end that is unreinforced brick masonry as Figure 24 shows. The brick portion is not braced by a roof diaphragm, and the ekra walls do not provide adequate support. This portion is likely to be damaged by strong shaking.

Figure 24. Back view (left) and front view (right) of the old OPD, now staff quarters, showing brick masonry portion on end

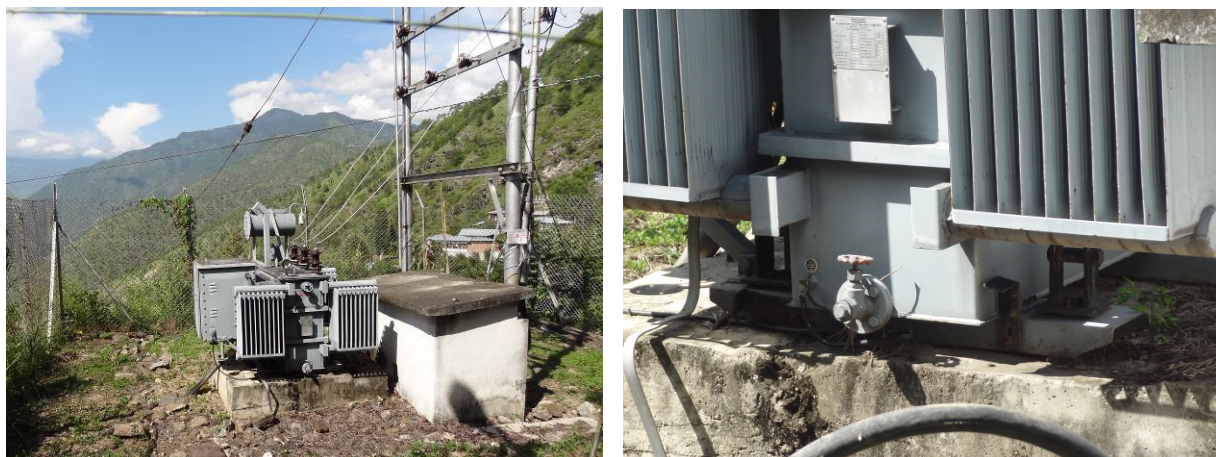
The transformer that receives the grid power supply appears not to be bolted to its concrete base (the team could not confirm, as entry was restricted). The entire system that connects to the grid should be checked for seismic vulnerabilities to ensure that the hospital can access grid power, once it is restored.

Figure 26. Transformer connecting grid power to the hospital (left); close-up of apparently unanchored base (right)

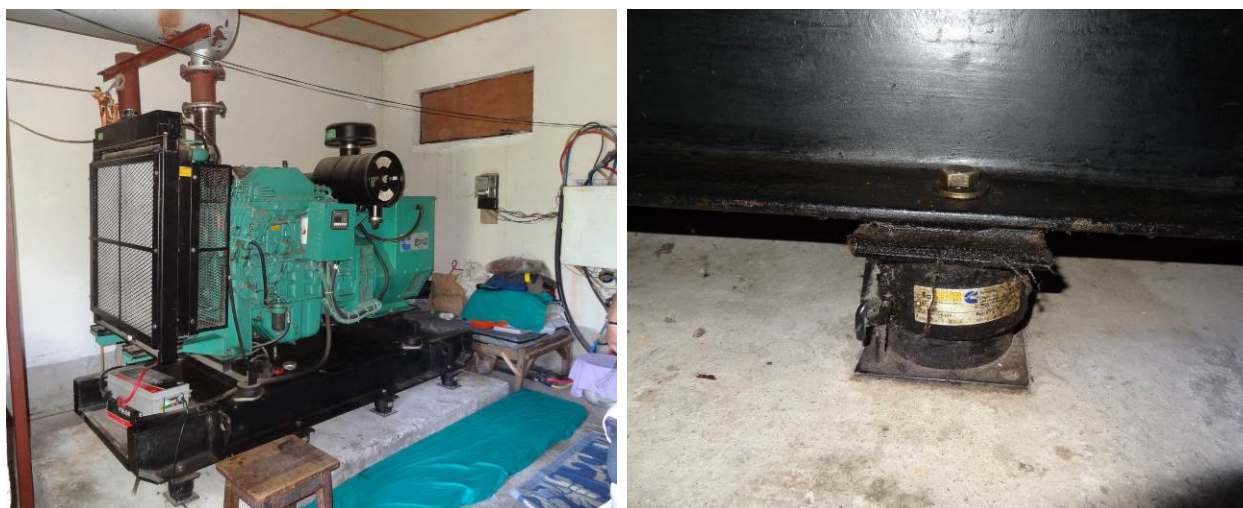
During the immediate response period following an earthquake, and even for days or weeks afterward, the hospital will need to rely on backup power supplied by emergency generators. However, at the Trashigang hospital there is only one emergency generator of 160 KVa. The unanchored generator is likely to slide off of its small “pot bearing” vibration isolators in strong earthquake shaking. The batteries that enable the generator to start are not anchored and may break or become disconnected.

Figure 27. Unanchored emergency generator with inadequately braced exhaust system and unsecured batteries (left); non-seismic vibration isolators (right)

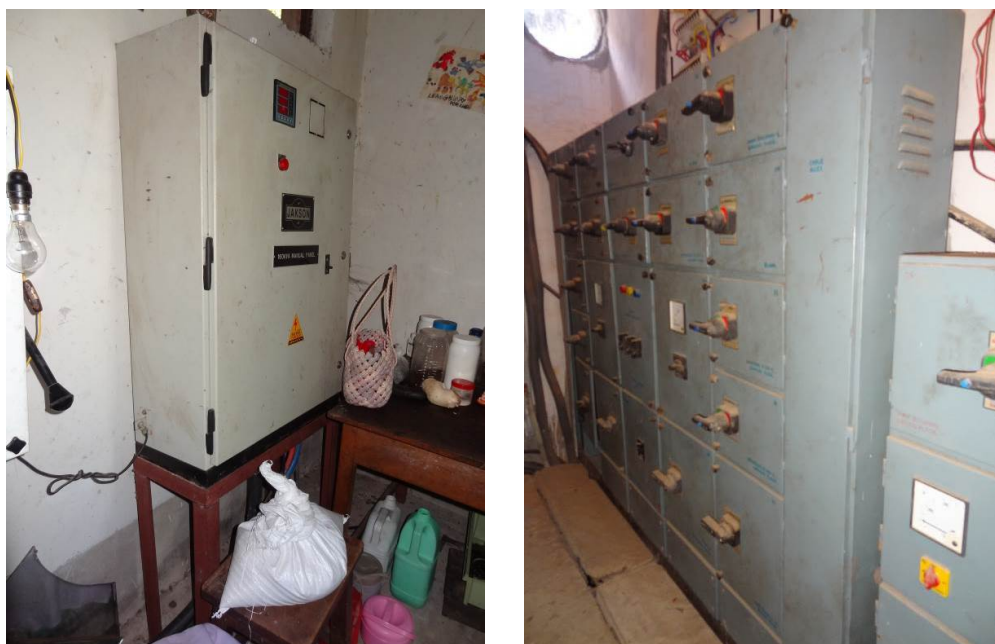
The electrical cabinets housing switchgear and controls are unanchored and could topple, because they are tall and narrow. The team recommends that the electrical cabinets be anchored appropriately, which is not difficult to do. However, electrical cabinets and other electrical equipment can be very dangerous – one can be seriously injured or even killed by opening an electrical cabinet unsafely. Only trained electricians should open or work on electrical cabinets or equipment.

Figure 28. Tall and narrow apparently unanchored electrical cabinets sitting on frame in generator house (left) and under stairs in main hospital building (right)

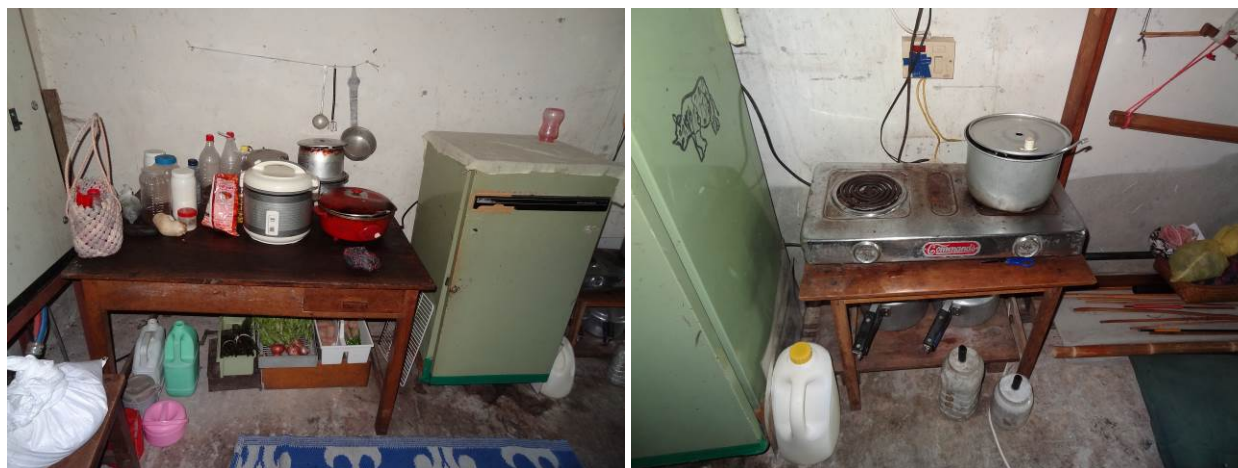
The team also observed that the support staff responsible for the operation of the generator and its maintenance was living in the Generator House with his family. The family had cooking gas cylinders, stoves and other household items that could pose a fire hazard to the generator house. While the team understands the shortage of staff housing and the need for the staff to be close by to operate the generator in case of emergencies, the team highly recommends shifting the family out of the generator house for their own safety and for the safety of the generator.

Figure 29. Inside the Generator House, also used for living quarters

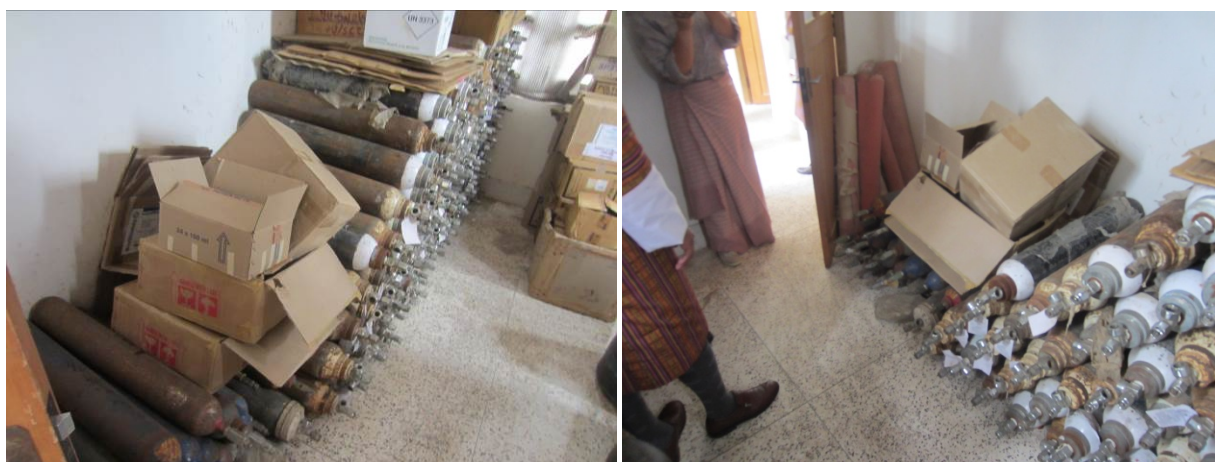
Figure 30. Medical gas cylinders stored inside the Medical Store (left), cylinders likely to roll down and block the door (right)

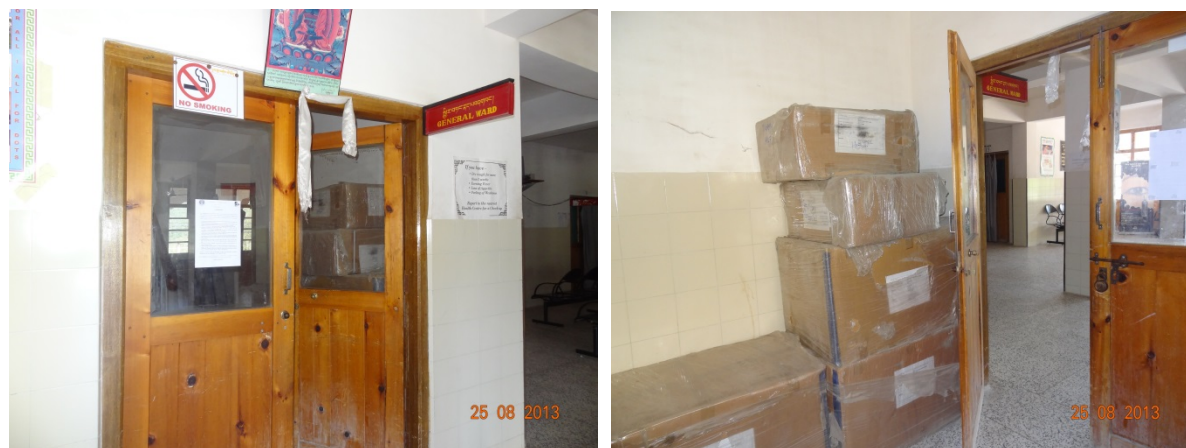
Figure 35. Entry to the general ward in the Main Hospital (left), entry/exit blocked by stored boxes (right)

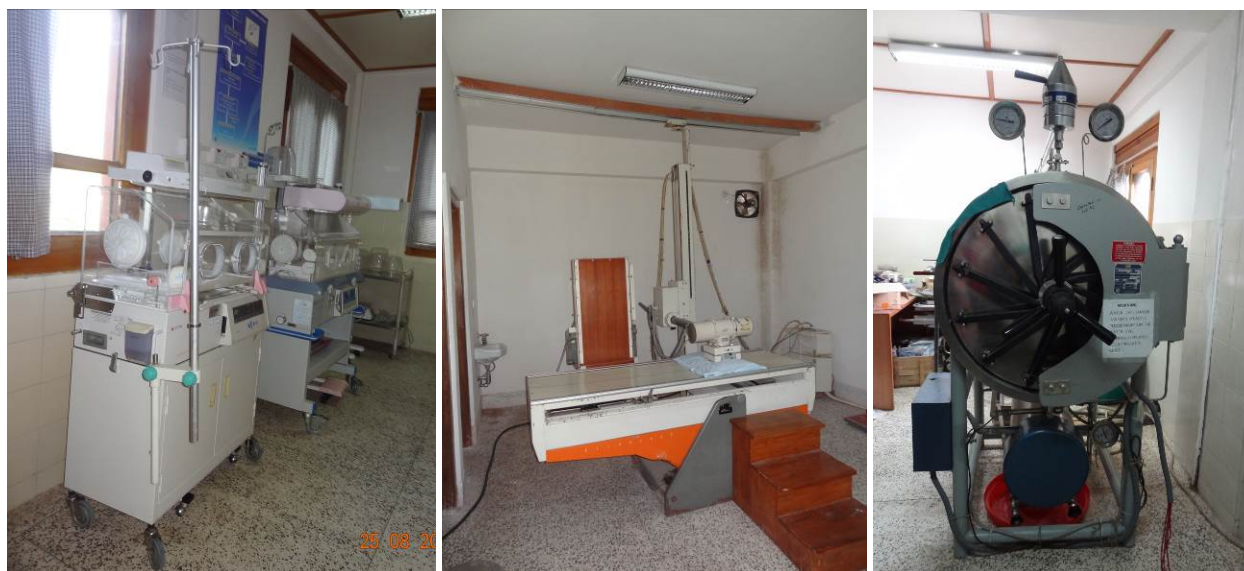
Figure 36. Unanchored medical equipment in Trashigang hospital including incubators, X-ray machine and autoclave

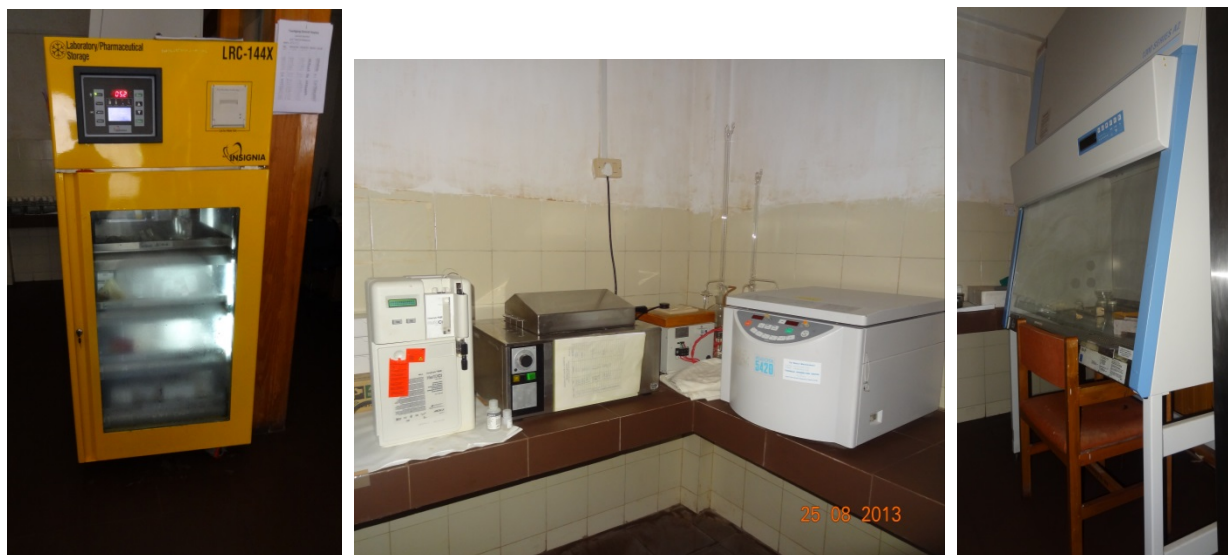
Figure 37. Unanchored laboratory equipment

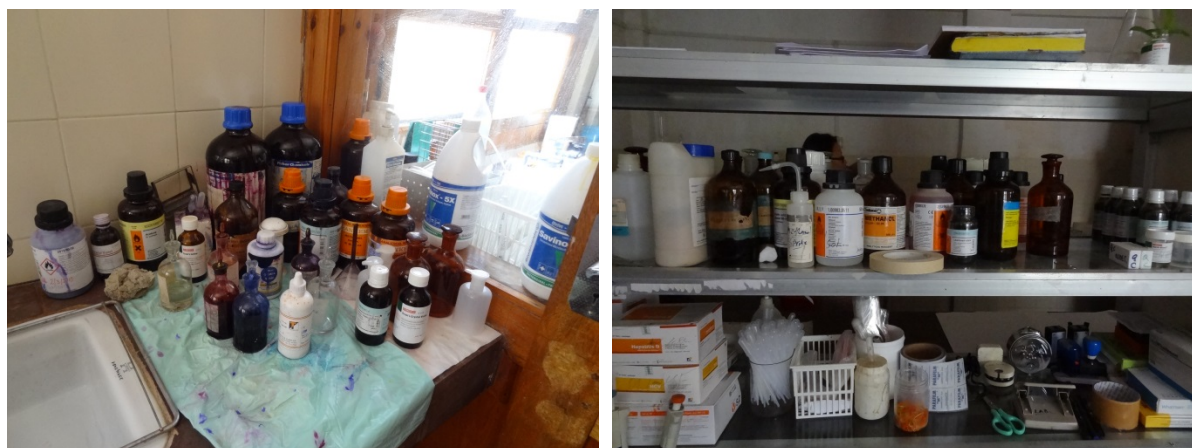
Figure 39. Potentially dangerous chemicals unrestrained on counter tops open shelving in the laboratory

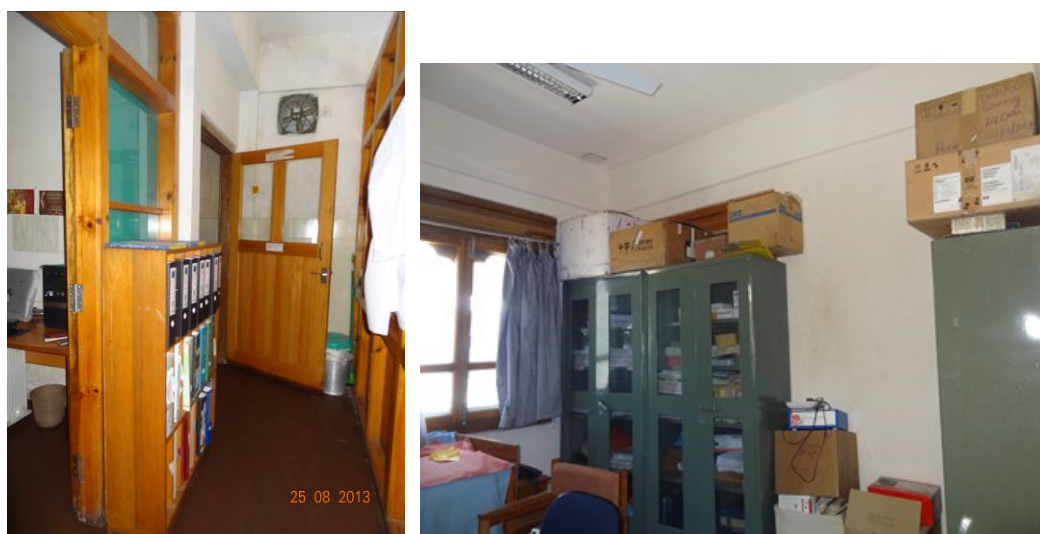
Figure 40. Heavy shelving and glass partitions by an exit pathway (left) and unsecured cupboards near staff work areas (right)

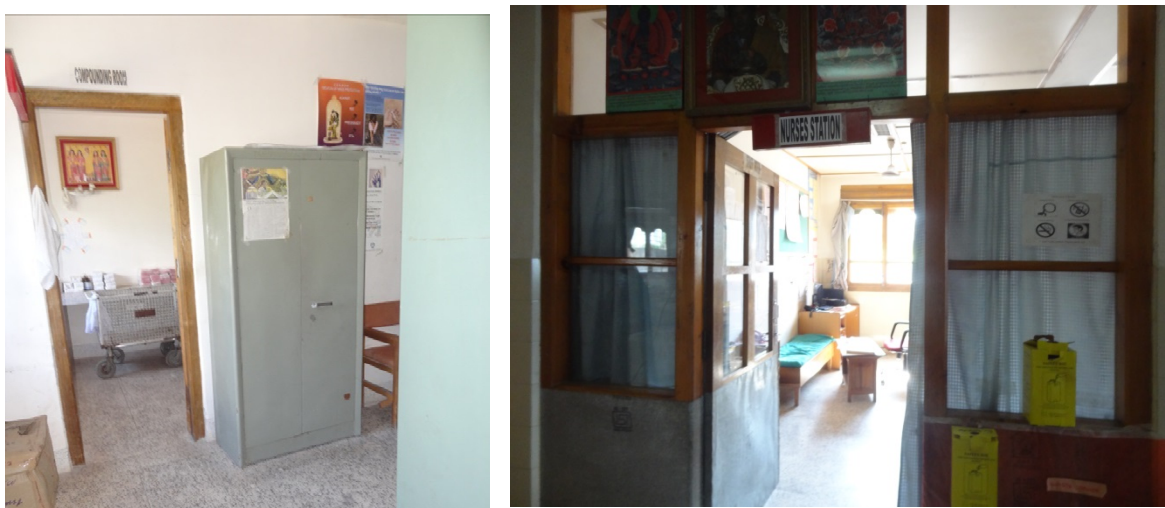
Figure 41. Single wythe brick partition too weak to support large cabinet if it were anchored (left); wood and glass partitions and doors in the nurses station (right)

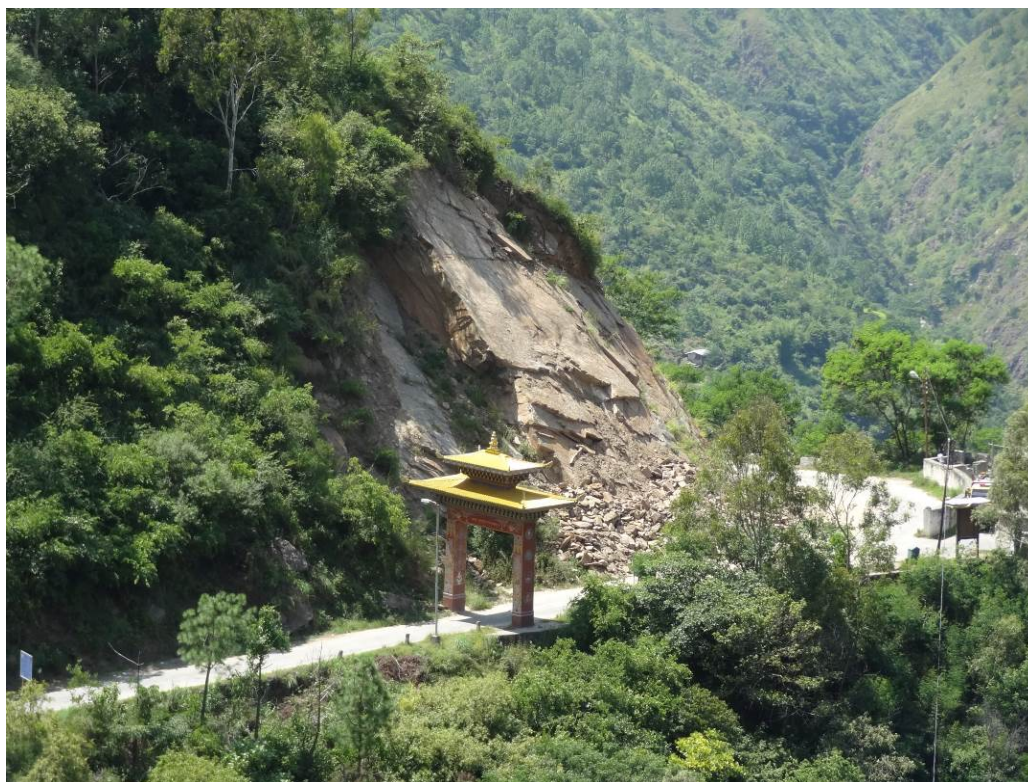
Figure 42. Active landslide area at the entrance to Trashigang town

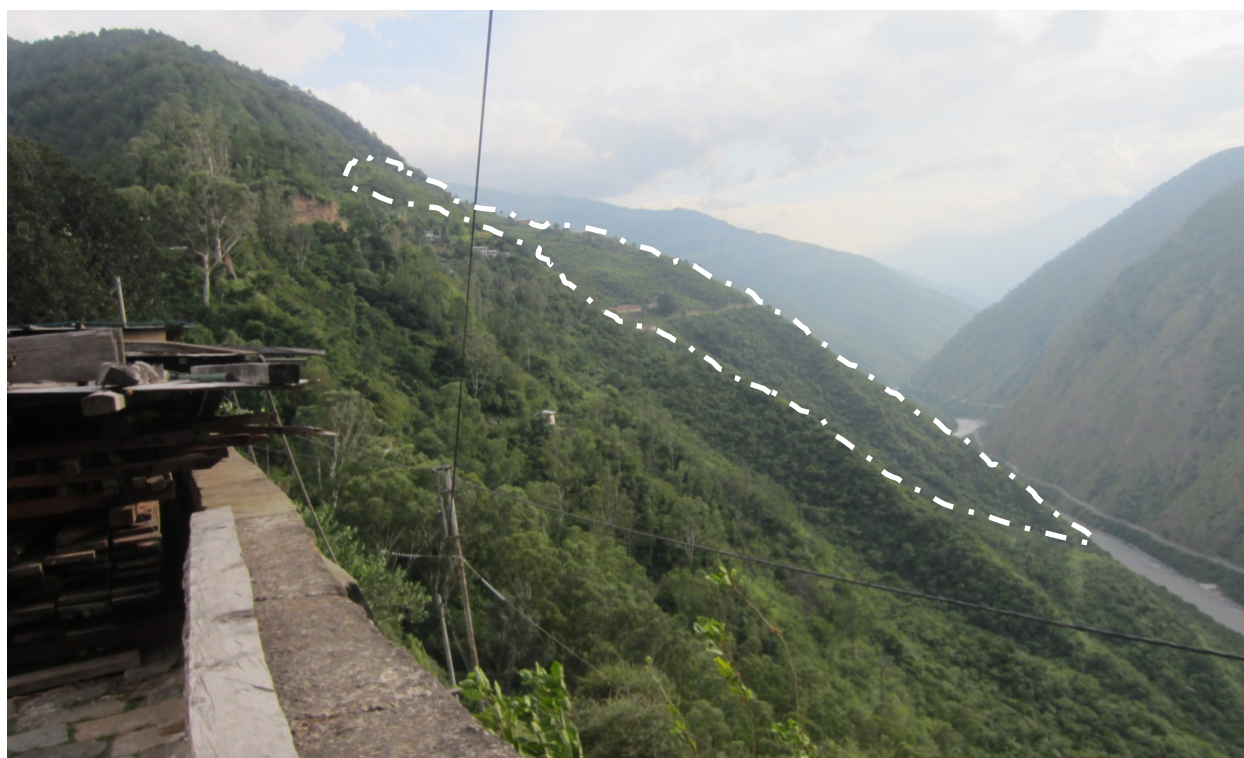
Figure 43. Road between Trashigang and petrol pump at center of photo crosses a large landslide deposit (white outline indicates approximate extent)
