# Initial Seismic Vulnerability Assessment of Trashiyangtse District Hospital Trashiyangtse, Bhutan

December 24, 2013

**GEOHAZARDS**

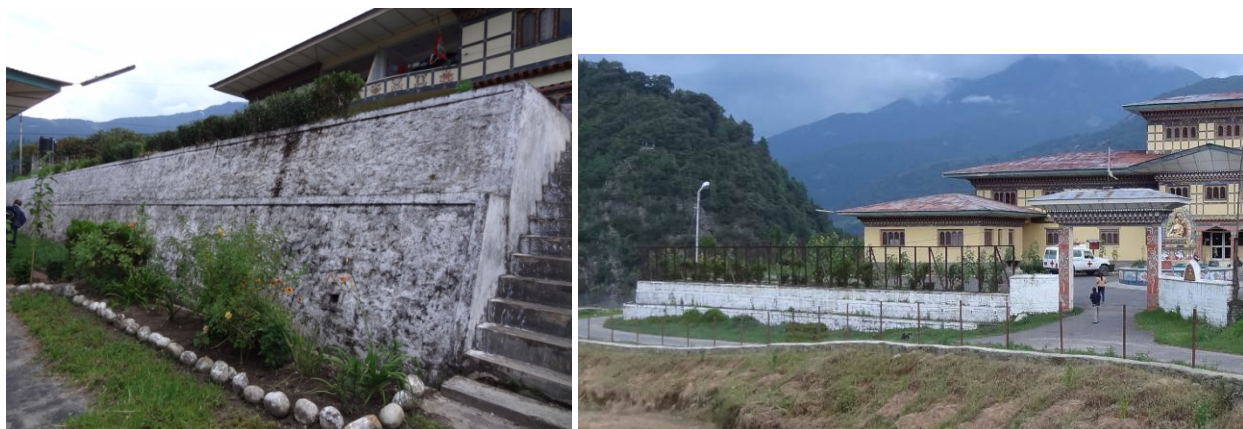
Geotechnical reports were not available for the hospital. The site has large stone masonry retaining walls below the main building and between the main building and the staff quarters as Figure 5 shows. According to HIDD, at the time the hospital was built, common retaining wall design practice considered gravity loads only (albeit for saturated soil conditions), and not seismic loads. As a result, the hospital's retaining walls could be vulnerable to earthquake damage.

**Figure 5. Retaining walls between main building and doctor's quarters (left); below main building (right)**

causing additional damage to that which is described in this report. The evaluation team did not investigate the adequacy of drainage and storm water management at the site, but these should be assessed. The team recommends that any detailed evaluation include a thorough investigation of the site's geotechnical and geologic conditions, drainage conditions and the major retaining walls.

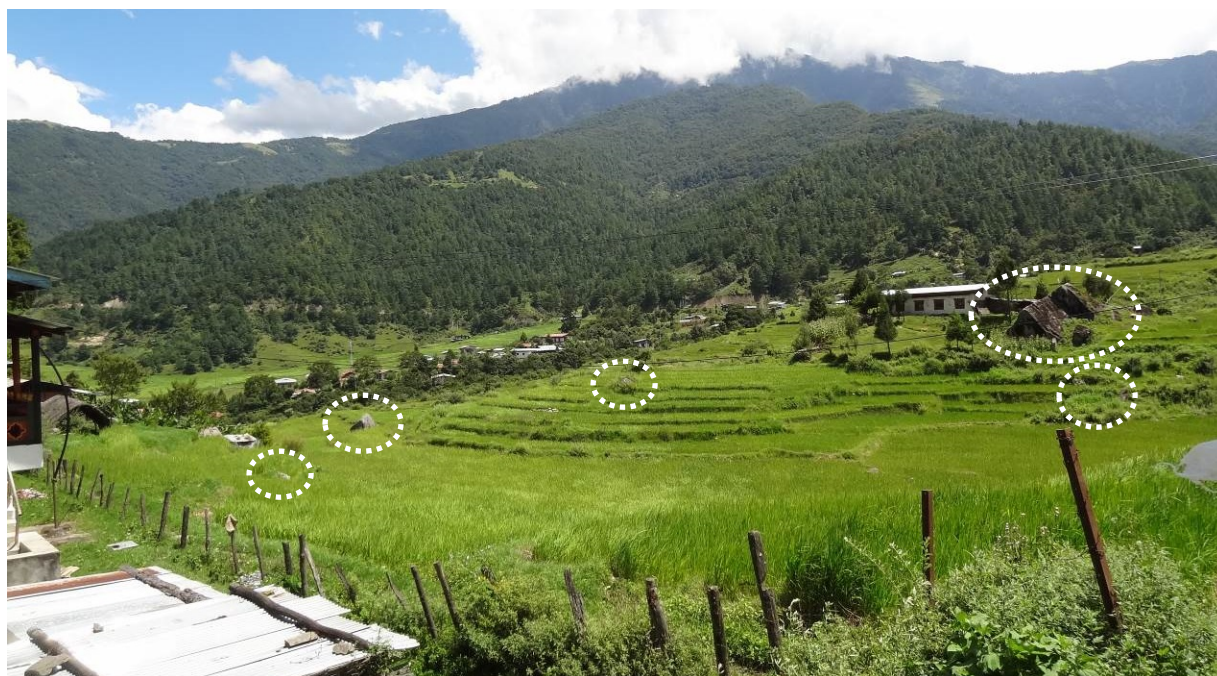
Intermittent debris flows originating in the mountains above Trashiyangtse over the last many thousands of years have deposited a large alluvial fan complex upon which the hospital and Trashiyangtse Town are located. Debris flows continue to be active on the landscape with historical reports of debris flows depositing large boulders and material on the fan slopes just north of the hospital (Figure 6).

Figure 6. Boulders in rice terraces north of hospital that may have been deposited by debris flow

The relative age of deposits on the fan surface can be estimated by geomorphic analysis. Older fan surfaces are higher in elevation and more heavily dissected than younger fan surfaces. Older fan surfaces are often more heavily vegetated and expose fewer coarse deposits such as boulders than younger fan surfaces. Preliminary interpretations of Google Earth imagery and site photographs indicate that the Trashiyangtse Hospital is located on a relatively older fan surface, labeled Qf4 (Quaternary fan 4, where Quaternary refers to the current geologic time period) in Figure 7. The active drainage channel is bounded by the youngest and most active fan deposits (Qf1) with successively older fan surfaces stepping away from the active channel. The potential for a large debris flow to affect Trashiyangtse hospital is considered low due to the relative age of the Qf4; however, a detailed debris flow hazard study is recommended for this site.

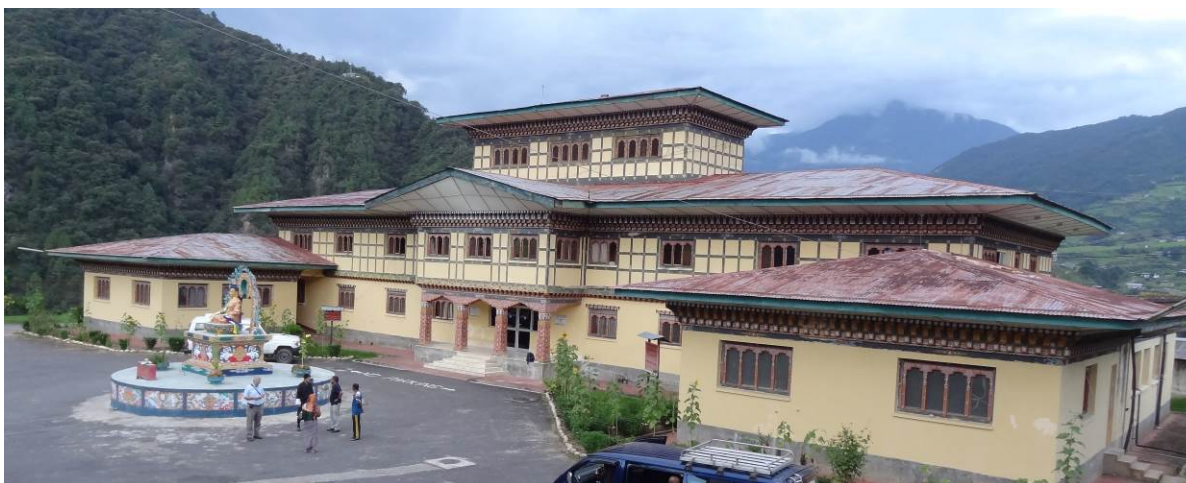
The main hospital building, shown in Figure 8, was built in 1996-1998 with funding from the Government of India. The Lhuentse District Hospital was also built with this same design. The building is a reinforced concrete frame building with masonry infill walls. Most of the building is ground-plus-one-storey, with a small ground-plus-two-storey central portion containing offices, including the District Medical Officer's (DMO) office; this portion of the building will encounter more damage in severe shaking, as will be noted in the hospital impact scenarios. On the front side of the building, the first storey has architectural brick walls that project out beyond the columns to mimic the rabsey (window assemblies) in traditional Bhutanese buildings. These brick walls are not in line with the frame, and as a result they are more likely to topple outward. Normal infill walls in line with the frame are surrounded and confined by the beams and columns, and are less likely to fall out. Bricks from projecting infill walls can fall and create a hazard for people down below.

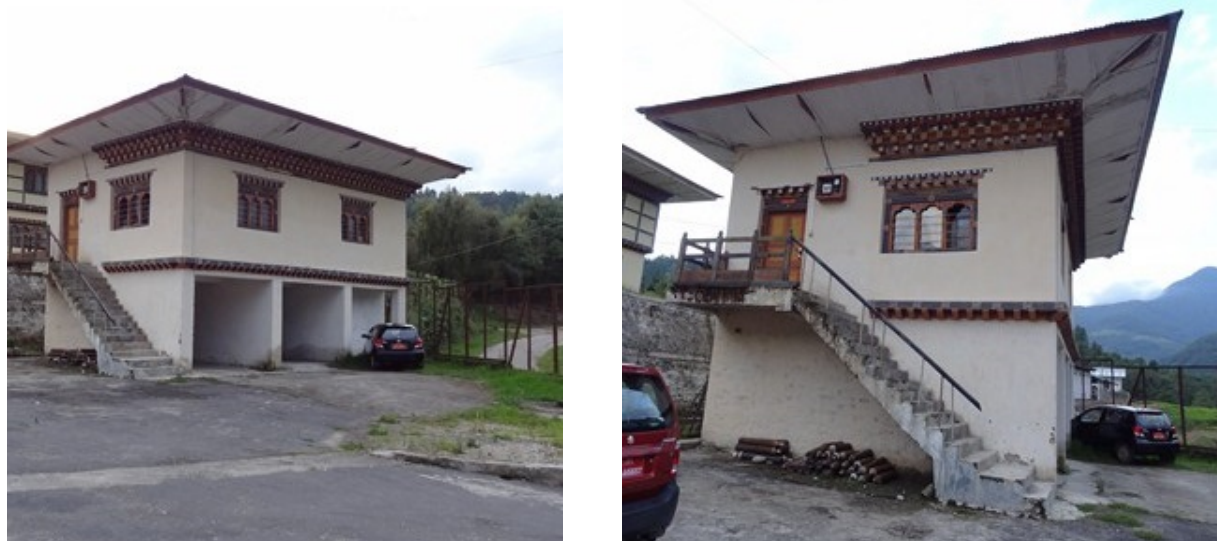
The medical store building, shown in Figure 11, was built at the same time as the main hospital building, also with funding from the Government of India. The building is a ground-plus-one-storey reinforced concrete frame building. The ground floor was built as a car garage, but one side was closed in with stone masonry walls and now houses an autoclave machine for sterilizing medical waste before it goes to the municipal disposal. Because of the garage, the building has a relatively open ground storey with fewer walls than the storey above. In past earthquakes elsewhere, buildings with open ground storeys have performed poorly, with many collapsing. Though there are some solid walls in the transverse (short plan dimension) direction, the ground storey in the longitudinal (long plan dimension) direction is open and appears much weaker than the storey above.

**Figure 11. Front (left) and side (right) views of the medical store building**

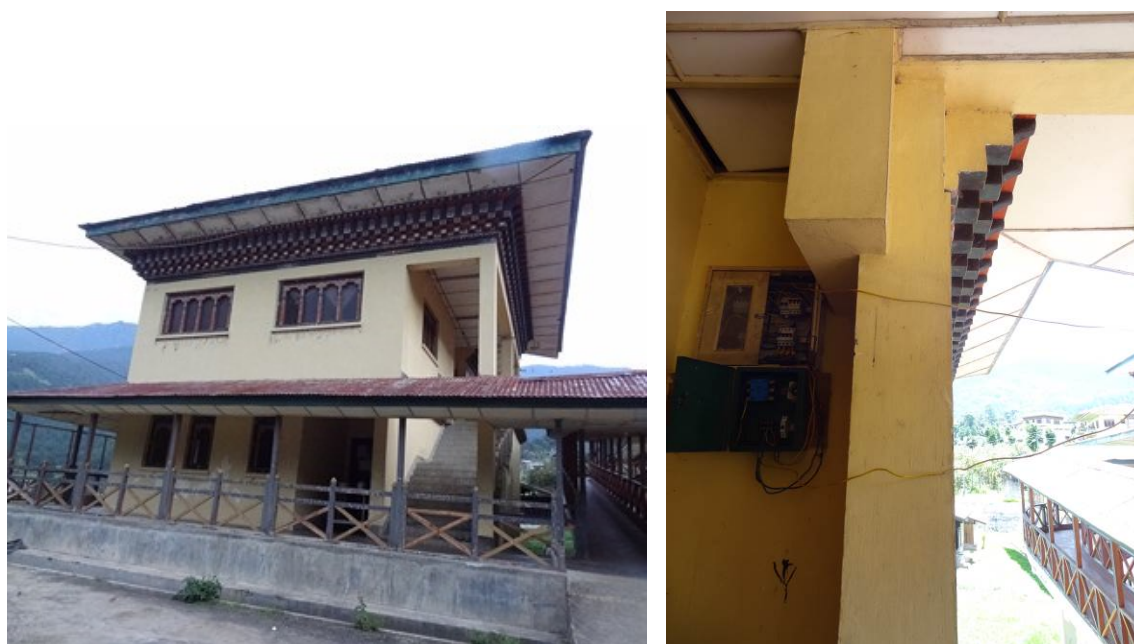
The kitchen and non-drug medical store building, shown in Figure 12, is a ground-plus-one-storey building constructed together with the main hospital building. It is a reinforced concrete frame building with masonry infill walls. The building also has architectural brick walls that project out beyond the frame, similar to those on the main building.

**Figure 12. Side view of the kitchen and non-drug medical store building (left); brick walls projecting beyond frame (right)**

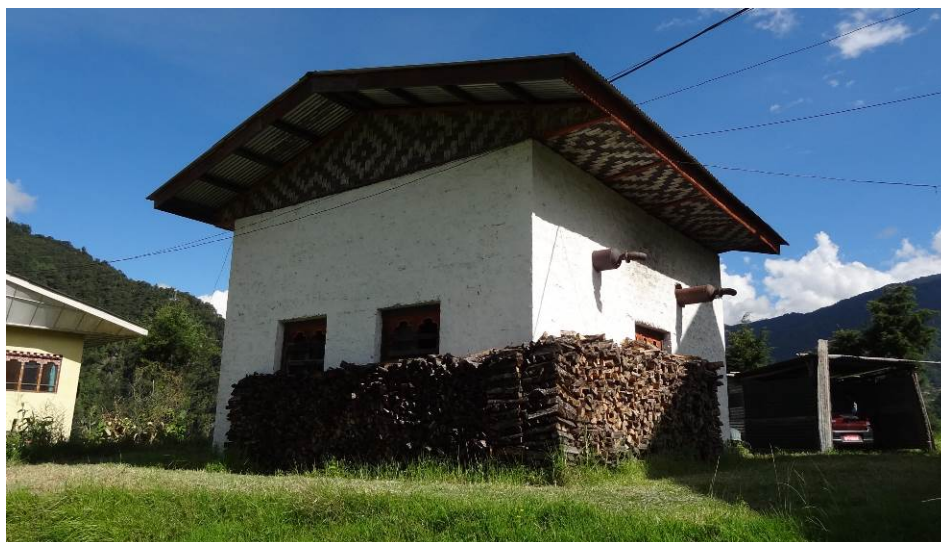
Figure 13. Generator building

building does not have seismic bands or other earthquake resistant features. As a result, the generator building is expected to experience more damage than will the concrete frame buildings.

“through stones” (long stones that connect the inner and outer wythes together). The walls are quite tall, there is no roof diaphragm, and there is no seismic band, meaning that the stone walls are quite vulnerable to earthquake damage.

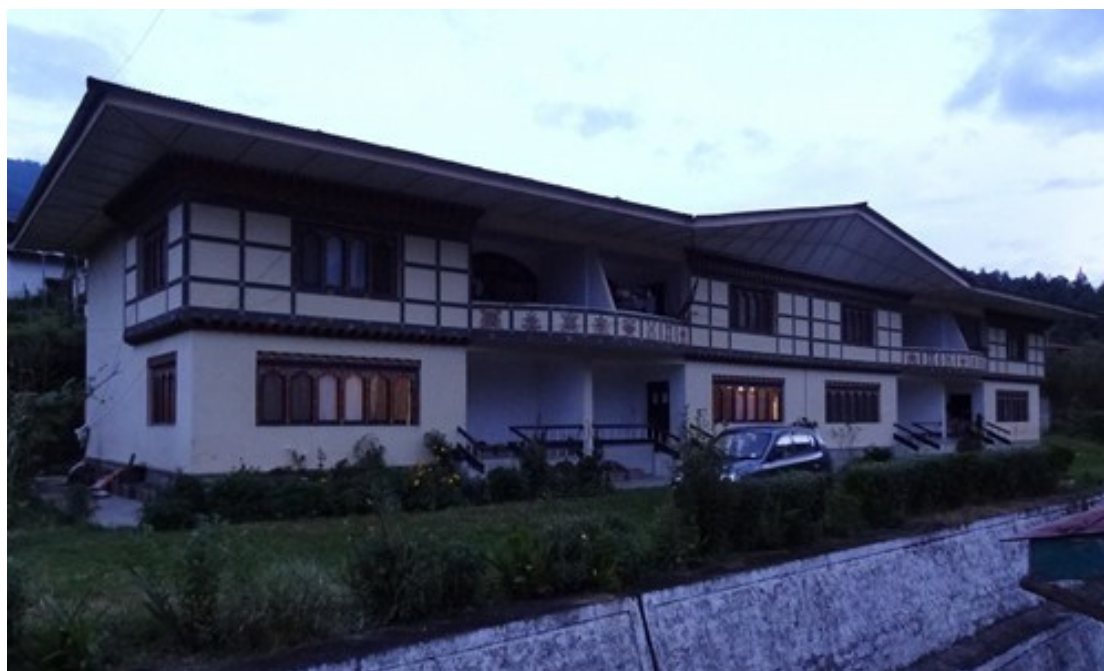
Figure 14. Type I Fourplex Doctor's Quarters

The hospital has a building with four quarters for doctors and senior staff, shown in Figure 14. These reinforced concrete ground-plus-one-storey buildings were designed by HIDD and constructed from 1997-1998. HIDD refers to these buildings as “Type I” quarters. Buildings constructed from this same plan are present at Jigme Dorji Wangchuck National Referral Hospital (JDWNRH). The building has double wythe brick exterior walls and single wythe interior brick partitions. The front of the building has architectural brick projections in the first storey, which can fall from the frame much more easily than normal infill walls that are in line with and therefore restrained by the frame. Bricks from these walls create a falling hazard for anyone who happens to be down below.

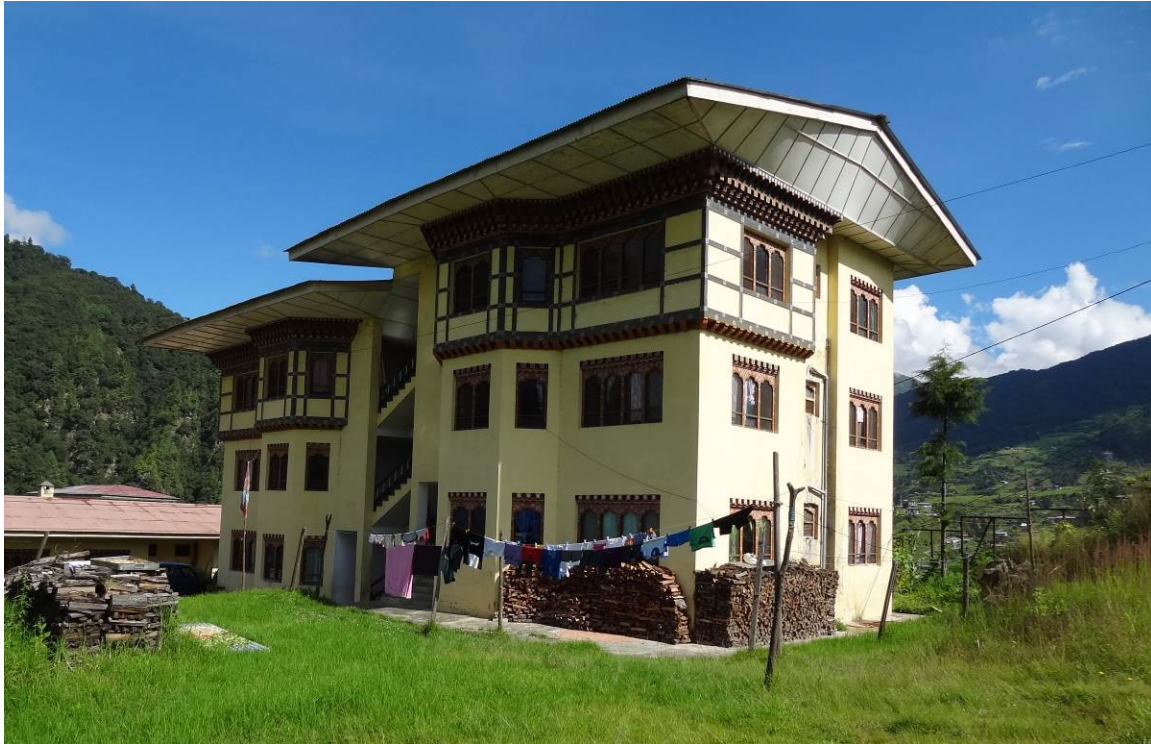
Figure 15. Type II Nurses' quarters

The hospital has one building that is a Type II nurses' quarters building constructed at the same time as the main hospital building. The “Type II” is a standard plan building, and there are a number of identical buildings at JDWNRH. It is a reinforced concrete frame building with masonry infill walls, with a very large step in elevation – almost a half storey - at the center of the building. The top storey has brick architectural projections that can fall during strong shaking.

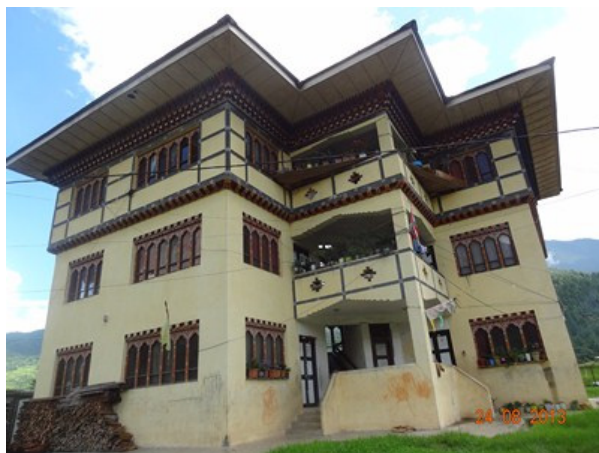
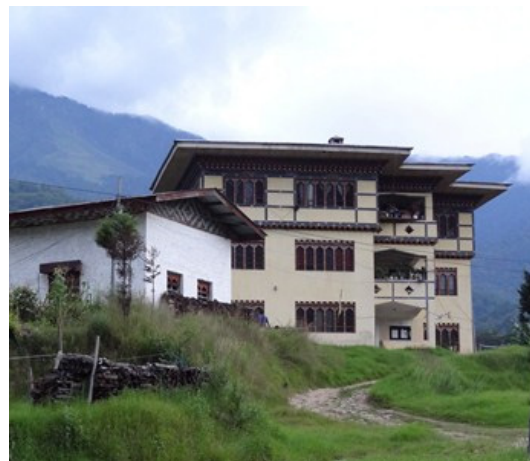
There is one Type III ground-plus-two-storey building housing staff working at the hospital. The building was built in 1997-1998 from standard plans designed in HIDD. As is the case with the Type I and Type II staff quarters, buildings constructed from the same standard plans are also located at the Jigme Dorji Wangchuck National Referral hospital. The building has a reinforced concrete frame, presumably with ductile seismic detailing per the Indian Standard IS 13920, and brick masonry infill walls. Like the other staff quarters at the site, the building has architectural brick projections in the top storey, which can fall from the frame much more easily than normal infill walls.

Figure 16. The ground-plus-two storey staff quarters front view (left) and side view (right, with generator building in front)

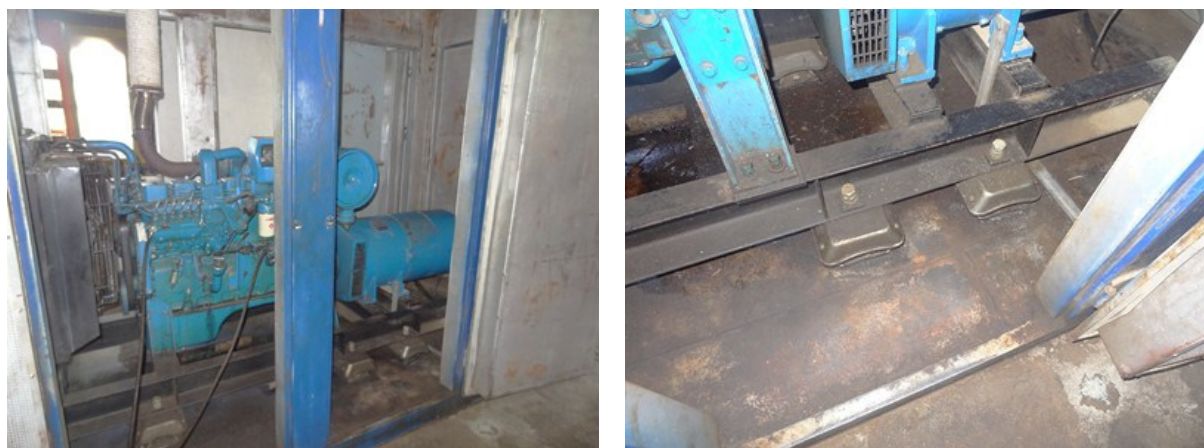
During the immediate response period following an earthquake, and even for days or weeks afterward, the hospital will need to rely on backup power supplied by emergency generators. Trashiyangtse District Hospital has two generators, but only one generator with 63 KVa capacity is functional at present. Figure 17 shows the functional generator, which sits unrestrained on rubber shoe isolators, and is likely to slide off of its base during earthquake shaking. The muffler is not braced, and can be damaged by shaking, which may prevent the generator from operating. The batteries that enable the generator to start are not anchored (see Figure 18) and may break or become disconnected. The diesel fuel storage tank is likewise unanchored and may slide during shaking, breaking the fuel lines. Moreover, the generator is in an unreinforced stone masonry building that is likely to be badly damaged or even collapse in strong shaking.

**Figure 17. Emergency generator (left); non-seismic generator vibration isolators that cannot prevent the generator from sliding (right)**

The team recommends procuring at least one more emergency generator for Trashiyangtse hospital, as overheating of generators during extended use is a common problem. The hospital maintenance staff reported that Trashiyangtse's generator had overheated after four hours of continuous use. Having one more generator would allow use of generators on a rotational basis to prevent overheating. Similarly, the team recommends that the hospital store coolant on site for the generators to avoid this overheating problem.

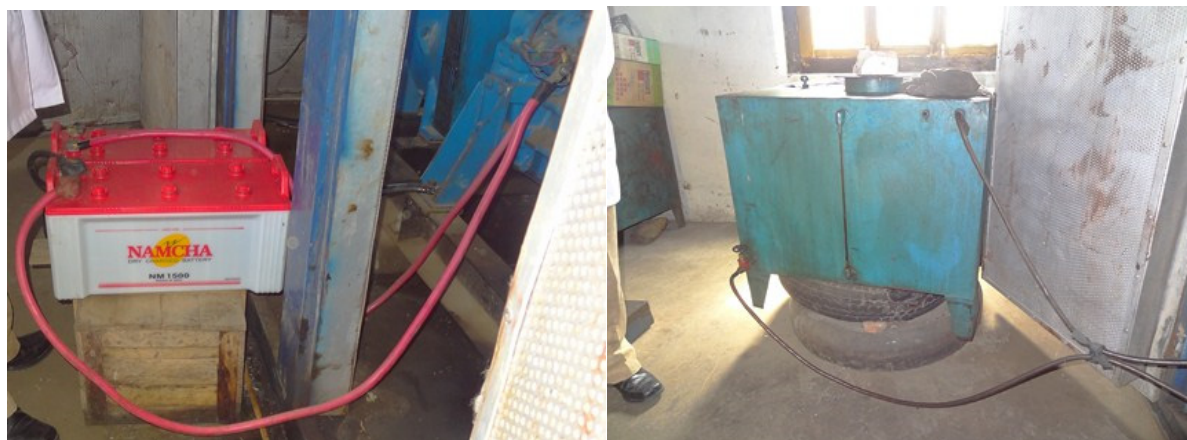
**Figure 18. Unanchored generator batteries (left) and unanchored diesel fuel tank (right)**

The Pan American Health Organization (PAHO) recommends that hospitals have a fuel supply sufficient to last five days (120 hours). Given Trashiyangtse's geographic isolation, the hospital should keep fuel on hand for a much longer period of time than PAHO recommends, basing the amount of stored fuel on realistic estimates provided by Bhutan Power Corporation of the potential length of time required to restore grid power after a major earthquake.

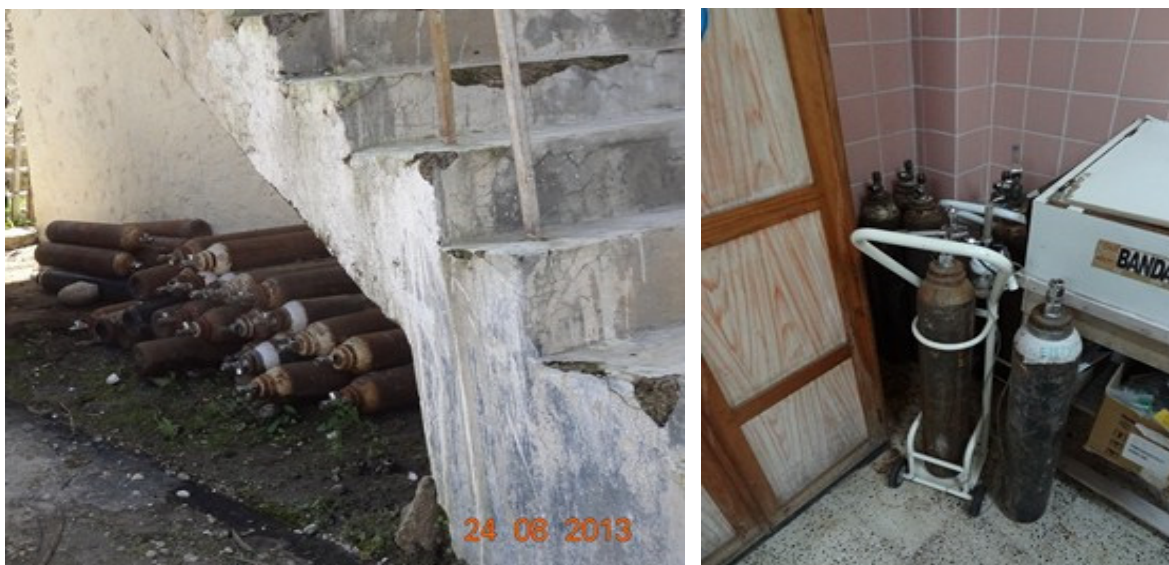
The medical gas system relies on cylinders that are taken to the locations within the hospital where they are needed. The hospital does not have piped oxygen supply, a central manifold for cylinders, or a bulk oxygen tank. Medical gas cylinders are stored inside the medical store and the empty cylinders are stacked under the stairs going up to the store. The hospital stores around 40 cylinders and procures 20-30 cylinders from the Medical Supply Depot in Phuentsholing on a half yearly basis and as required. The hospital uses an average of 3-4 cylinders per month, with a maximum usage of 5-6 cylinders per month. PAHO recommends that hospitals maintain a 15-day supply of medical gas, so the supply maintained by the hospital should be adequate, even with a higher usage rate following an earthquake due to the influx of patients. Due to landslides blocking the roads to Phuentsholing after a major earthquake, resupply would not be available for weeks, if the hospital happened to need more medical gas. However, there is no anchorage system for the cylinders, and in case of strong earthquake shaking the cylinders could roll around on the floor and start leaking. Leaking oxygen is a fire and explosion hazard.

Figure 19. Empty medical gas cylinders stored under the medical store stairway (left), cylinders stored in the hospital dressing room (right)

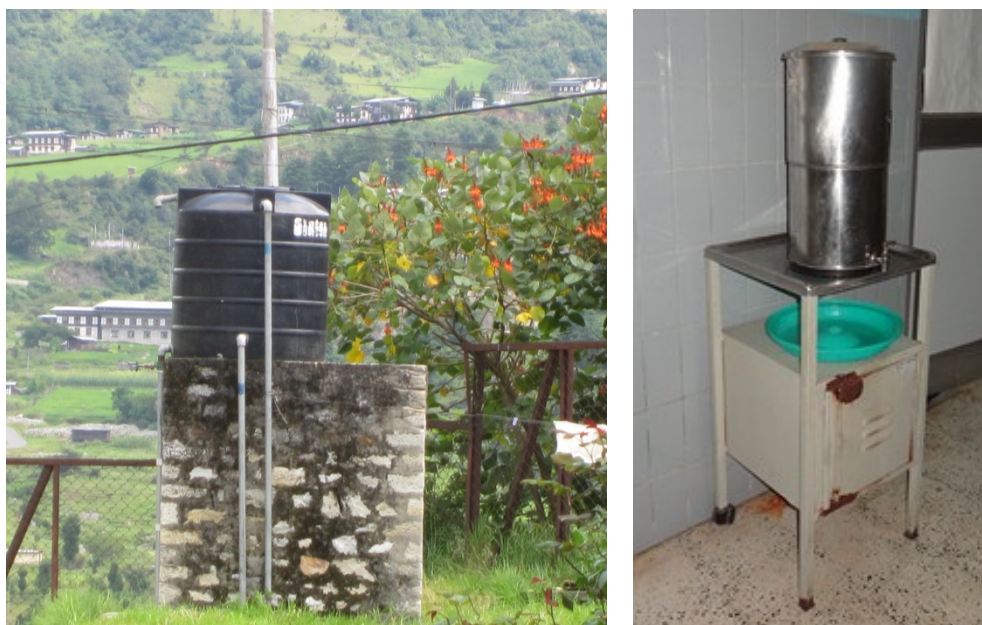
service. For normal usage levels, the tank has a supply adequate for less than a day; the hospital staff reports that the backup supply is adequate for only about four hours. The staff quarters should have a water supply and backup water storage capacity that is separate from that serving the main hospital.

**Figure 20. Trashiyangtse Hospital water tank (left) and drinking water filter in front of the medical ward (right)**

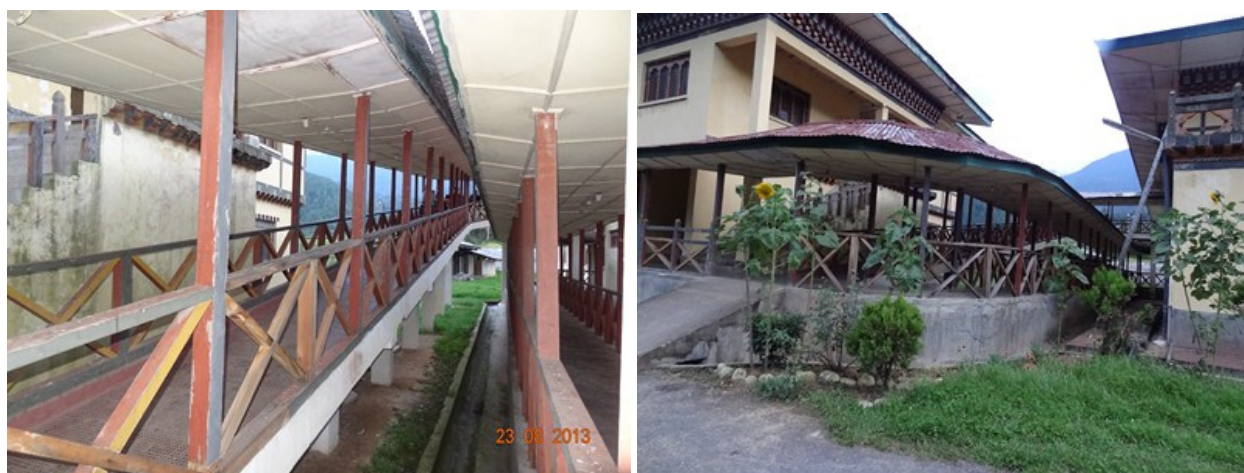
The main hospital building has a reinforced concrete ramp structure at the back, which is separated from the main building by a seismic joint. The ramp seems to have been designed for seismic resistance but may warrant further investigation; it is the only exit (and entrance) to the first floor wards and would be essential in any evacuation. The hospital should also consider installing a second exit from one of the terraces at the ends of the building.

**Figure 21. Ramp behind the main hospital building leading to the operation theatre and the ward**

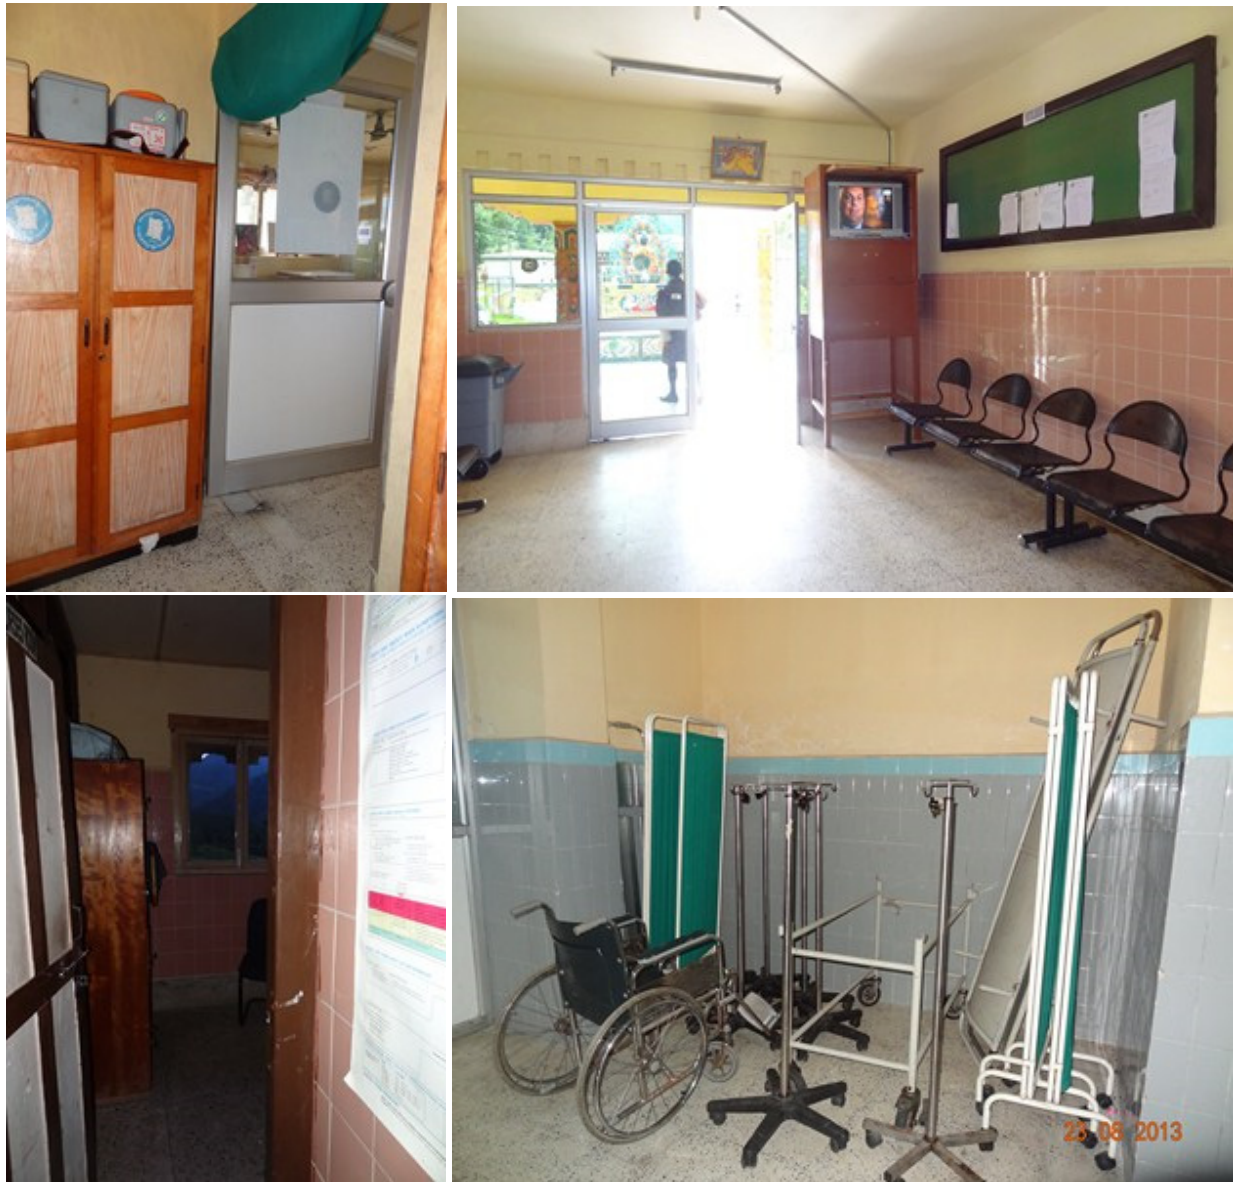
Figure 22. Large cupboards near entry into consultation rooms (above and below left), large TV stand by main entry into the hospital (above right); items stored in hallway leading to the operation theater (below right)

The team noticed that many doors and exits were partially blocked by boxes, cupboards, racks or old equipment and furniture. The team recommends that all exits be open and cleared of stored items that could block the exit route during emergencies.

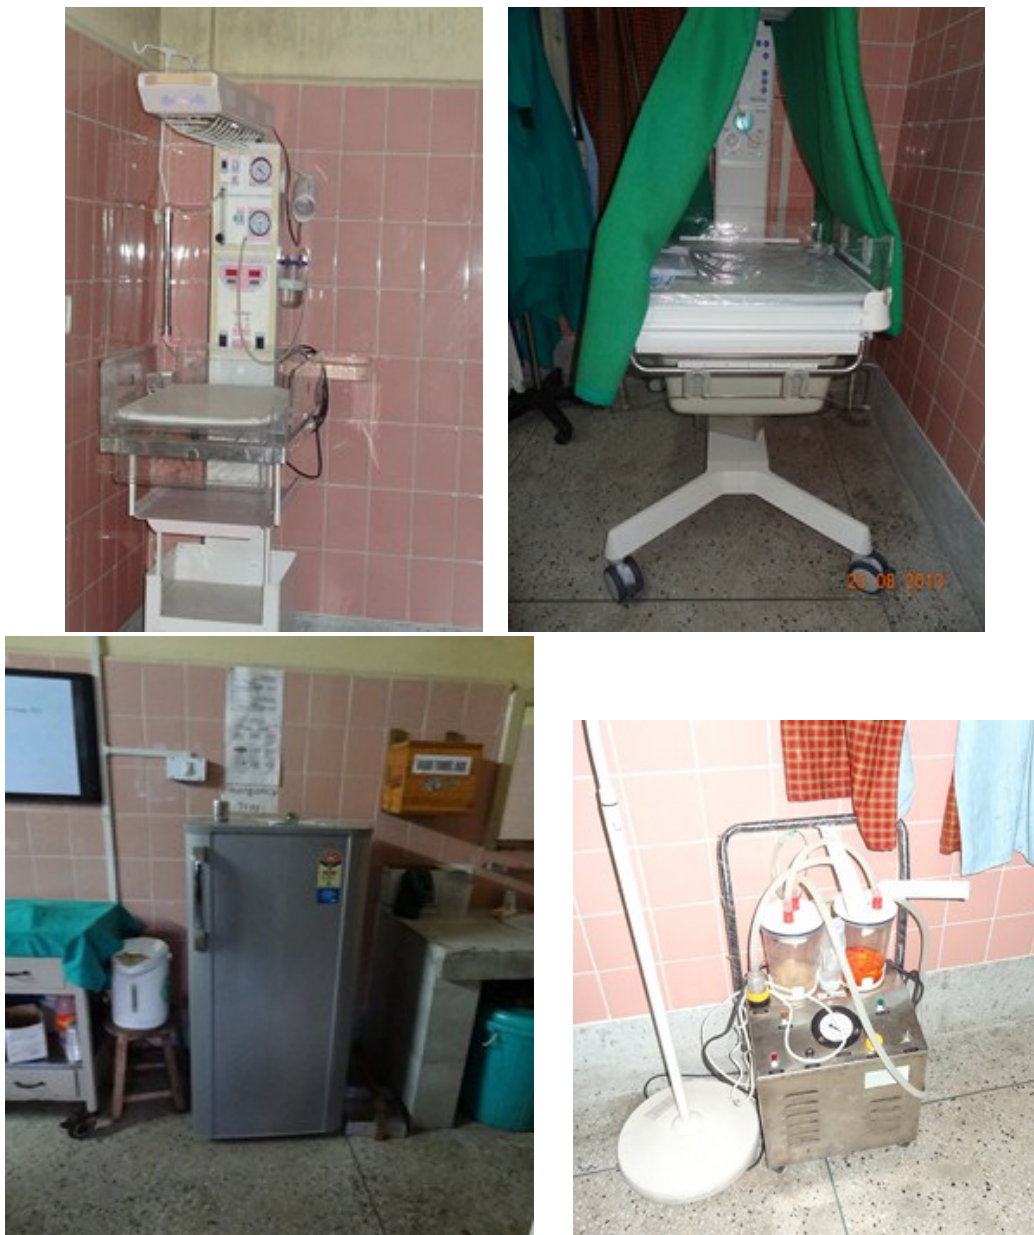
Figure 23. Various unanchored medical equipment in Trashiyangtse Hospital

Trashiyangtse Hospital has several pieces of specialized and costly medical equipment, shown in Figures 23-25. The equipment used most often is the laboratory equipment, X-ray equipment, and radiant warmers for newborn babies (there are 10-12 deliveries per month at the hospital). Most of the equipment is critical to the ability of the hospital to deliver essential medical services, but it is not properly anchored or tethered. The team recommends that the hospital assess existing equipment and begin anchoring it to help prevent earthquake damage.

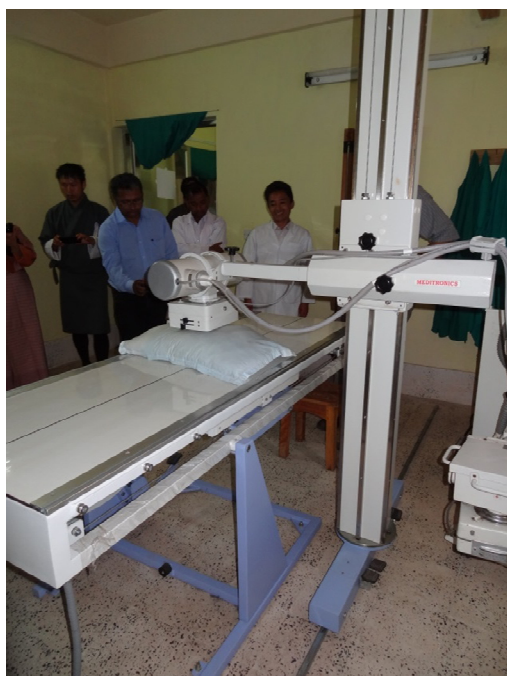
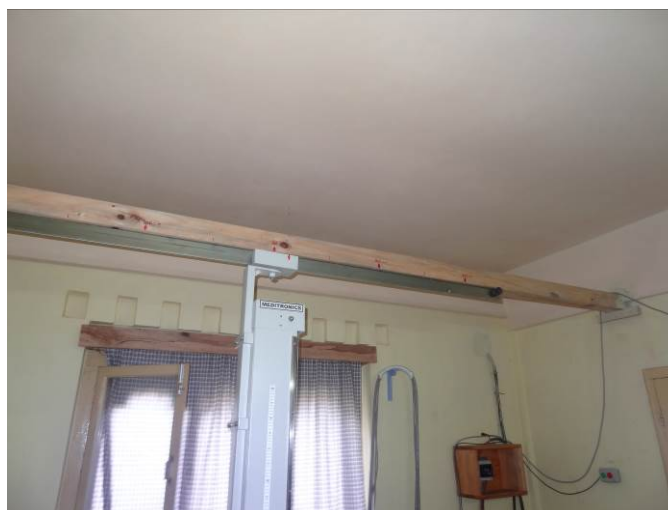
Figure 24. X-ray machine (left) with ceiling rail inadequately anchored to resist shaking (right)

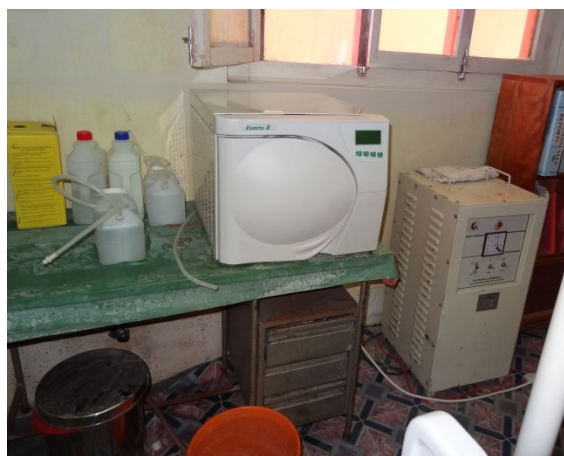
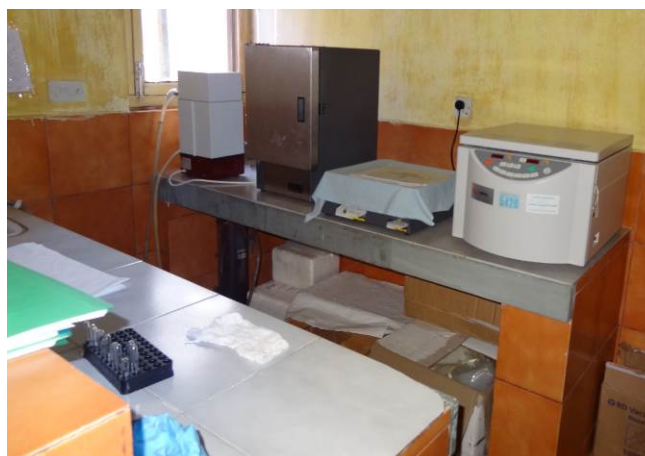
Figure 25. Unrestrained benchtop laboratory equipment

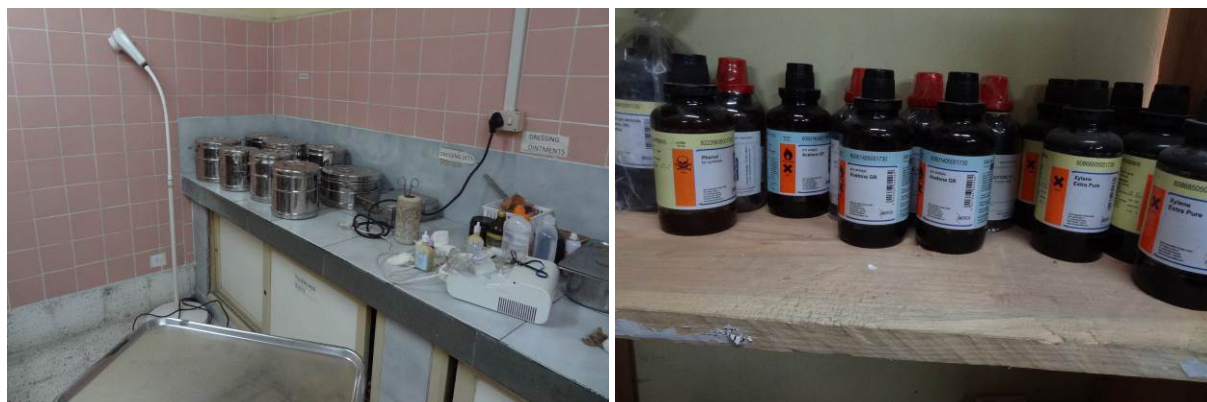
In several areas of the hospital building and medical store, important items such as medicines and sterile surgical instruments are stored on unanchored shelving that may topple in an earthquake or on countertops where they can slide off (Figure 26). In both the medical store and non-drug medical store, glass bottles were near the edge of shelves without any shelf restraints. In the non-drug medical store, some of these bottles contained poisonous or flammable chemicals. In the case of strong shaking, the bottles could fall and break, which could cause a chemical hazard to staff trying to enter and retrieve supplies.

Figure 26. Sterile instruments unsecured on counter in dressing room (left); toxic, flammable and other potential harmful chemicals in glass bottles unrestrained on shelf in non-drug medical store (right)

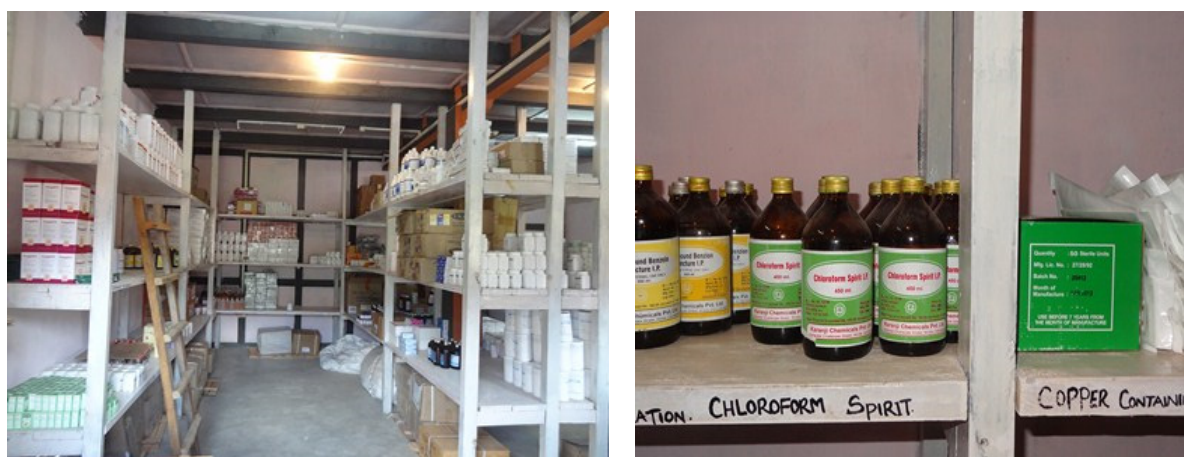
Figure 27. Medicines stocked in medical store above garage (left); glass bottles on racks near entrance (right)

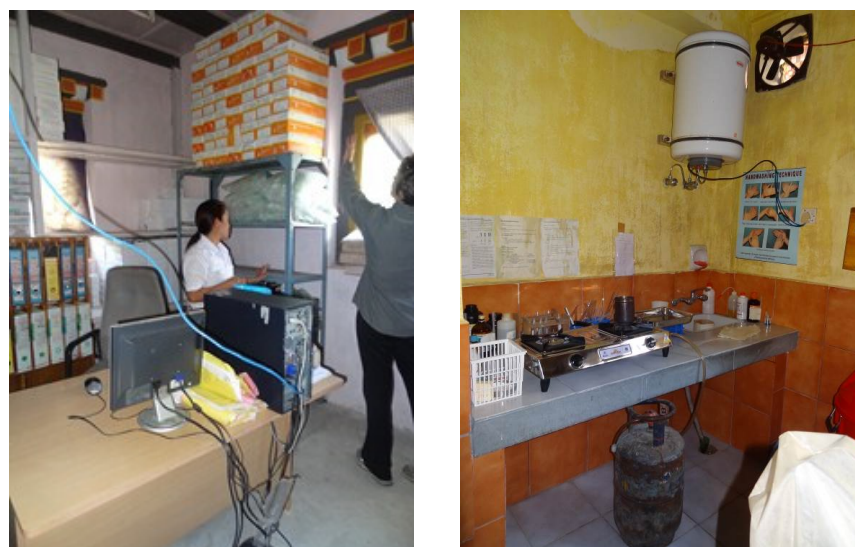
Figure 28. Supplies stacked above a staff desk in the medical store (left); potential ignition sources (stove and geyser) in laboratory may cause a fire following an earthquake (right)

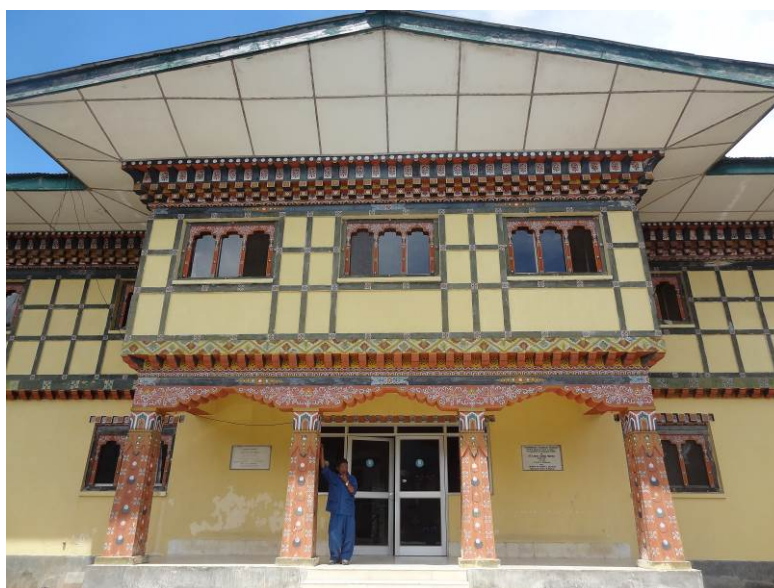
**Figure 29. Brick architectural projection walls, a falling hazard, above the main OPD entrance.**

The hospital should anchor or otherwise mitigate the falling hazard created by the walls outside the frame line directly above the main OPD entrance shown in Figure 29.
