**Report:** M02061312 4123 Sierra Gold Drive **Address:** 4123 Sierra Gold Dr

**Confidential Inspection Report**

**4123 Sierra Gold Dr  
Antelope, CA 95843**

<i>Inspection #</i>	M02061312.
<i>Inspection Date:</i>	06/13/2012.
<i>Inspector:</i>	Mike Thick
<i>Client:</i>	Arif Siddique.
<i>Property Address:</i>	4123 Sierra Gold Drive.
<i>Weather Conditions:</i>	Hot.

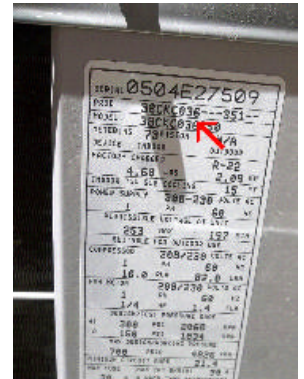
811a Air Conditioning #1: S; Electric split central air unit. The condensing unit and evaporator coils were at different locations.  
 Location: With compressor located at rear, of home.  
 Brand Names: Carrier.  
 Approx. Age(s): 2004.  
 Approx. Size(s): 3 ton.

Shut off/disconnect: Electrical disconnect as required at unit.  
 Air temperature Differential: Temperature drop/differential observed was less than recommended 15 degrees. A

licensed HVAC specialist should be called to make further evaluation .  
working ok but not reaching minimal difference intake to output, It was a hot day in 90's,  
Suggest a service to improve efficiency and life.
