RADIUS PROJECT OF GUAYAQUIL

Municipality of Guayaquil - Ecuador

GUAYAQUIL CITY FINAL REPORT

Risk Assessment tools for Diagnosis of Urban areas against Seismic disasters

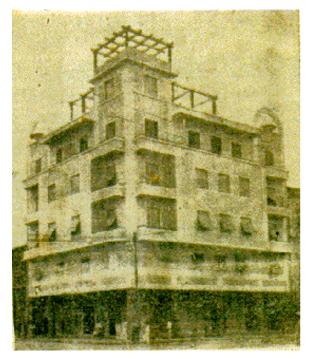
There were 40 people who died, the main cause being crushing, because of the total collapse of buildings. Forty three persons were taken out alive from the debris of the buildings, 21 of them fatally injured. There were 11 people injured in other parts of the Central Zone, the majority of them because of fallen debris from walls or roofs. The largest number of deaths occurred in the total collapse of a five story building where Clinica Arreaga was functioning. See figure 3.

Figure 3. Building of Arreaga Clinic that collapsed during the earthquake.

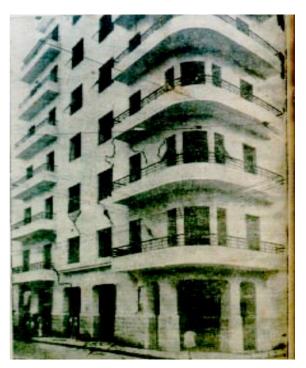
The largest losses occurred to reinforced concrete buildings, three buildings of 4 to 5 stories collapsed and many buildings of more than 3 stories suffered a lot of damage, five of them were later demolished [15]. Other buildings suffered different degrees of damage: cracking of columns and walls, falling of facades and walls, interior damage and inclined buildings. The majority of damage always occurred on the first and second floors. See figure 4.

Figure 4. Building of Hotel Pauker. It suffered heavy damage and was ordered to be demolished in 1942.

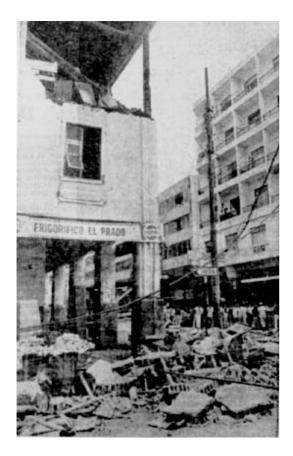
The aftermath of the earthquake: 49 "mixed" houses had to be demolished in the Parroquias of Bolivar, Ayacucho, Sucre and Garcia Moreno, in the Central and South Zones of the City. If we consider that the earthquake was reported with an Intensity of VII degrees, it must be accepted that a future earthquake with an Intensity of VIII degrees would destroy the majority of these houses. The age of the affected structures ranged between 20 and 40 years old. Nowadays the structure of these houses has deteriorated and many of them are over 40 years old. See figure 5.

Figure 5. Damage in "mixed" structures during the earthquake of August 18, 1980. Source: Diario El Universo de Guayaquil (IIFIUC archives – Project RADIUS)

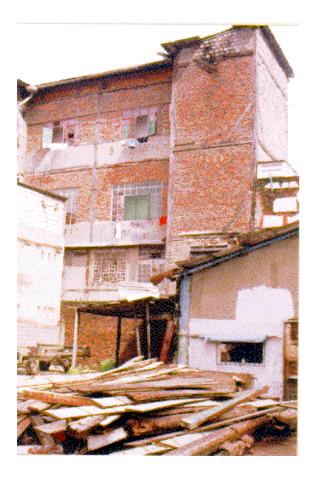
Figure 6. "Mixed" houses have the highest risk of collapse, many of them are over 40 years old, and their wood structure has deteriorated with poor confinement of brick walls within the wooden frames. There are more than 200 buildings of this type in the Central Zone of the City.

The falling of debris from walls and facades of the "mixed" houses is the main cause of fatalities during an earthquake, as seen in 90% of the cases during the earthquake of August 18, 1980. 10% of more than 300,000 buildings of the city are "mixed" structures, and one fourth of them are obsolete structures, many of them would collapse partially or totally. The risk of fire is very high in these buildings because their electrical installations are old and dangerous.

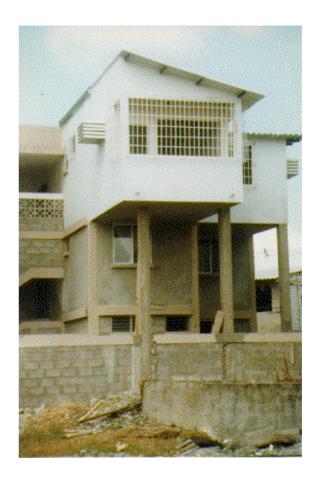
However, the number of fatalities in the current conditions could be much larger, because the present vulnerability of the city has grown due to the aging of many buildings (see figure 6), and also because of informal construction with heavy materials without seismic provisions and the lack of application of seismic design codes (see figure 7).

Figure 7. Condominium BEV-BM6. Especially in the North Zone, many reinforced concrete structures do not follow seismic codes. This structure is located in Sauces IX, and has been remodeled without technical supervision. The result is the increase in its seismic risk in a zone initially characterized by its

b) It is recommended that the Municipality of Guayaquil establishes a code for the seismic resistant design of structures. This will make it possible to strengthen the control over informal construction and to better the approval of construction permits for new buildings, as well as the checking of safety of existing structures

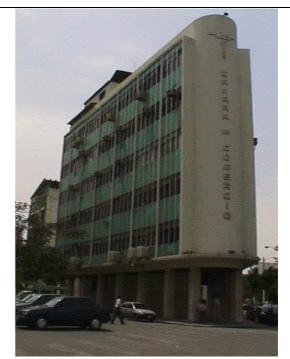
Chamber of Commerce Building: Minor damage and partial destruction of walls during the 1980 EQ.

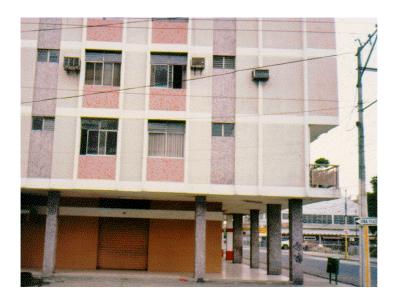
Figure 21. Reinforced concrete building, built between 1930 and 1970, which has many risk factors: weak columns, soft first story, and located at a corner. It belongs to type H.

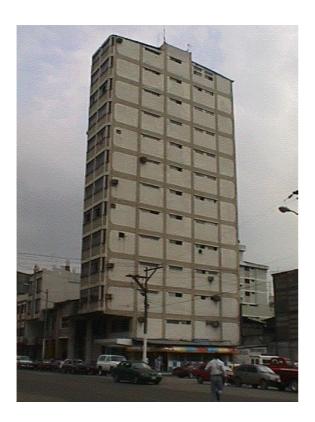
Figure 23. Example of type I building, with a critical slenderness ratio.

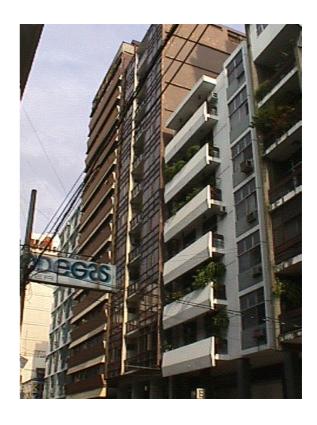
Figure 24. Example of type I building, leaning against each other and with risk of impact.
