# 3801 Update

January 2017

## Repairs to Boiler 3819

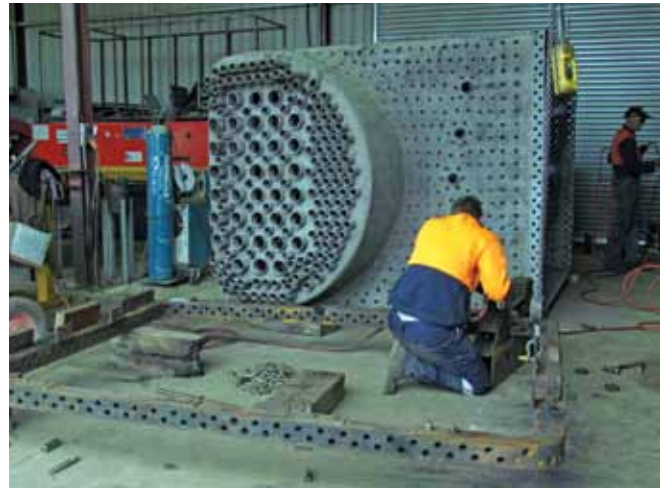
*Within a few days of removal the firebox was sand blasted on all surfaces to allow detailed visual and non-destructive examination. This view shows the box inside Ainsworth's workshop and also the foundation ring in the process of being cleaned up for inspection.*

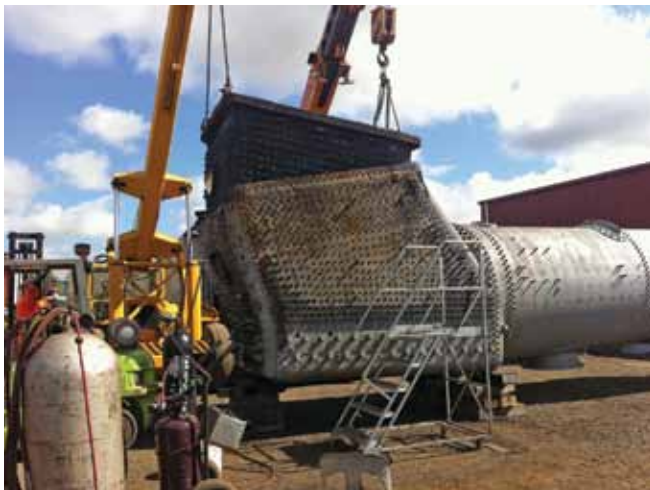
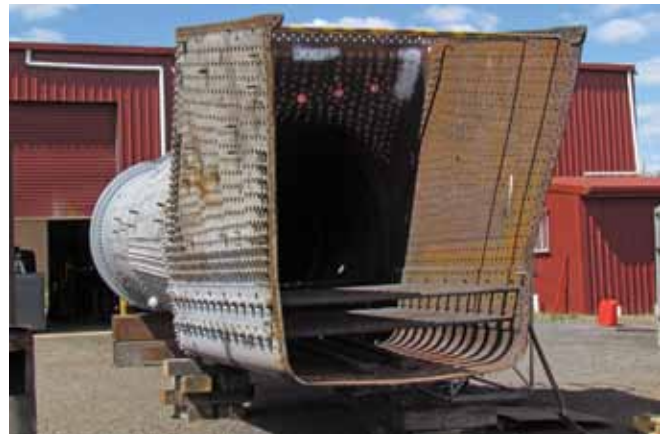
The outer casing crown sheet (seen in some of the photos) was the subject of investigation when the original scope was being developed. The plate itself has corroded and thinned significantly on the rear third of the plate and many of the rivets at the crown-backhead joint have wasted away. Our intention was to cut away the thin section of plate and butt-weld in a replacement section. After further consideration, we believe that it is a better option to replace the entire crown. Although this means a larger plate, a greater amount of welding and drilling, reaming and tapping additional crown stay holes, doing the job this way (and combined with a new inner firebox crown) brings about a number of advantages. The complete plate is actually easier to form and is simpler to fit and graft onto the existing casing. The fact that we are working with all new sized crown stay holes means that instead of having to manufacture a range of different sized stays to suit a range of hole sizes, all the stays can be of a single 'new' size and one set of tooling of a single size is required. We feel that these advantages will go some way towards negating some costs of the additional work.

*With the outer casing backhead and inner firebox removed, it is now possible to inspect the water side surfaces of the boiler shell or casing.*

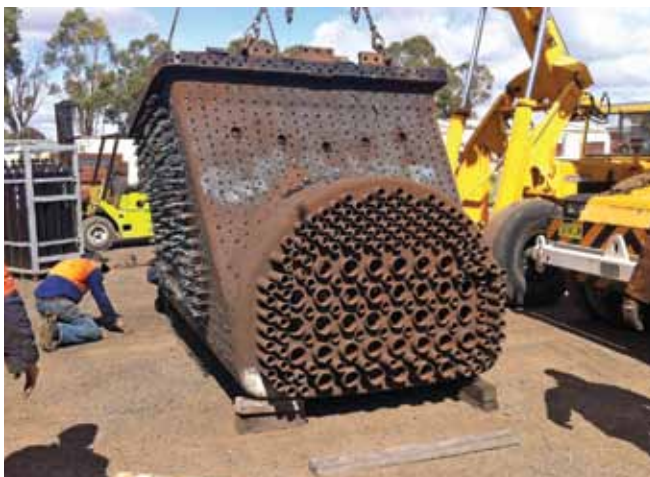
*Removing a C.38 class inner firebox from the casing involves lifting and rotating the box to allow the combustion chamber to withdraw from the barrel. This is the first time this box has been removed from the boiler since it was installed in the 1980s. This particular box is a fully welded design. We will be reverting back to the original riveted construction.*

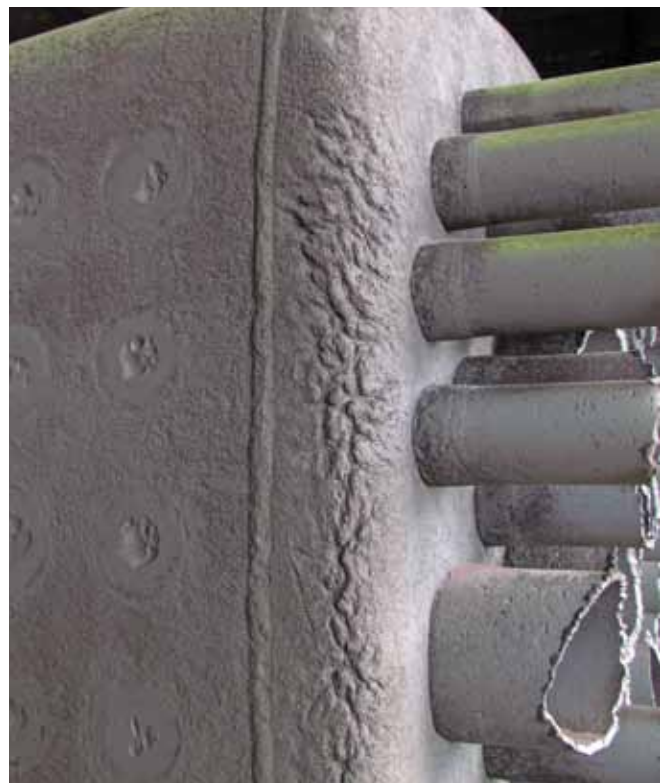
The firebox tube plate has significant stress-corrosion cracking around the flange on the (water) side and the same type of cracking has commenced down the flanged sides of the throatplate. There is widespread

**Right:** *A close-up view of the top flanged edge of the firebox tubeplate. The deep grooves caused by stress-corrosion can be clearly seen. This damage extends all around the flanged edge of the tubeplate and is also evident on the sides of the throatplate.*

Thus, a new wrapper sheet will be required (i.e. the sides and crown of the inner box) as well as a flanged inner backhead plate. This will require additional design and castings for flanging dies.
