An Archaeological Report on an excavation at Shop Lock Ty Coch

This report details the results of a programme of archaeological works commissioned by Torfaen County Borough Council. The archaeological programme comprised shallow excavations undertaken at Ty Coch, Cwmbran during June 2013. The archaeological contractor was The Ancient Cwmbran Society Ltd. The contract was project managed and directed by a qualified member of the Institute for Archaeologists (IfA), R Burchell MA, PlfA.

The archaeological programme comprised excavations undertaken at Shop Lock, Ty Coch, Shop Lock Cwmbran during June 13, 14 & 15 2013 centred on NGR 329258-193078. The site is comprised of a canal-side plot of land believed to contain a building, the nature of which was investigated through the means of an archaeological excavation. The removal of turf and topsoil to the level of the first indication of archaeological remains was by the use of a mechanical excavator and small dump truck; this was conducted under the supervision of R. Burchell MA, PlfA the previous day, 12th June.

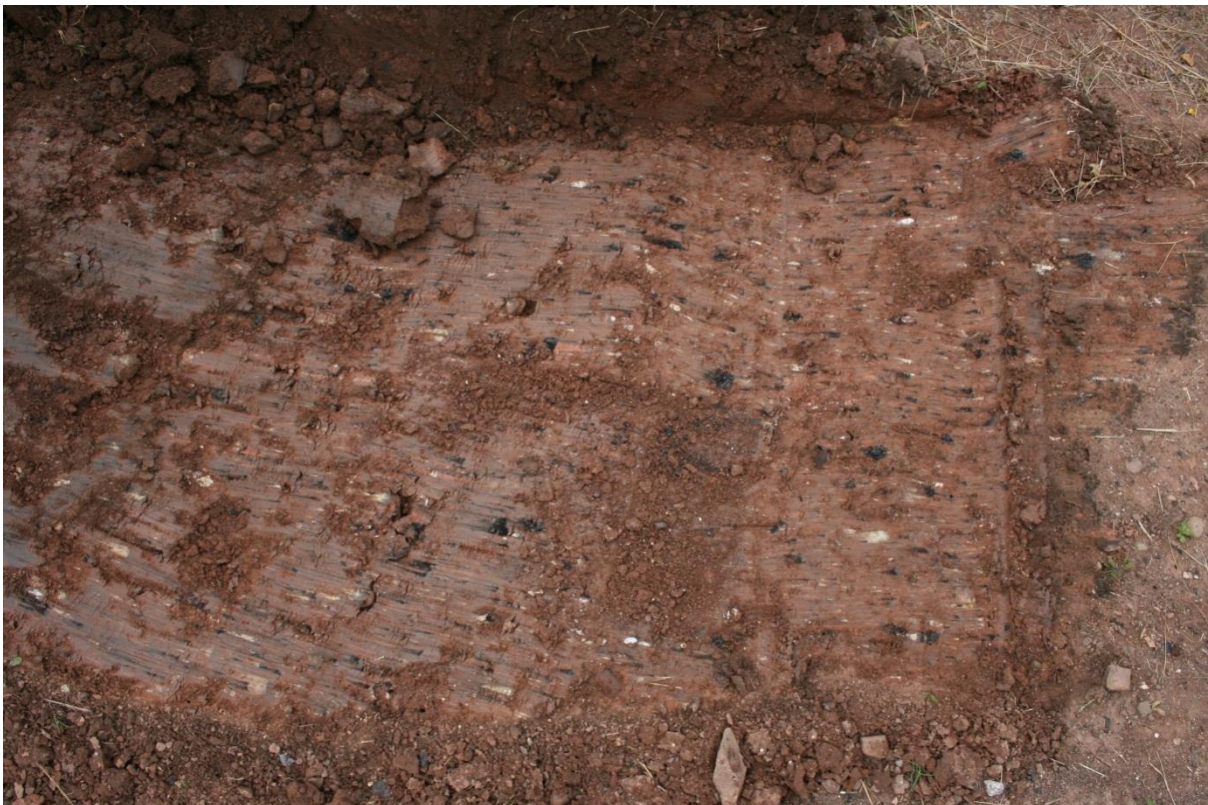
Plate 3. Exposure of subsoil showing marls with ash and clinker inclusions.

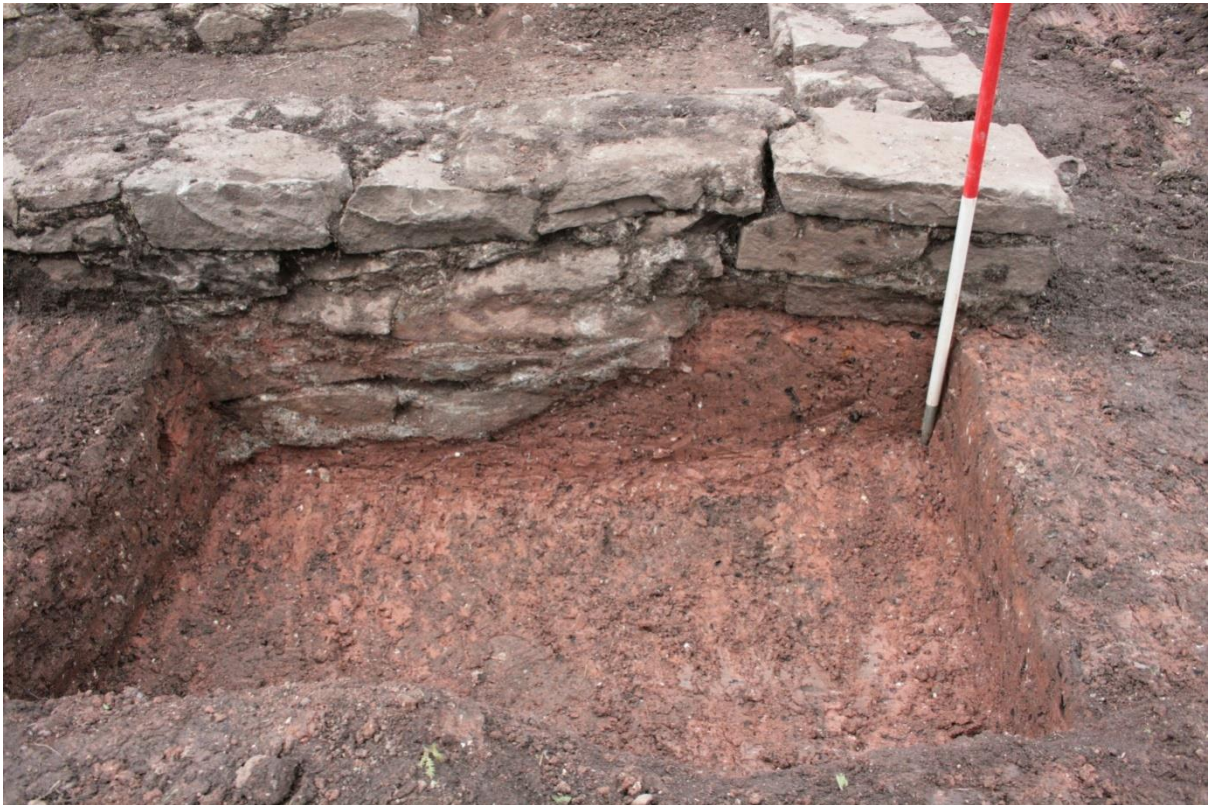
Plate 4. Trench 1 showing surviving depth of masonry and underlying soils. Looking north.

Trench 1 revealed the depth of remains on the south eastern corner of the large building; it was seen to be constructed of coursed stone set in a lime mortar matrix that survived at that point to three courses below the current ground levels. The wall (1001) had an overall height of 600mm, 280mm of which was visible above ground level. The

underlying soils were a mixed soil comprised largely of the local marls (1003 & 1004) but here contaminated with ash, coal, charcoal and a single sherd of pottery. The pottery (1004/001) was identified as 'Mocha' ware probably of Staffordshire origins and has a lengthy history commencing in the mid 18th century and throughout the 19th century. It was also apparent that the building had suffered some distress at this corner as the easternmost end of the wall had a distinct downward trend breaking away from the main body of the wall (Fig 2 & Plate 4), possibly caused during the buildings demolition or the infilling of the pit.

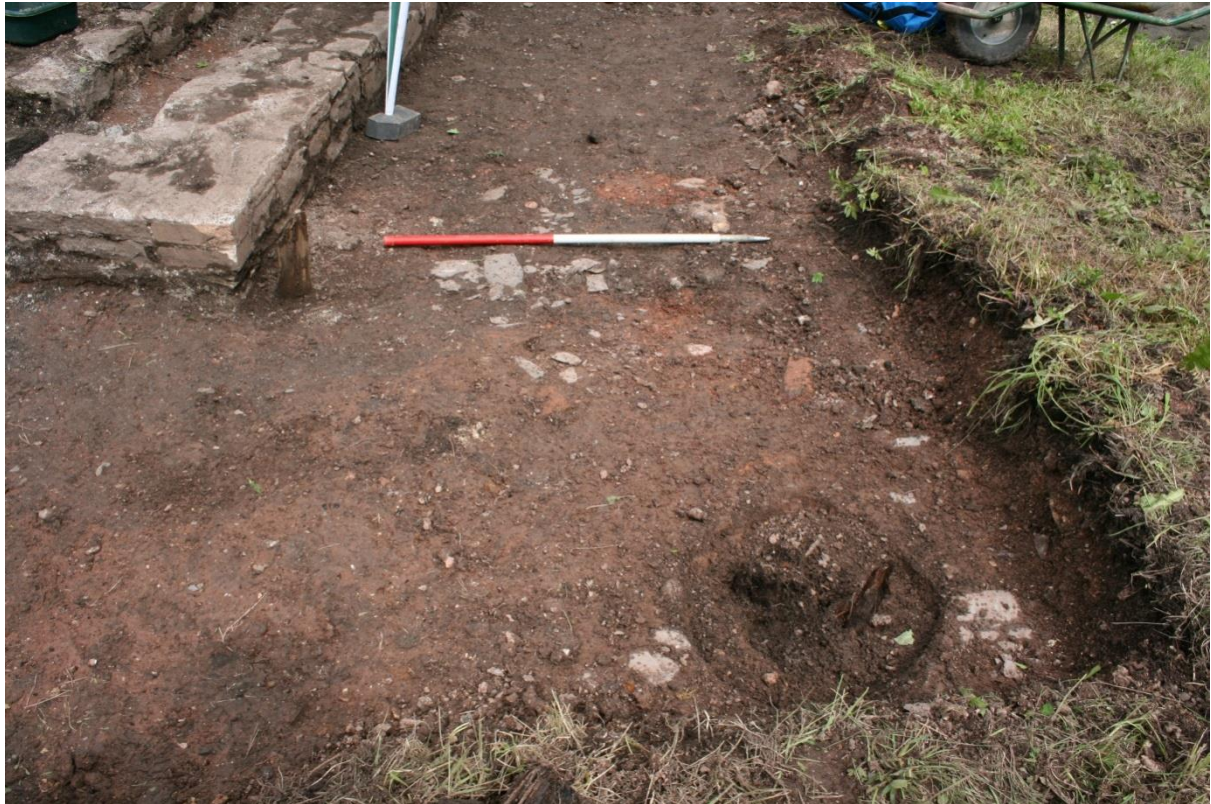
Plate 5. General view of Trench 2 showing post hole and debris scatter looking east.

Trench 2 was able to provide information on the area outside the south western corner of the building. Here it had been noted that two wooden posts had survived just below ground level whilst stripping the site of topsoils, (2009) and (2002) No further posts were found within the area following hand cleaning and no relationship could be drawn between the larger post in the south western corner of the trench and the smaller post set against the building. It is possible that the larger post delineated the end of a fence line that was the boundary of the lock keepers cottage garden as such a boundary is shown on the tithe map of 1846 for this area that approximates its position. The scatter of material overlying the subsoils was seen to contain stone, tile, brick and slate and was of the same nature as the debris scatter seen across the whole of the excavation site and can be understood to be demolition debris of this building and also of the adjacent Lock Keepers cottage situated only a few metres away.

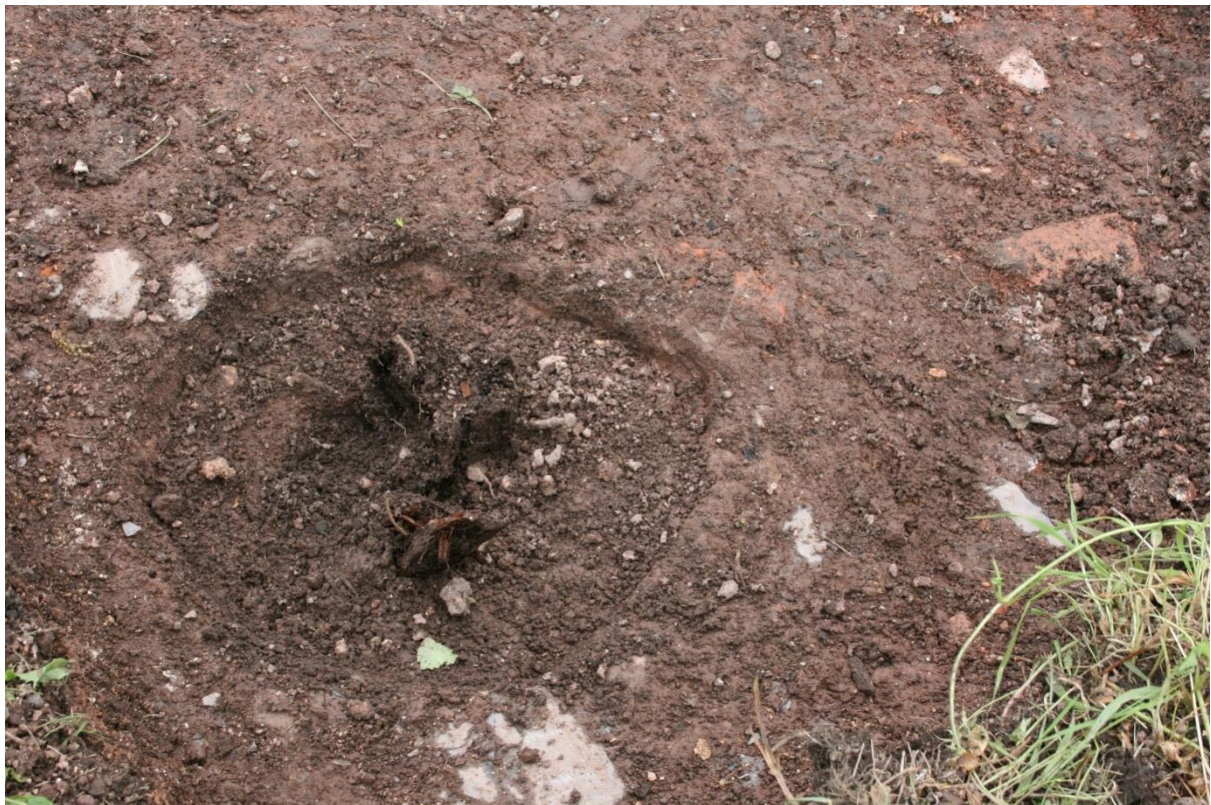
Plate 6. Detail of post hole extreme south west of Trench 2.

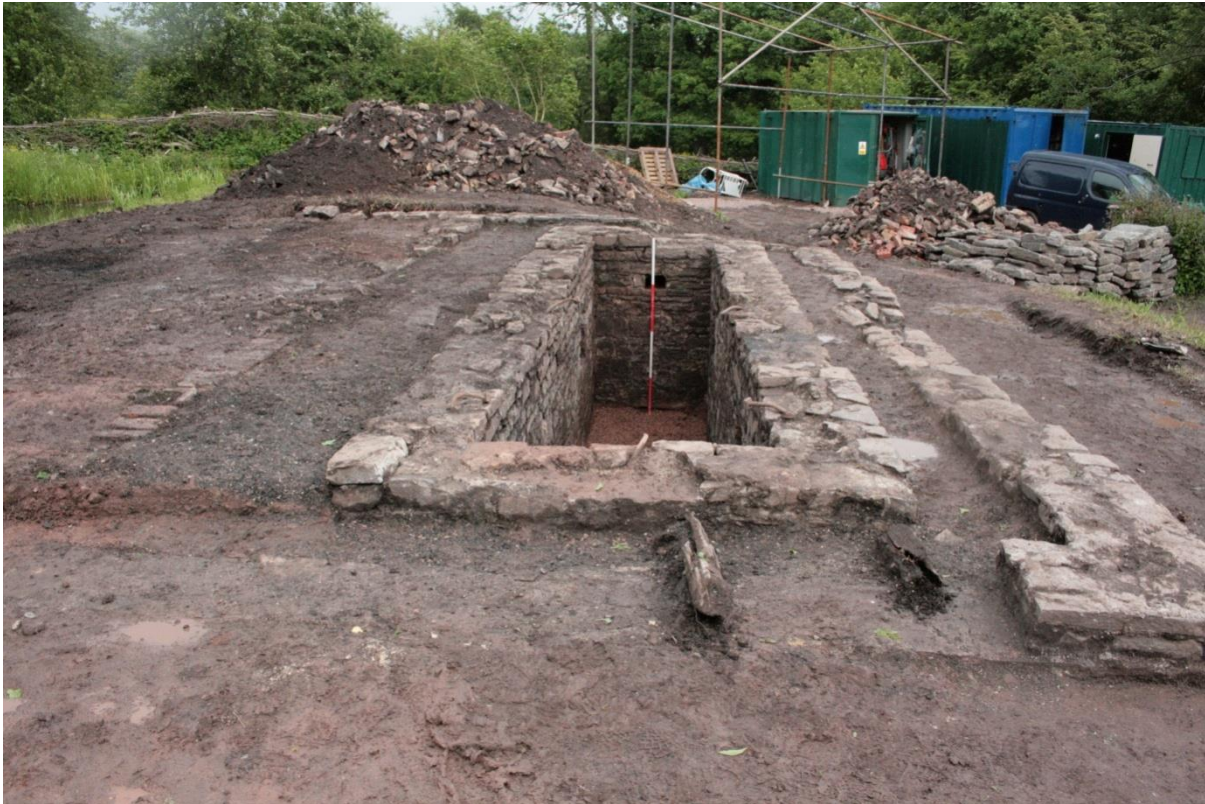
Plate 7. View east showing remains of doorway, timbers and sawpit.

The area was reduced by approximately 150mm across the whole site revealing a series of stone walls with random brick forming an outline of a building that was approximately square in plan, Fig. 1, (Building 1 Shop Lock Ty–Coch). Within the outer walls of the building was a second rectangular structure (3002) (Plate 7).

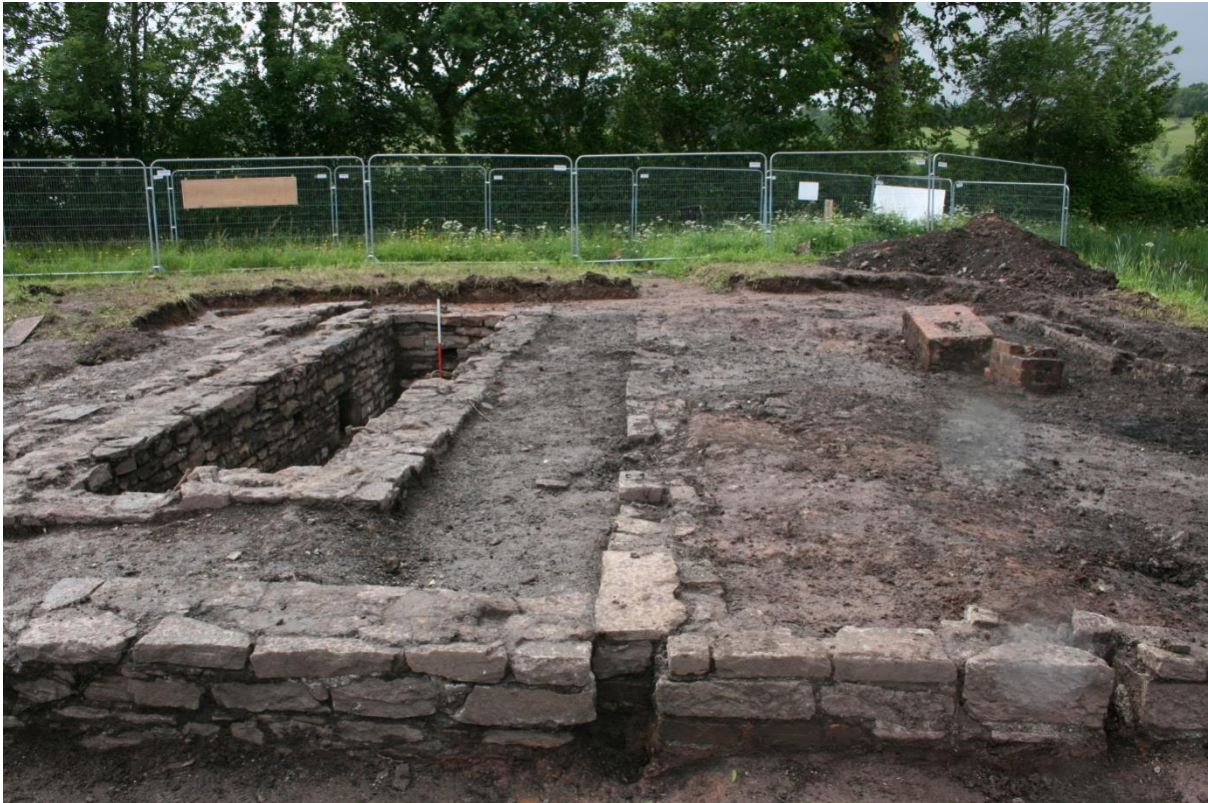
Plate 8. View of eastern wall of building showing post socket (3016) and sawpit.

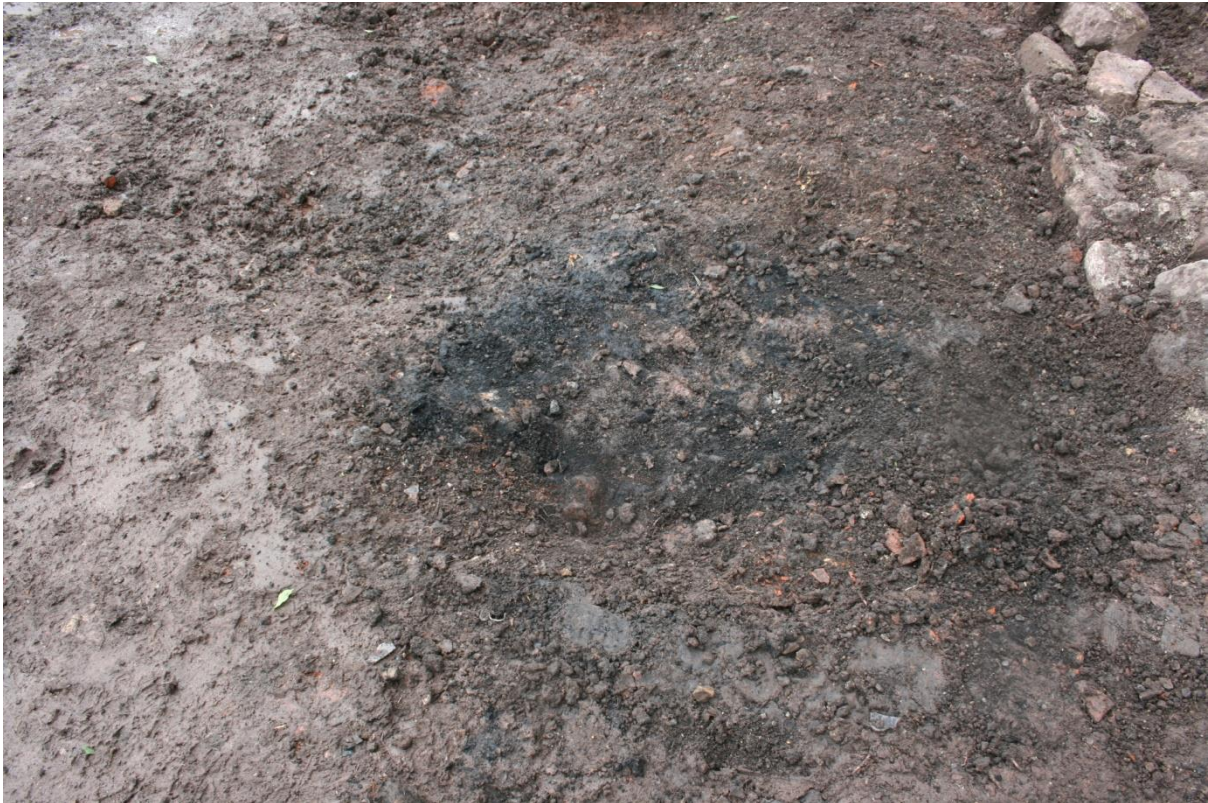
Plate 9. Showing Oily deposit / ground contamination. (3026).

The northern sector of this building bounded by (3007), (3008) (3009) and (3010) is comprised of a surface (3027) of re-deposited rubble containing coal ash, coal, brick, roofing pan-tile, sundry discarded iron artefacts, including tools and an oily deposit (3026) (Plate 9), all of which overlie a pinkish /red brown clay equivalent to (1004) as witnessed in Trench 1. Context (3026) an oily deposit was sub-circular in shape and approximately 900mm in diameter with a depth of 55mm; samples of which have been retained. In the north eastern corner of (3027) was (3025) a small section of masonry wall lying above (3027) and abutting to (3007), this 'wall' had dimensions 260mm X 620mm and was aligned west to east. In the north western corner of (3027) was (3030) a wooden stake, labelled as Post 1 and having a diameter of 120mm.

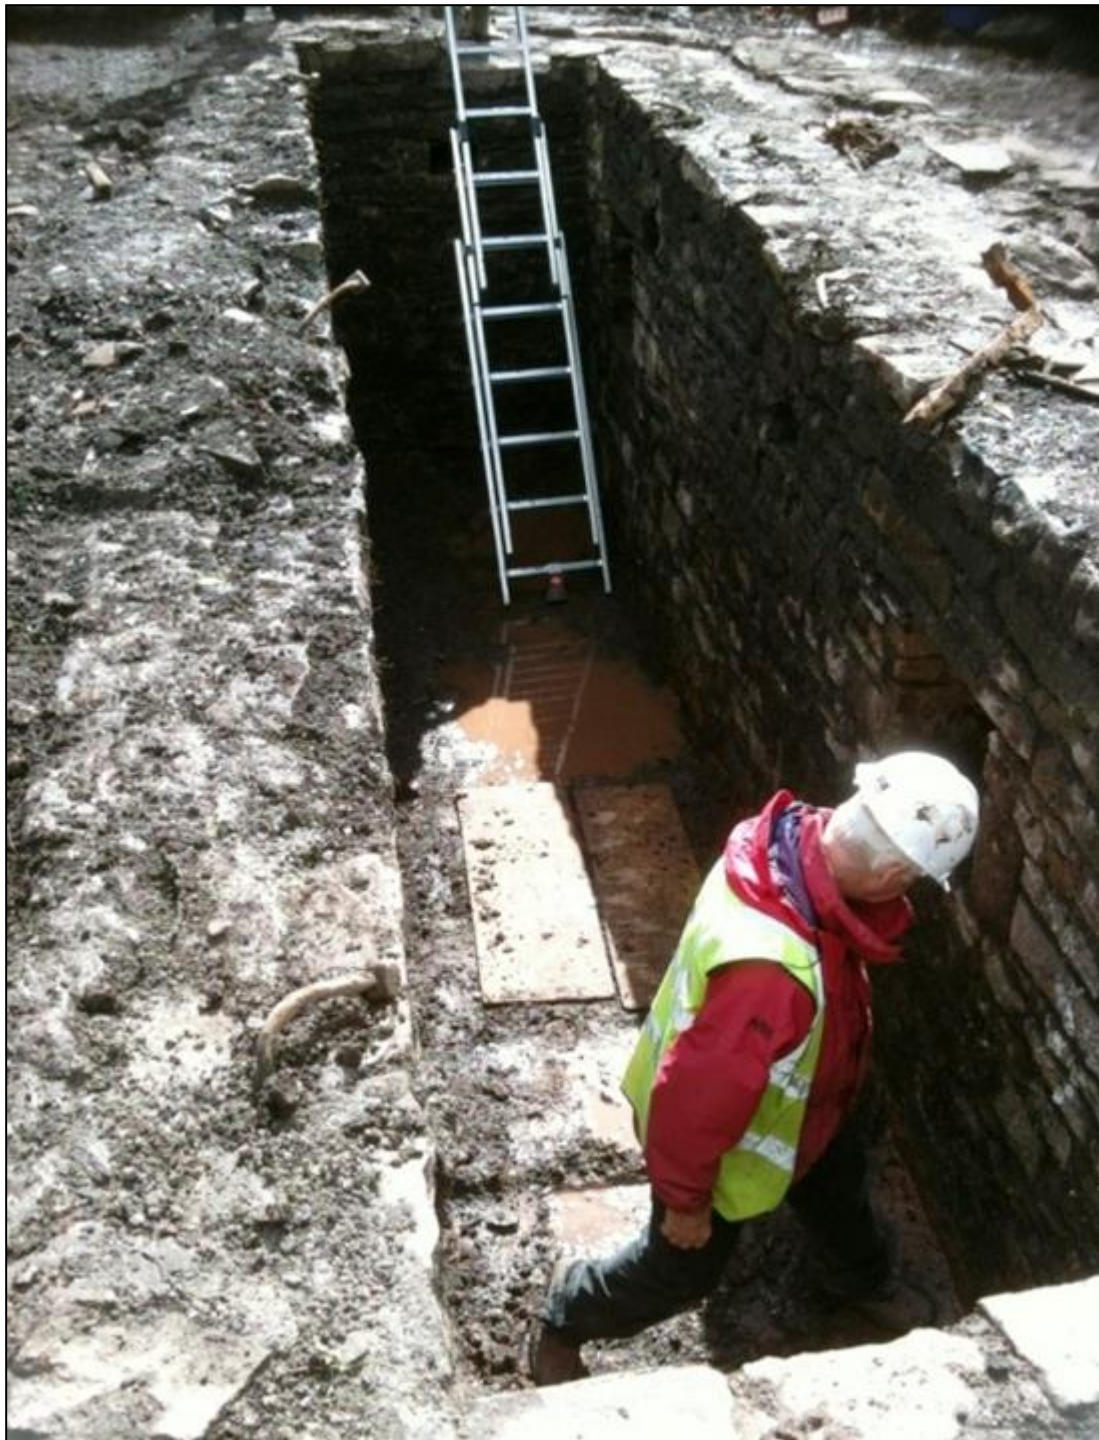
Plate 10. Sawpit following removal of fill.

The Sawpit was seen to be constructed from stone and brick bonded with a lime mortar (3002) and forming an oblong pit below ground level. Its dimensions internally were 6.44m X 1.28m X 1.9m deep (Fig. 5). It can be seen that there are two phases in the development of this Saw mill. The first phase is manual. Set into the north and south walls are four alcoves that are staggered along the length of the pit, these were to provide shelves for lamps thus lighting the underside of the sawpit whilst it was in use by the 'Bottom Sawyer'. The timbers to be sawn would be close to floor level with the 'Top Sawyer' standing on or over them, the 'bottom sawyer' being below him. The nature of the work demanded that timbers are sawn up into planks or beams by the use of a large double handed saw used vertically, as illustrated below, (Appendix 8).

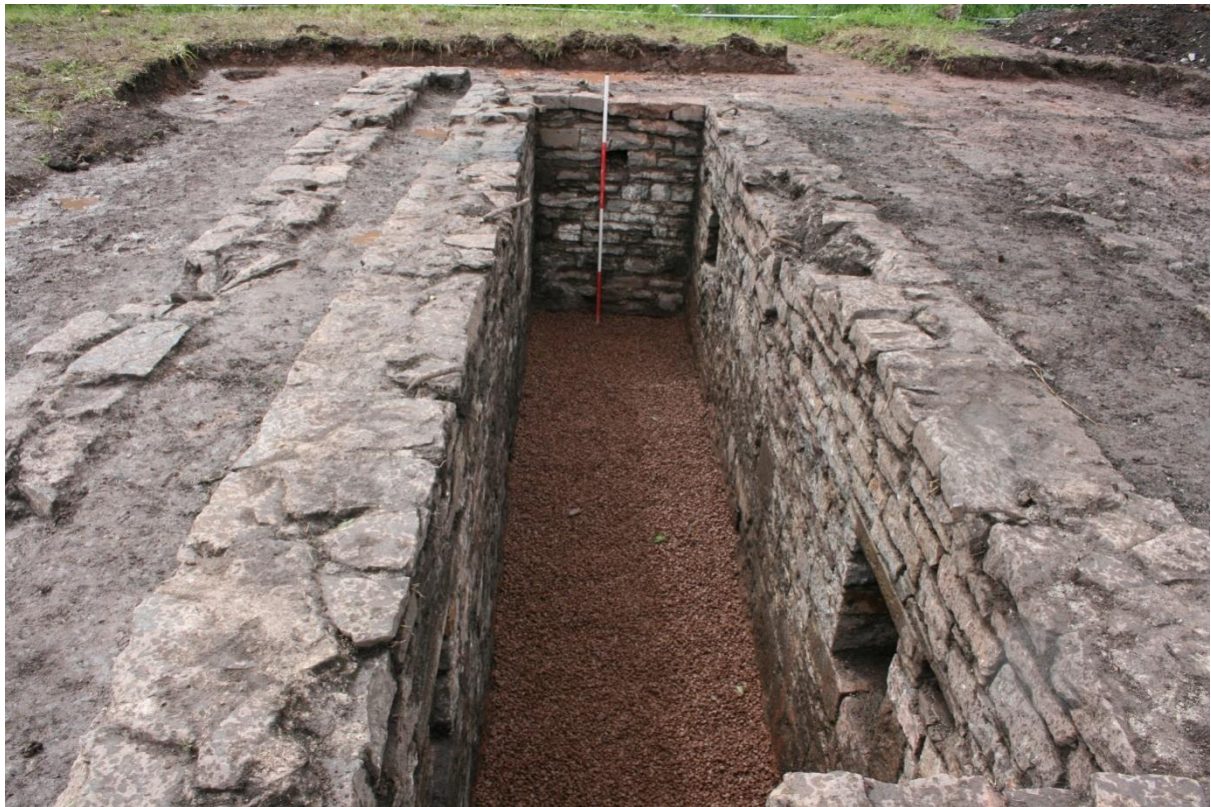
Plate 11. Sawpit following cleaning. Looking west.

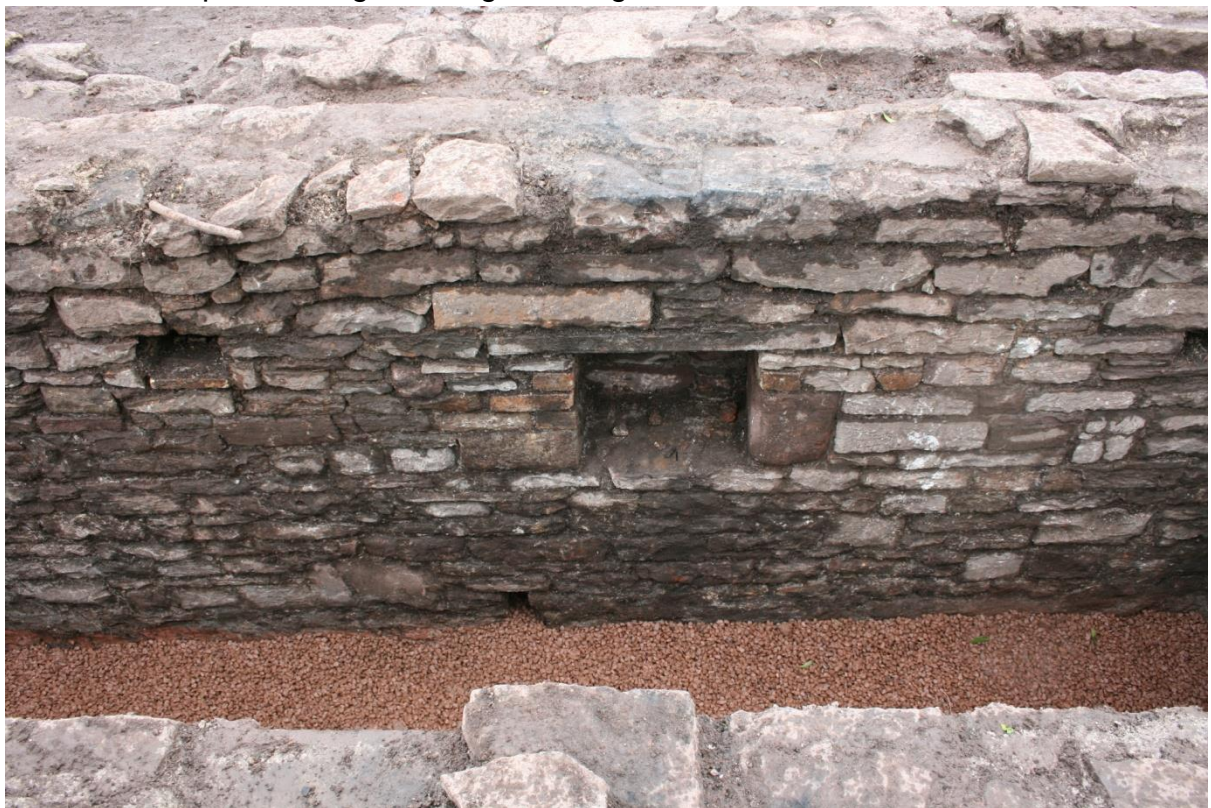
Plate 12. Detail of south wall of sawpit showing lighting alcove and shelf. Note cut out for bolt at upper left.

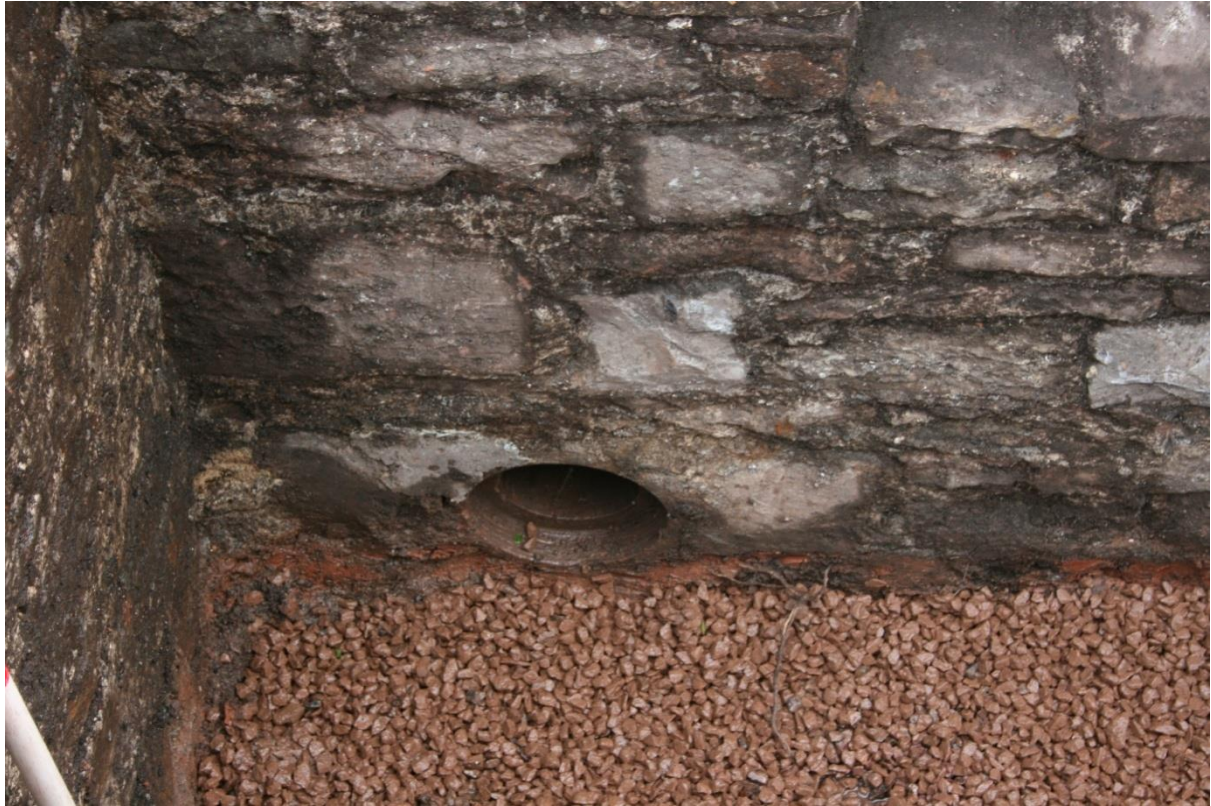
Plate 13. Drain South Eastern corner of sawpit

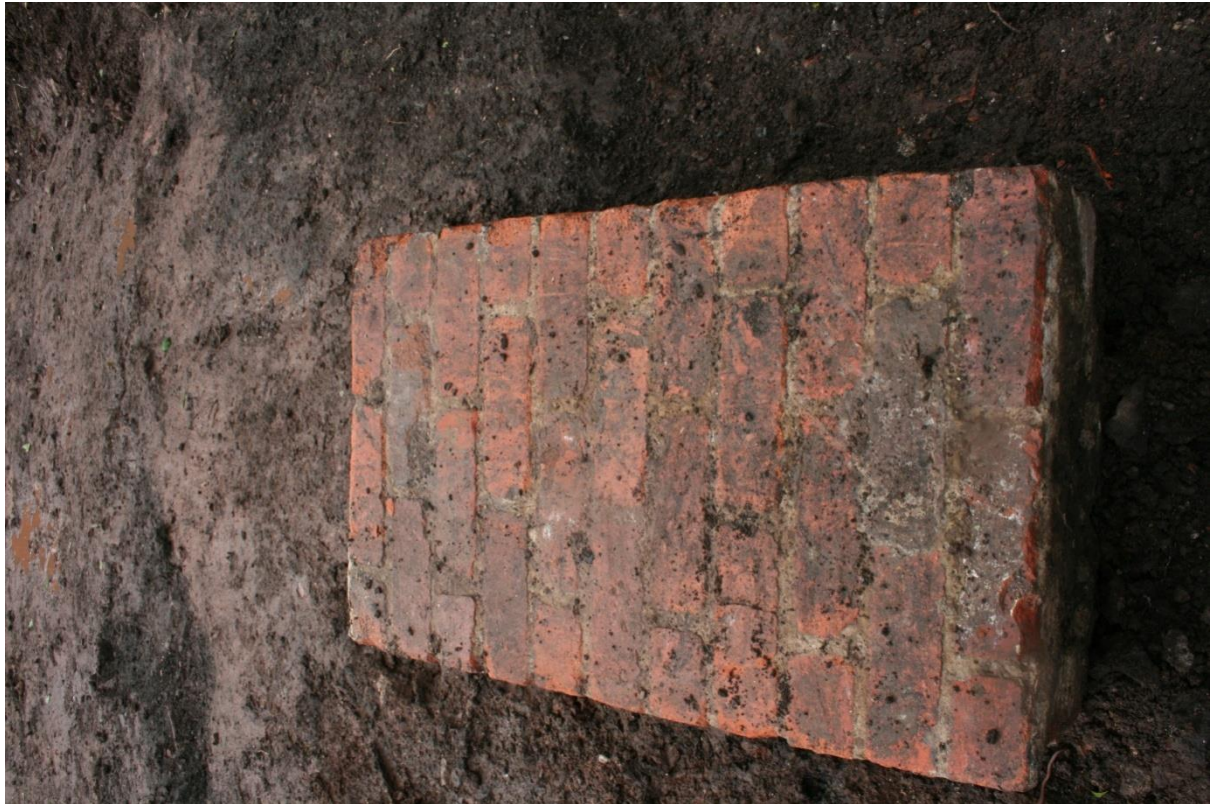
Plate 14. Remains of the brick pier.

The interior of the structure contained by walls (3002) was reduced, firstly by hand; and later, following a decision to remove the fill, (3003), by mechanical excavator. The fill, having been removed, it was then inspected by a team of volunteers who recovered all artefacts. The interior was excavated to the natural clays (4008), at its deepest point the interior was 1.9m below the excavated ground levels, the pit base lying at 40.910 A.O.D. The interior was then hand trowelled and cleaned prior to recording. The northern and southern walls of the structure were seen to contain two recesses each, such that they formed an alcove within the walls of the structure (4001) – (4004). These were numbered, 1 & 2 being designated to the north wall and 3 & 4 to the southern wall. Alcove 1 had dimensions 475mm in height X 480mm width and 300mm deep; Alcove 2 had dimensions 505mm in height X 500mm width and 300mm deep, Alcove 3 had dimensions 515mm in height X 460mm width and 240mm deep, Alcove 4 had dimensions 463mm in height X 490mm width and 280mm deep. It was also observed that where the 8 wrought iron bolts (3029) had been seen at ground level within the walls of the structure (3002) below ground level it was apparent that eight corresponding cavities in the masonry had been cut to allow access to their opposite ends. (4006) These access holes were not of a uniform size but were set at approximately the same level throughout the structure. In the base of the pit at its south eastern corner and passing through the southern wall was a salt glazed earthenware pipe forming a drain. The pipe had an internal diameter of 160mm. (4005) and rested upon the natural (4008). Seven 'weep holes' were apparent at the base of the walling (4007). Due to the wet conditions and the possibility of collapse due to the levels within the pit being reduced below the walling in places the pit floor was filled to the level of the stone work with clean sandstone chippings. During the excavation of this pit a large block of brickwork was removed in two pieces this was later realised to be a brick pier and was photographed for the record, and recorded as (3003) a constituent of 'fill of pit'. (Plate 14)

large brick pier that was removed from the sawpit provided additional support in the centre of the pit for the mechanism above it. There is no evidence for which type of mechanical saw that was employed at Shop Lock, there are only two systems known, the circular saw and the reciprocating saw. The motive power for the saw would have been generated by a small steam boiler, possibly housed exterior to the main building. A possible location for such a boiler is to the southwest of the building where a large amount of coal ash and clinker was seen when stripping the topsoils in the area of Trench 2 whilst the 'floor' (3028) surrounding the sawpit was largely comprised of ash and clinker. The building itself is quite rare as only one other sawpit is known throughout the 33miles (53 kilometres) of the canal system although it is probable that another remains to be located somewhere close to Fourteen Locks. The surviving sawpit building is alongside the locks at Llangynidr on the Brecon and Abergavenny section of the canal, however the sawpit has been filled in and concreted over and the building converted into a dwelling.¹¹

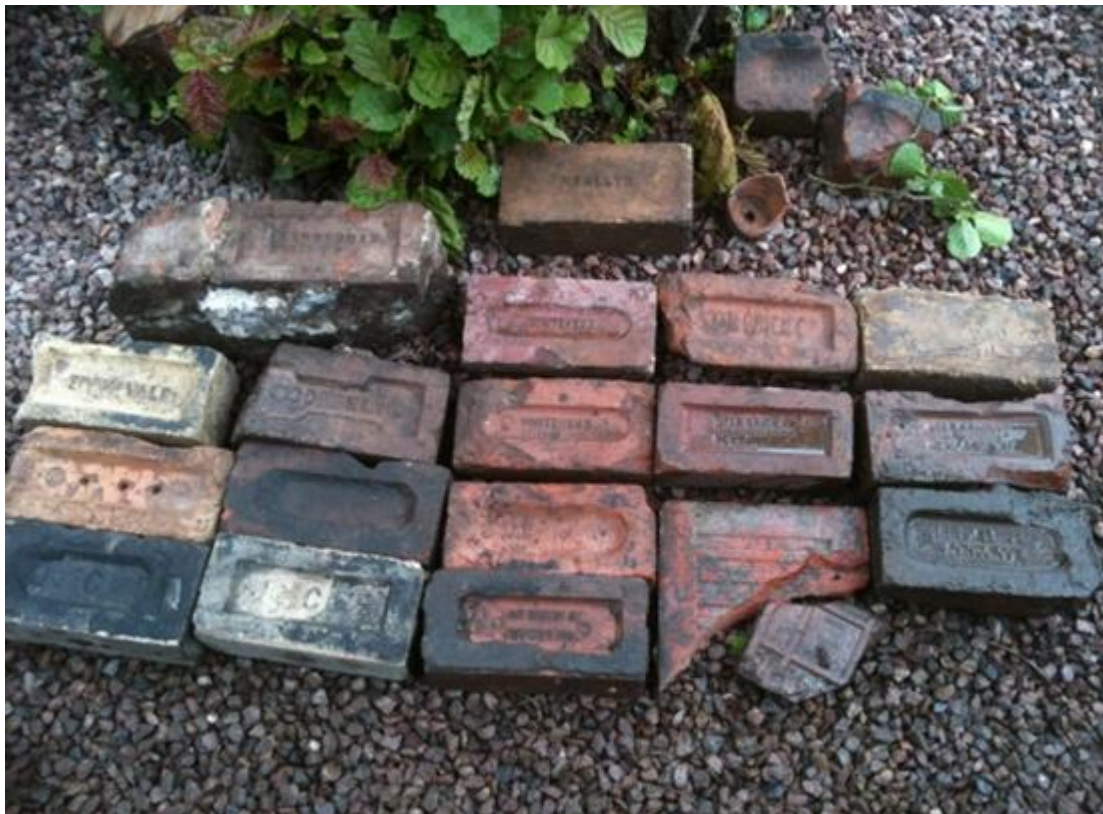
Plate 15. Selection of Bricks recovered from Ty Coch

Several bricks were recovered from the sawpit and along with those recovered amongst the surface scatter form a small representative sample of brick making in and around the Ty Coch area. (Plate 15)

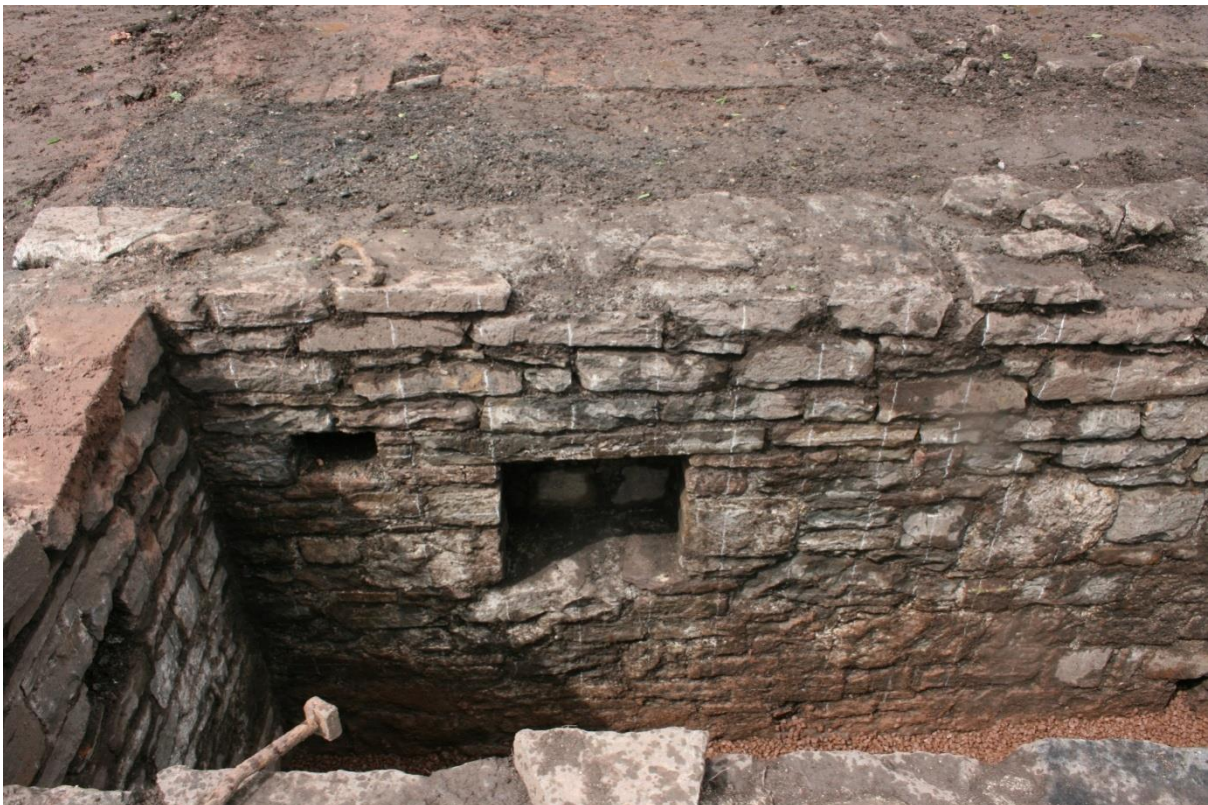
Plate 16. Recesses in Sawpit for lamps and bolts illustrating the advent of mechanical sawing

At some stage in the Saw mills life it would appear to have been converted to a mechanical Saw Mill. The eight large bolts (3029) that held down a frame for a mechanical saw having been inserted into the walls of the pit after they were built. The

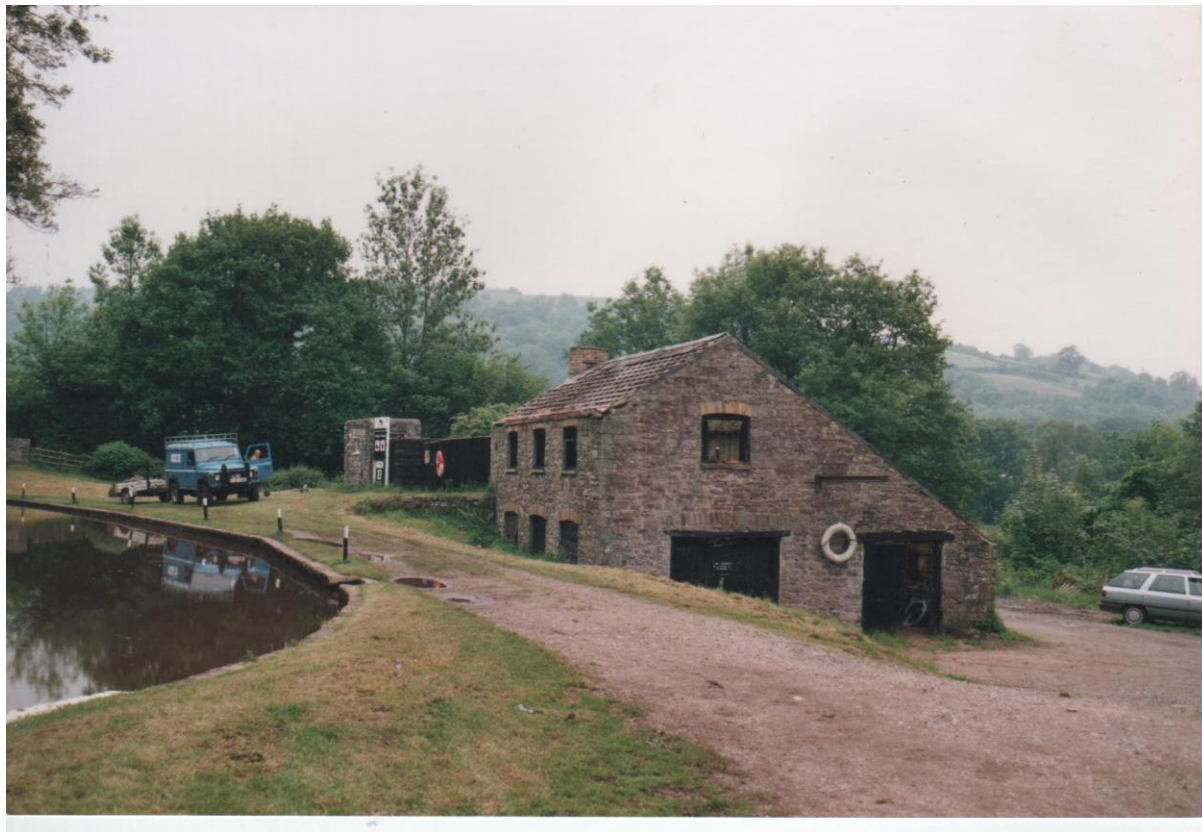
Plate 17. The sawmill and workshop at Llangynidr locks prior to restoration.

The general form of the building at Llangynidr is thought to be similar to that at Shop Lock however it can be seen that the sawmill area is the reverse of that at Shop Lock. The three shuttered openings shown on Plate 18 provided light and ventilation to the sawpit. Whilst the workshop was situated closer to the canal and in the view provided on Plate 18 the workshop was located behind the large doors to the left. It is possible to imagine a building of the same shape and form but using the 'cat-slide' roof to cover the workshop area as being the building that stood at shop lock. However, the difference in these buildings would have been that at shop lock the 'cat-slide' roof was supported, perhaps wholly, upon a timber frame with only the sawpits outer walls being entirely constructed of stone.

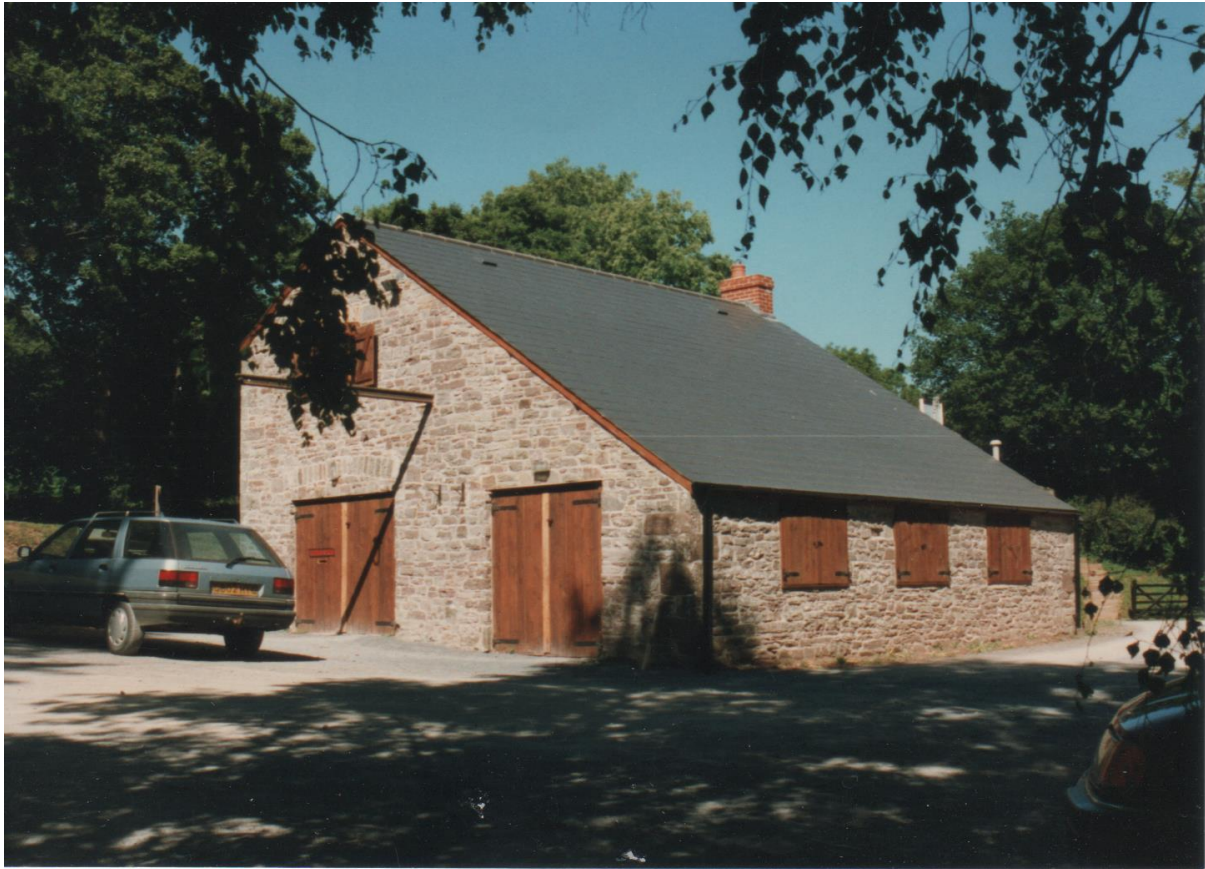
Plate 18. The sawmill and workshop at Llangynidr locks following restoration.

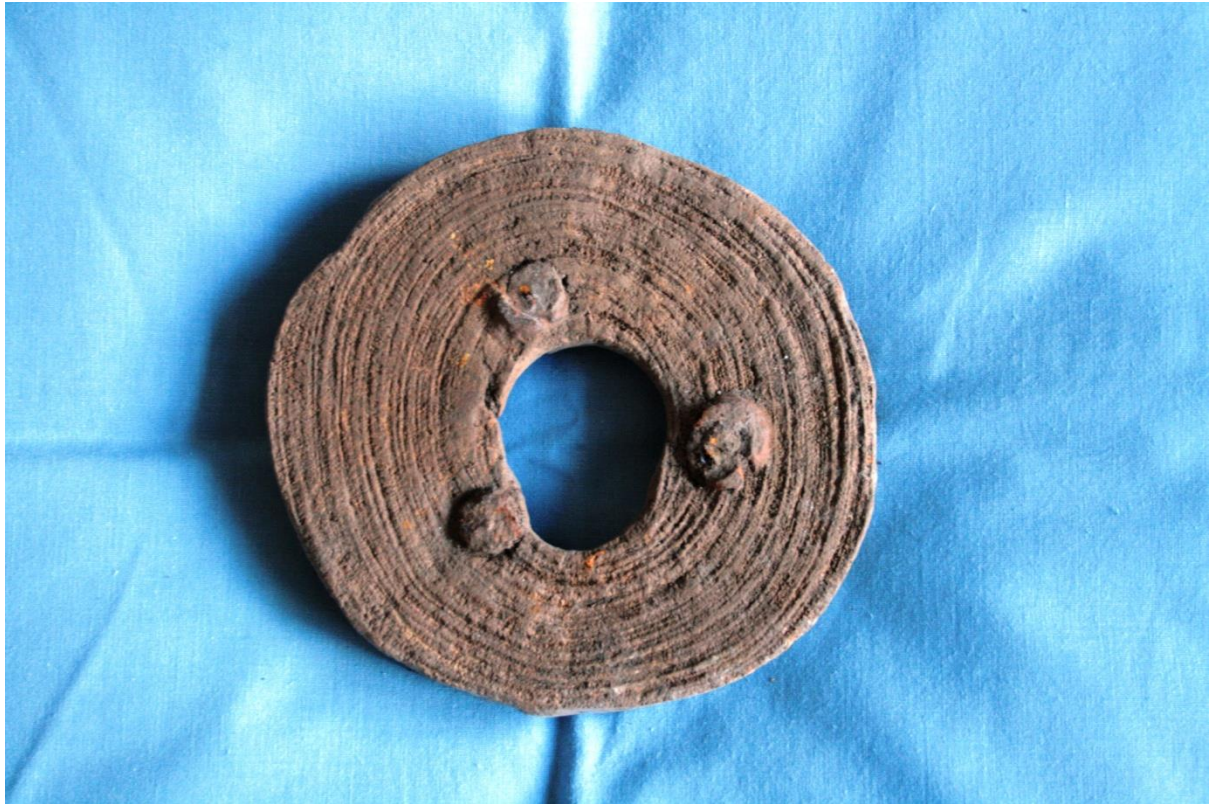
Plate 20. Flexible leather drive coupling.

A leather flexible drive coupling, 140 mm diameter and 22mm thick, was found within the workshop area and identified as a type commonly used on motorised drives for canal boats and within the engineering industry on powered tools. Plates 20 & 21.

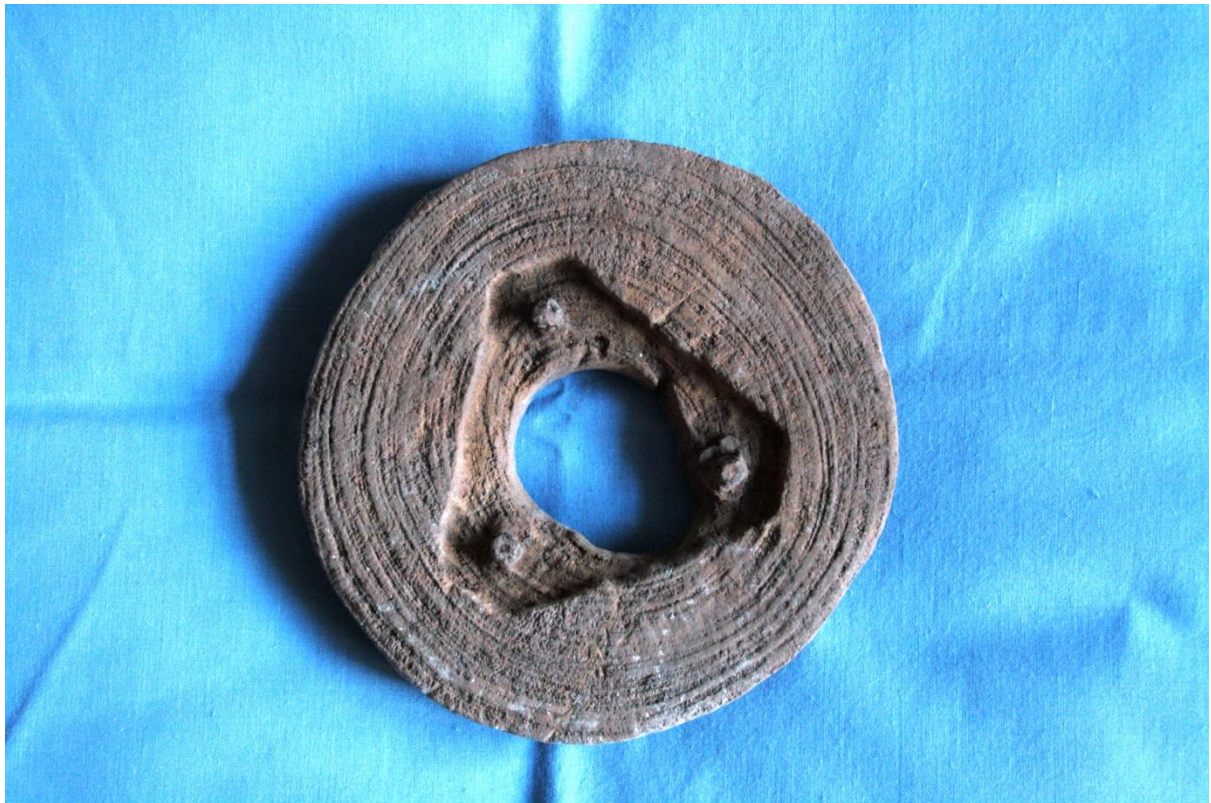
Plate 21. Flexible leather drive coupling. Reverse view.

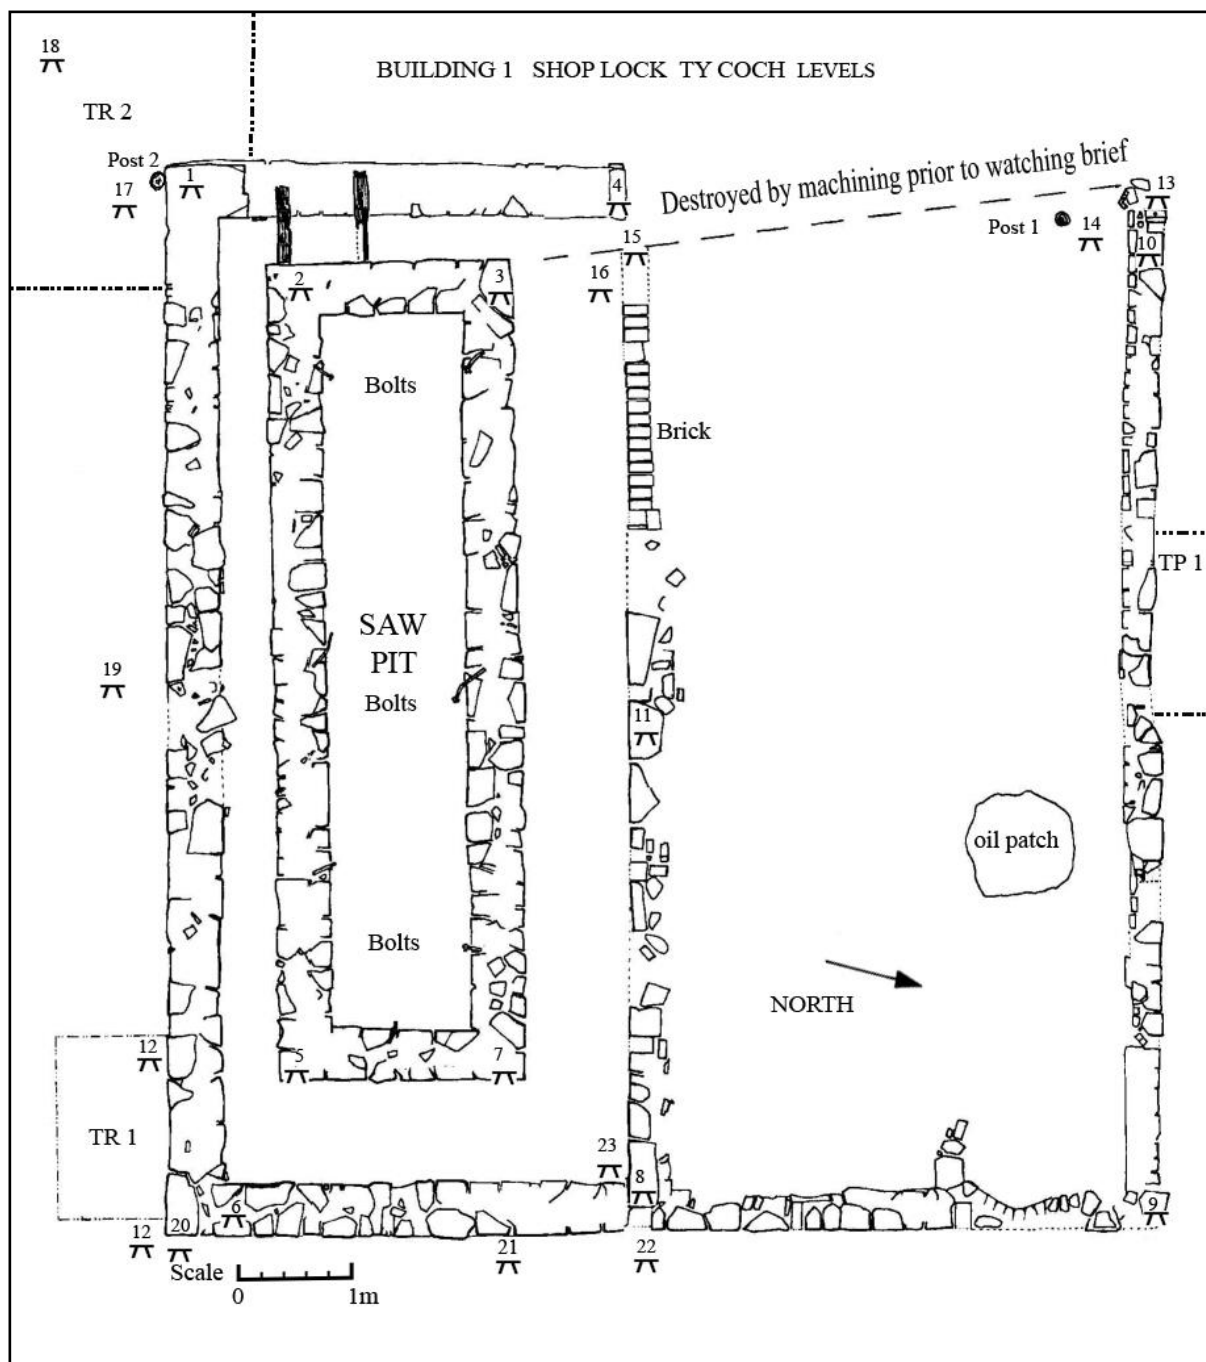
Drawing 4b. Scale 1:20. Building Ty Coch Shop Lock. Showing Level points.
