An Archaeological Report on an excavation at Shop Lock Ty Coch

This report details the results of a programme of archaeological works commissioned by Torfaen County Borough Council. The archaeological programme comprised shallow excavations undertaken at Ty Coch, Cwmbran during June 2013. The archaeological contractor was The Ancient Cwmbran Society Ltd. The contract was project managed and directed by a qualified member of the Institute for Archaeologists (IfA), R Burchell MA, PlfA.

The archaeological programme comprised excavations undertaken at Shop Lock, Ty Coch, Shop Lock Cwmbran during June 13, 14 & 15 2013 centred on NGR 329258-193078. The site is comprised of a canal-side plot of land believed to contain a building, the nature of which was investigated through the means of an archaeological excavation. The removal of turf and topsoil to the level of the first indication of archaeological remains was by the use of a mechanical excavator and small dump truck; this was conducted under the supervision of R. Burchell MA, PlfA the previous day, 12th June.

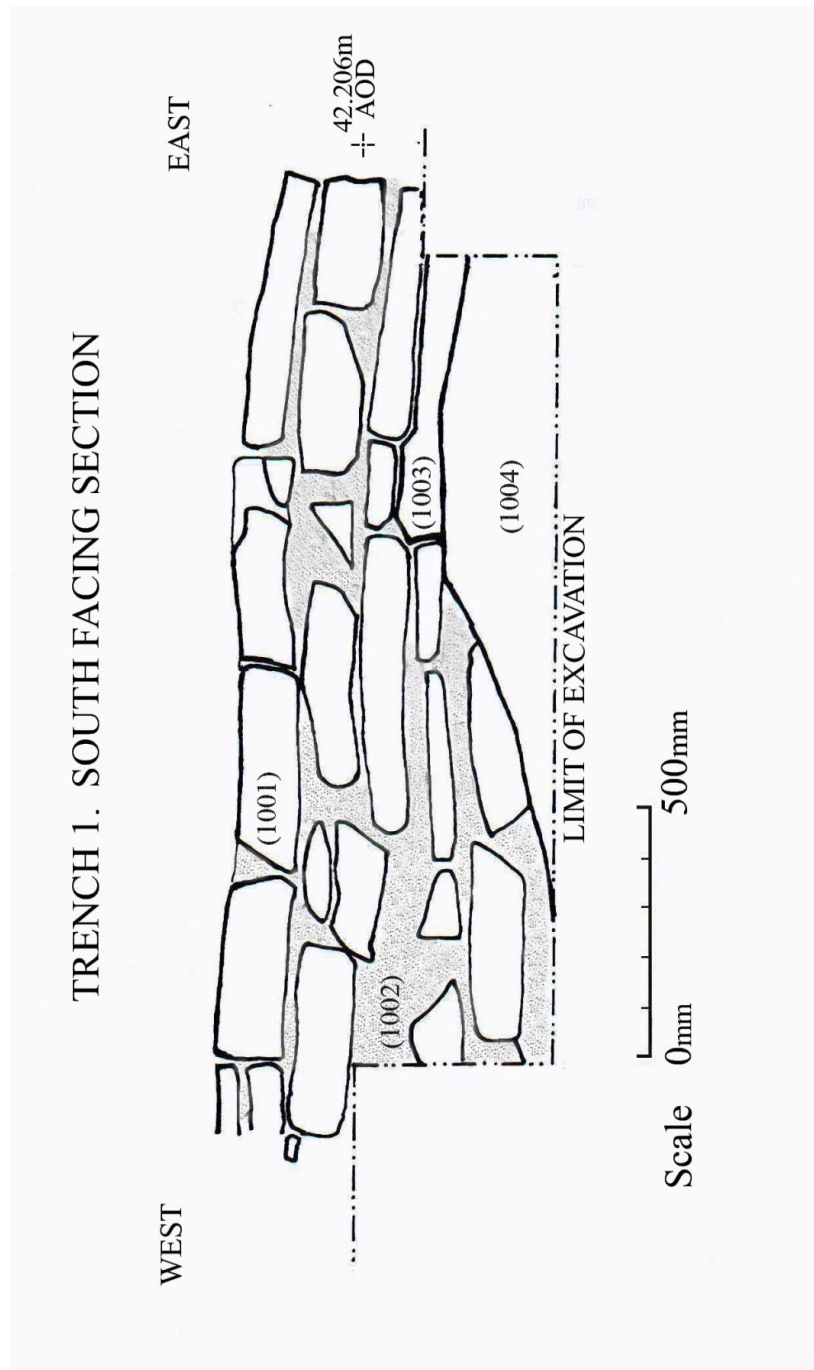
Drawing 1. Scale 1:10. South facing section of Trench 1.

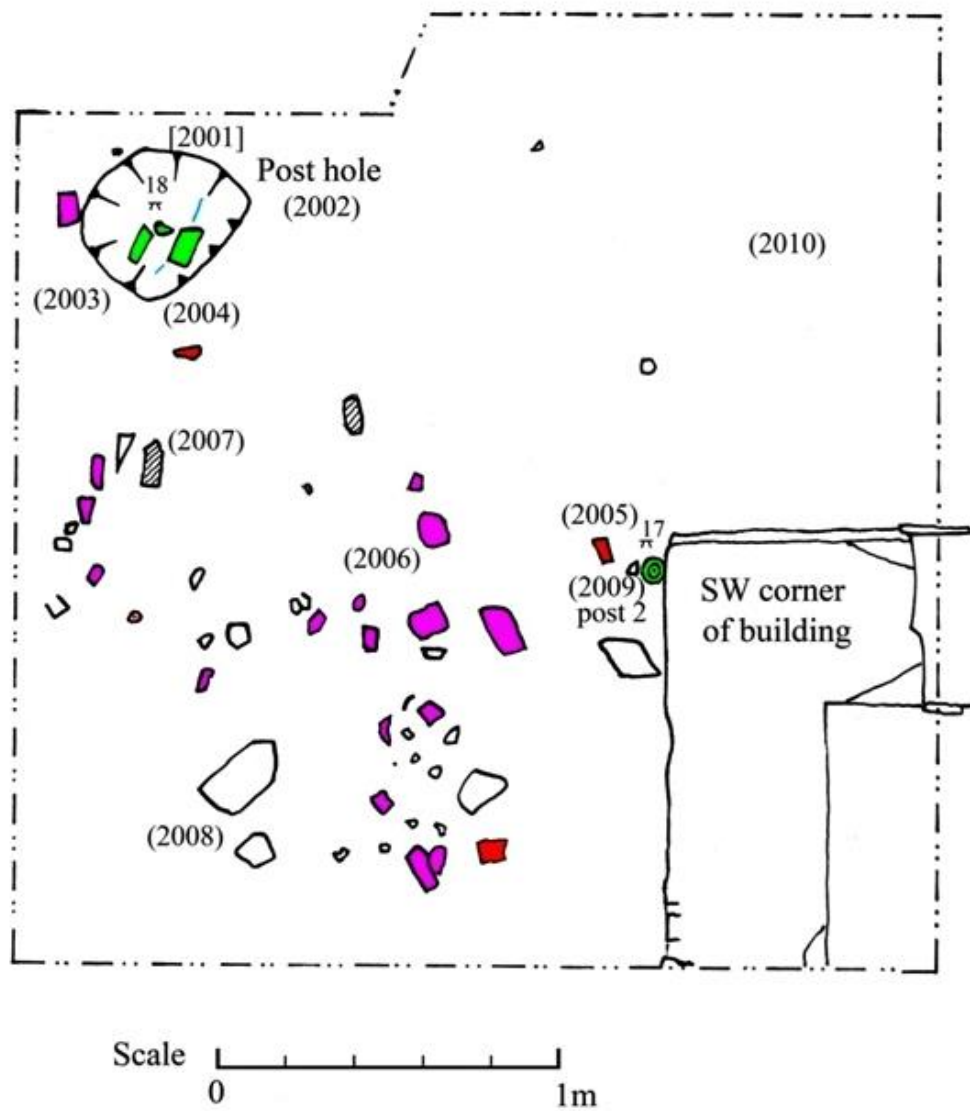
TRENCH 2. SHOP LOCK TY COCH

Drawing 2. Scale 1:20. Plan view Trench 2 with details.

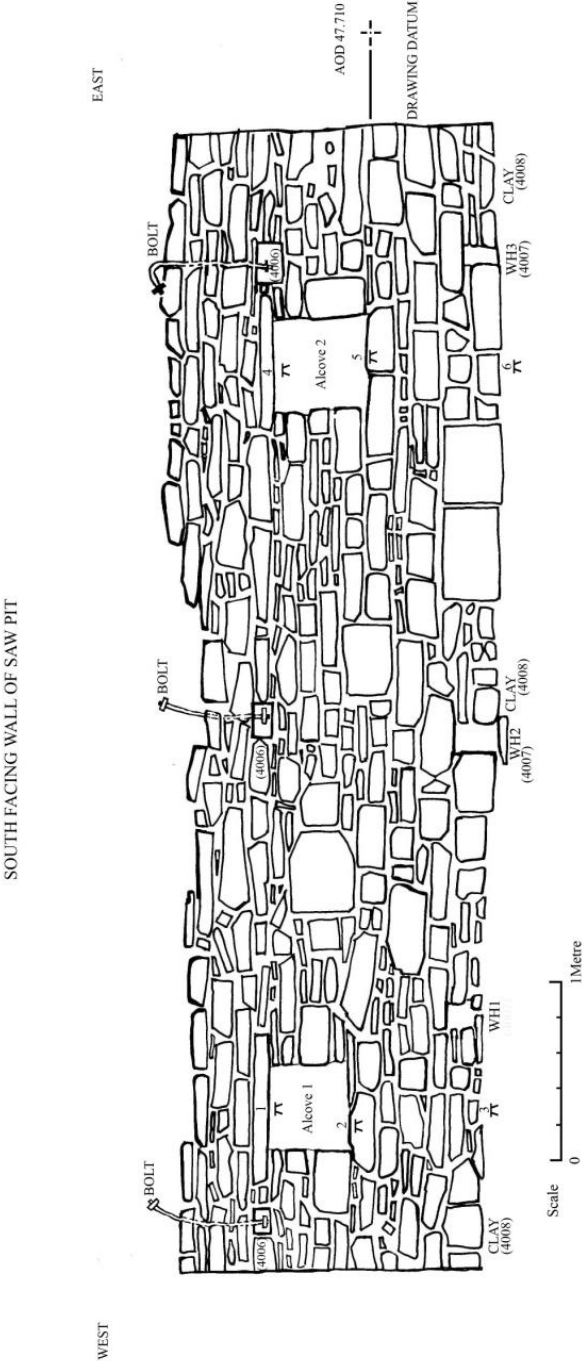
Drawing 3, Scale 1:20. South facing wall of Sawpit with details

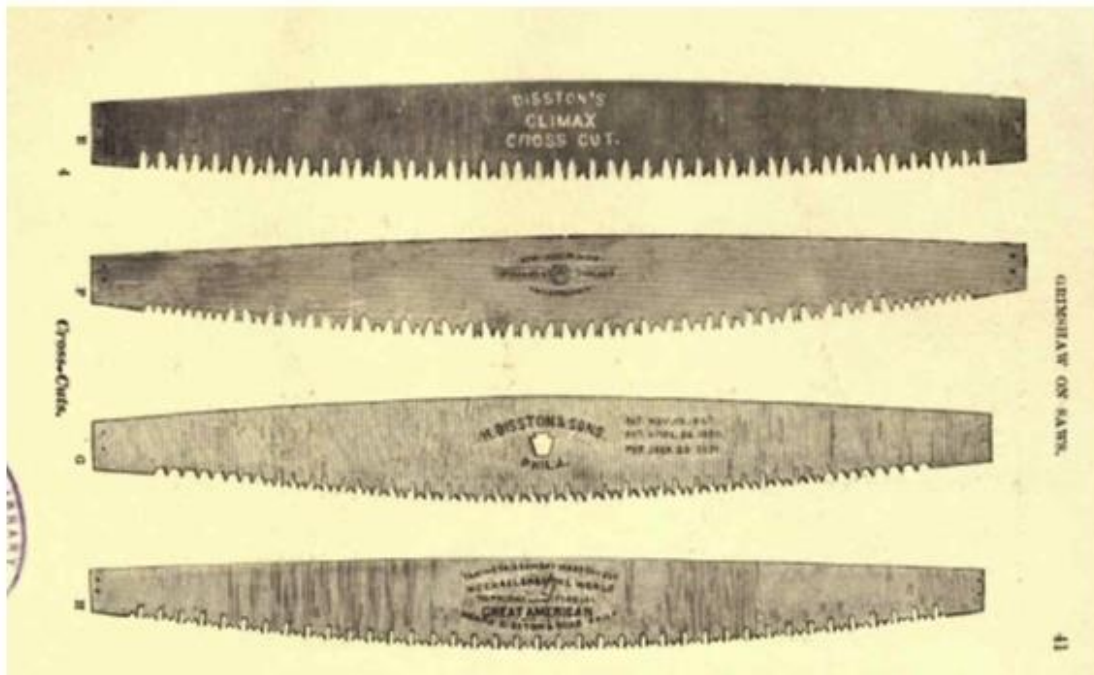
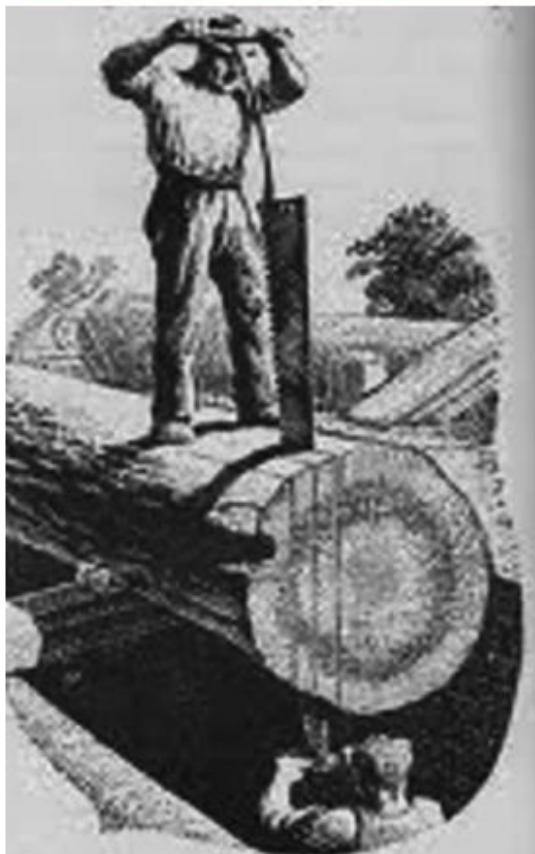
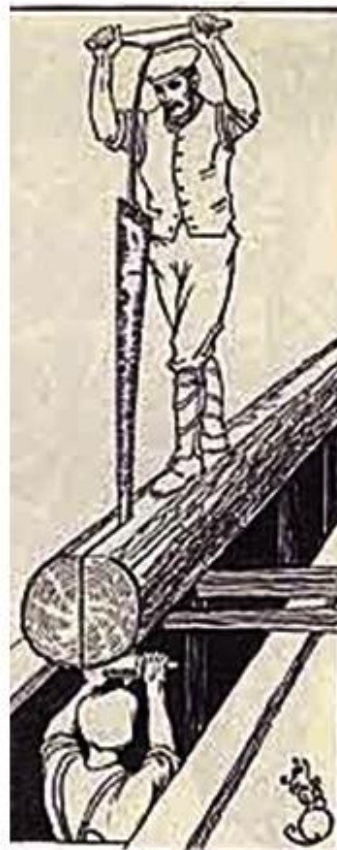
Fig 7. Top Grimshaw, R. 1880. Saws. Philadelphia: Claxton, Remsen & Haffelfinger; [etc., etc.], p.41 Bottom Left .

The Sawpit was seen to be constructed from stone and brick bonded with a lime mortar (3002) and forming an oblong pit below ground level. Its dimensions internally were 6.44m X 1.28m X 1.9m deep (Fig. 5). It can be seen that there are two phases in the development of this Saw mill. The first phase is manual. Set into the north and south walls are four alcoves that are staggered along the length of the pit, these were to provide shelves for lamps thus lighting the underside of the sawpit whilst it was in use by the 'Bottom Sawyer'. The timbers to be sawn would be close to floor level with the 'Top Sawyer' standing on or over them, the 'bottom sawyer' being below him. The nature of the work demanded that timbers are sawn up into planks or beams by the use of a large double handed saw used vertically, as illustrated below, (Appendix 8).

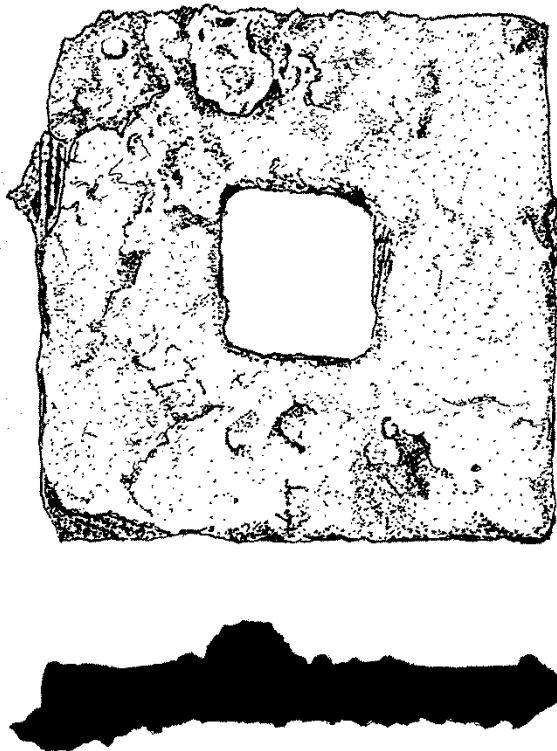
Square, hand forged washer in wrought iron. 70mm X 8mm. Hole 20mm X 22mm.

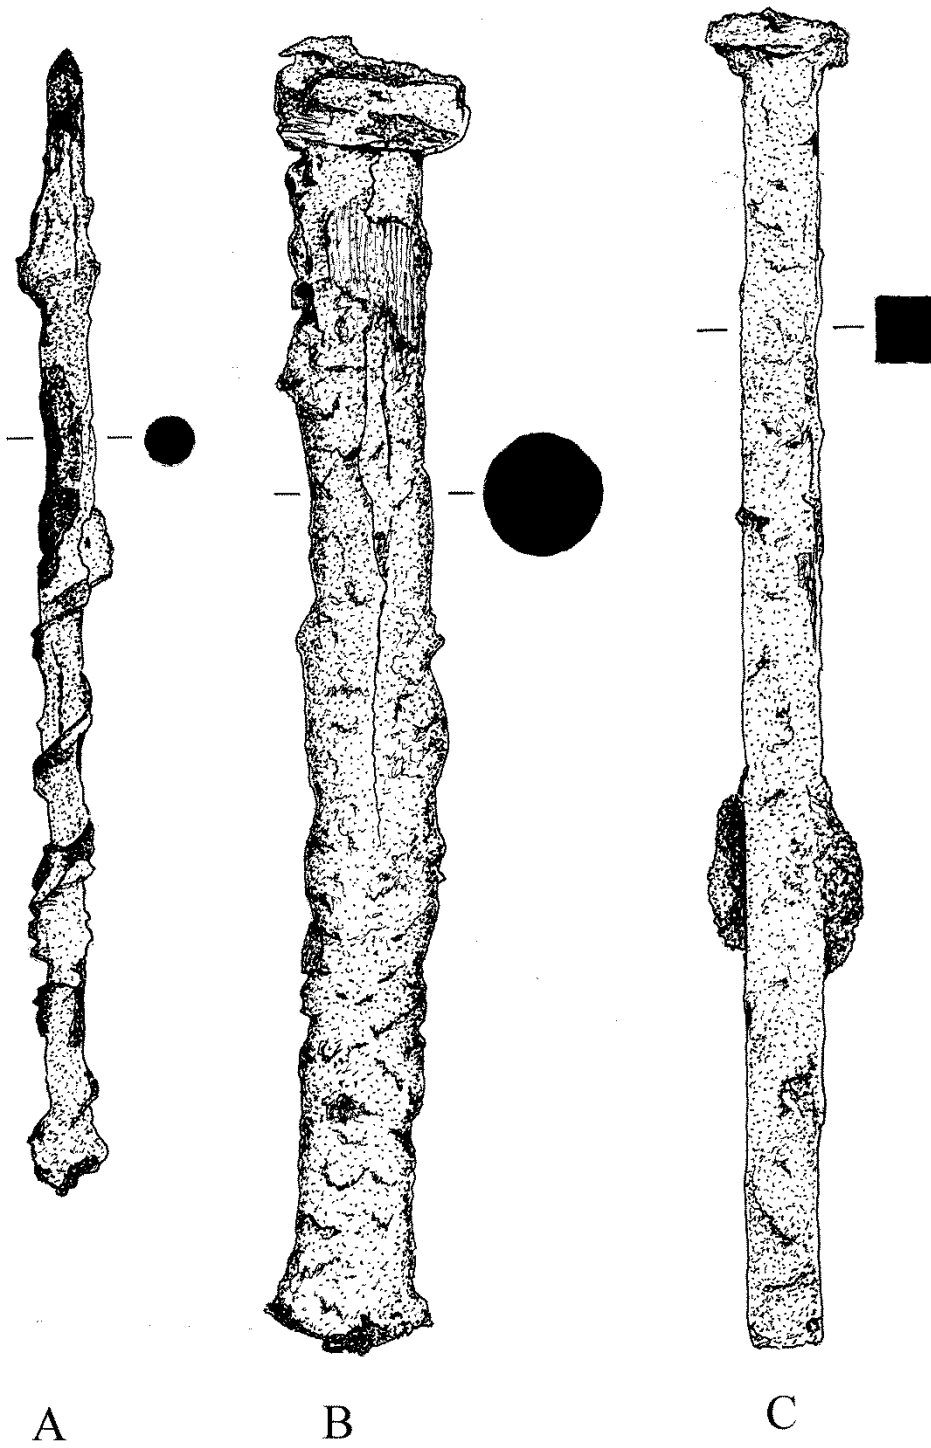
A. Auger – Woodworking bit.

B. Chisel. 16mm.

C. Chisel. 10mm

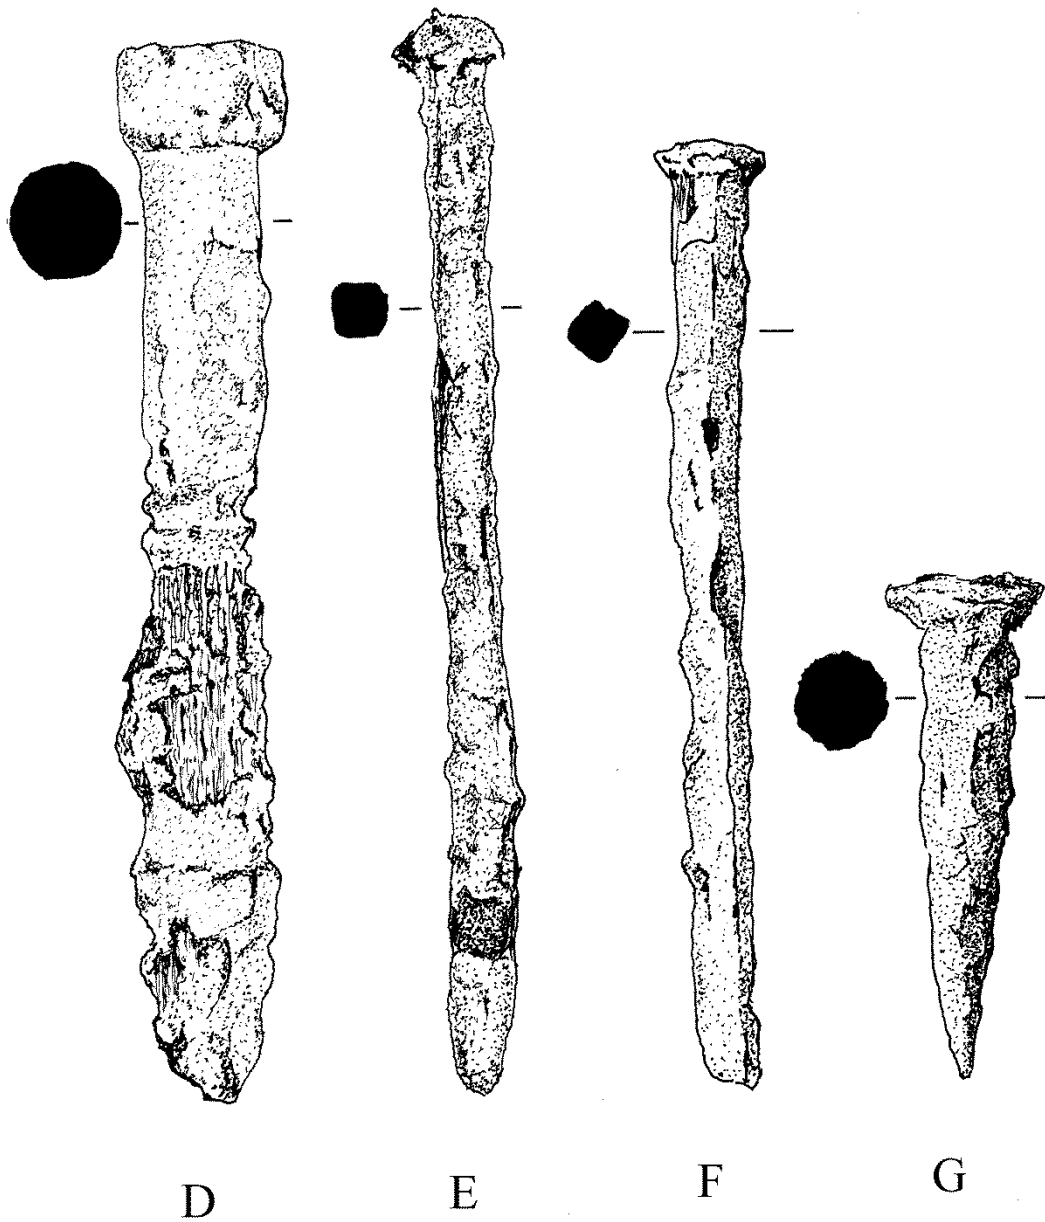
D. Hand made square headed bolt 15mm diameter.

E. Hand made large square shanked nail.

G. Short hand made nail

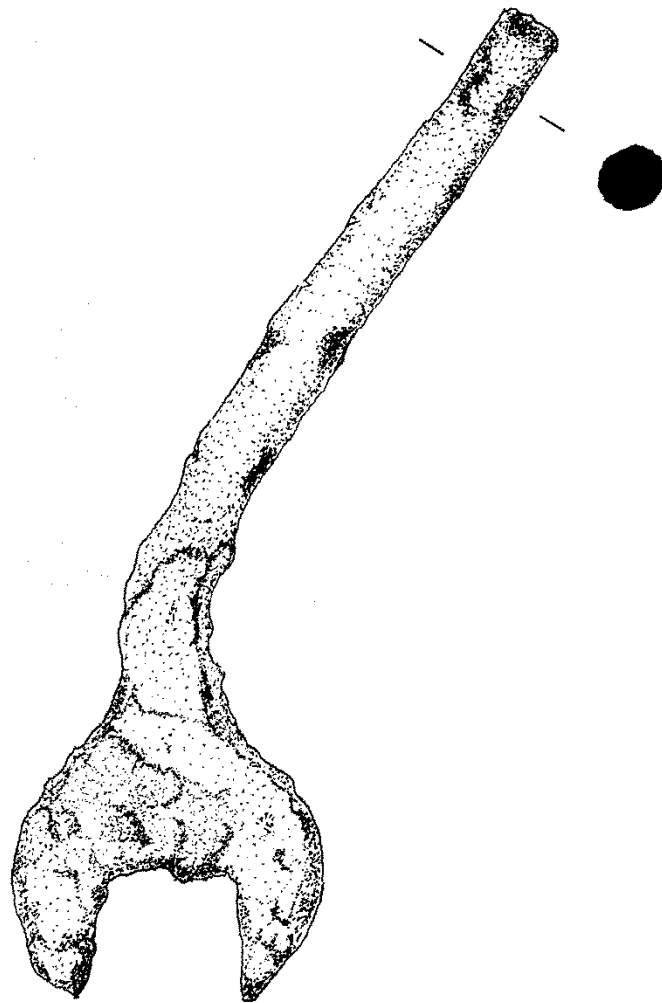
Cranked Spanner.

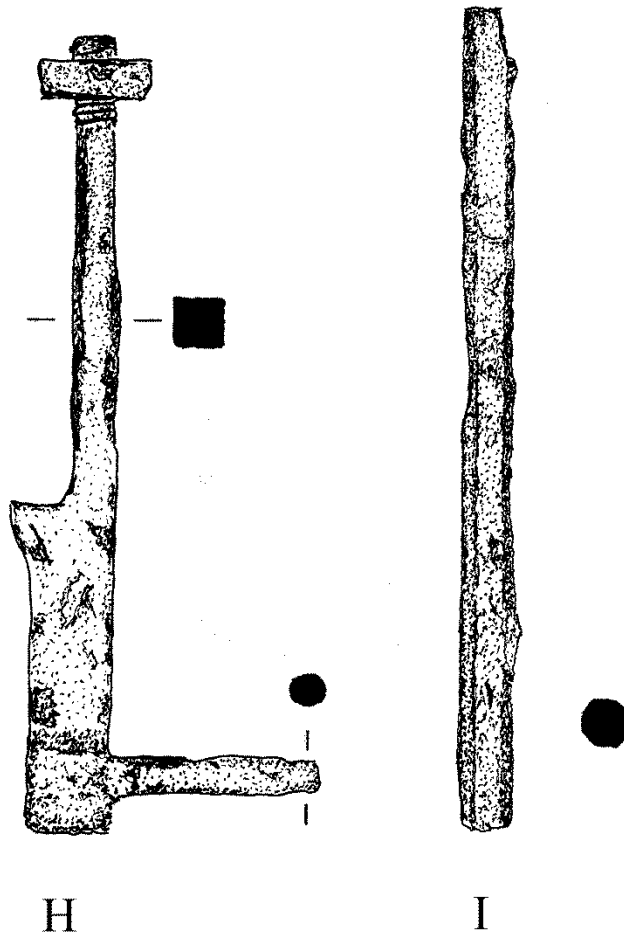
H. Wrought iron hinge with nut.

I. Steel hexagonal machine part drilled one end.

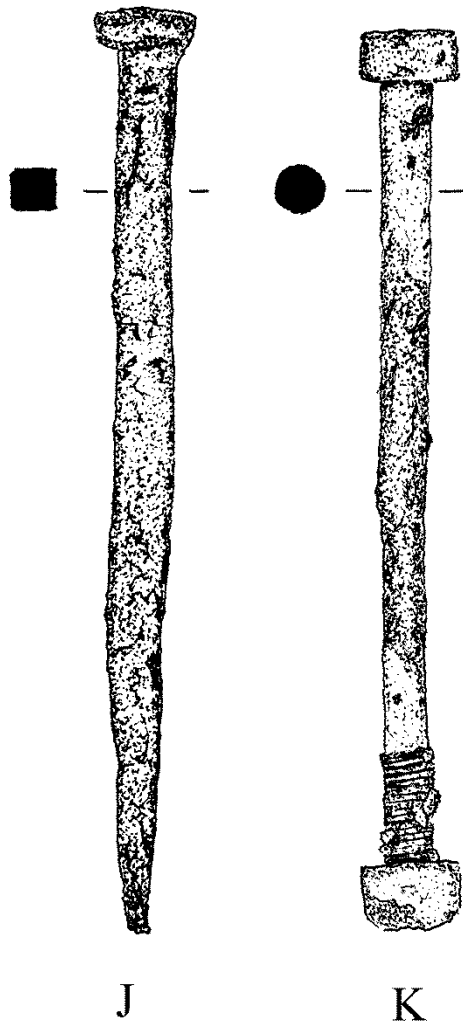
J. Forged square sectioned wrought iron spike.

K. Forged round sectioned wrought iron nut and bolt.

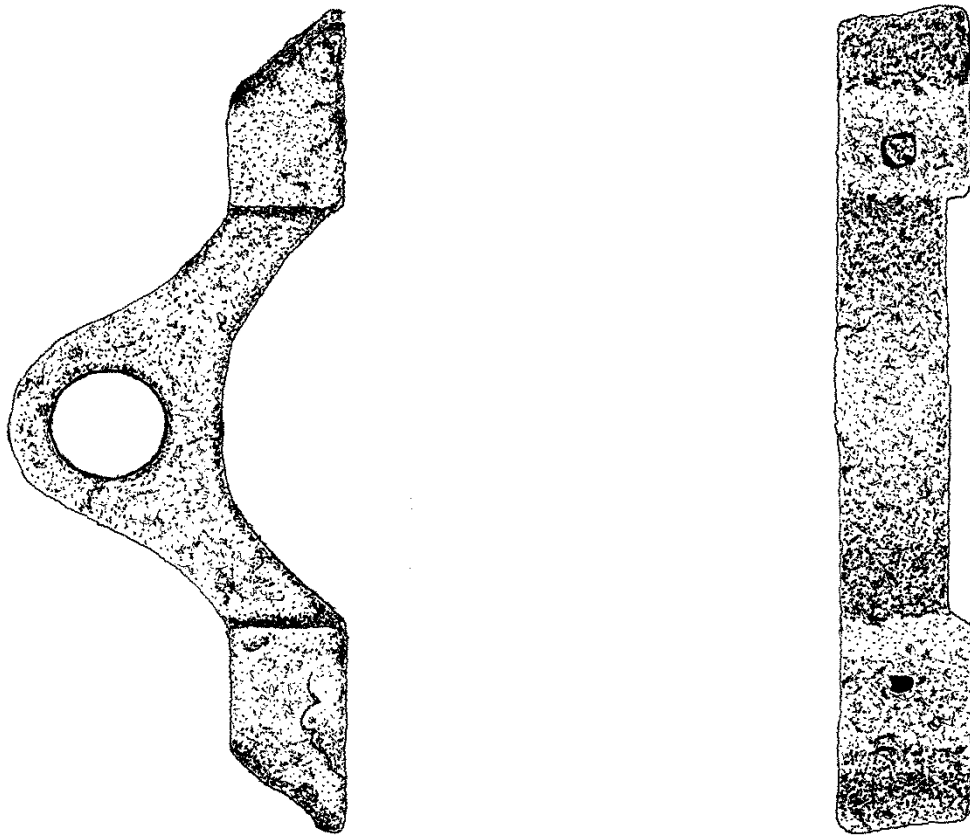
Cast iron Pinion mounting bracket from rack and pinion paddle gear. End elevation (left)

Bottom elevation (right).

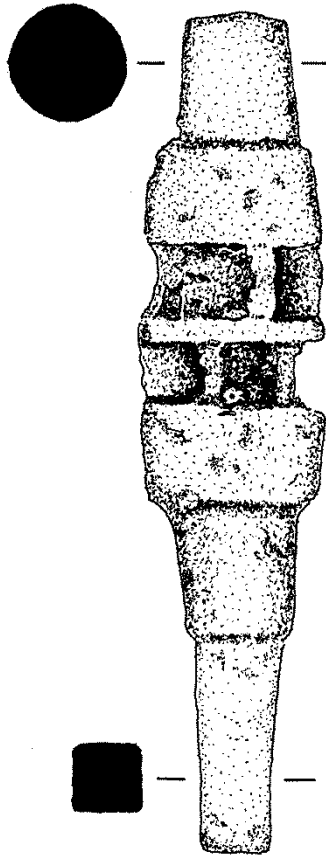
Cast iron Pinion from rack and pinion paddle gear. Fits into support shown above.
