**A Comprehensive Assessment of the
Architectural Hardware found at the
William LeDuc Residence in Hastings,
Minnesota**

**Documentation compiled and written by
Eric J. Nordstrom
Spring 2005**

SECTION 1
LEDUC HOUSE ARCHITECTURAL
HARDWARE

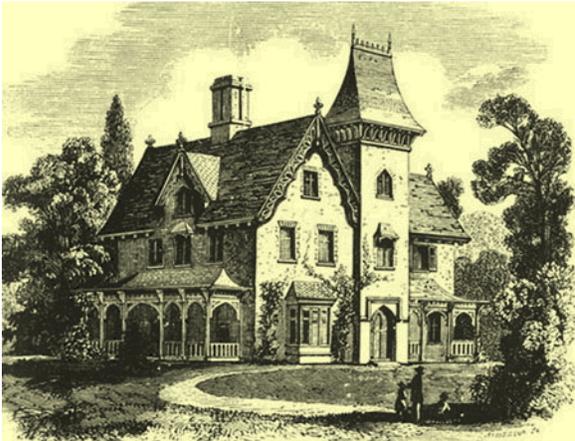
House Plan from Cottage Residences by Andrew Jackson Downing, 1853 that was “reversed” by Mrs. LeDuc, in order to provide more natural light and heat in rooms the family would be using most.

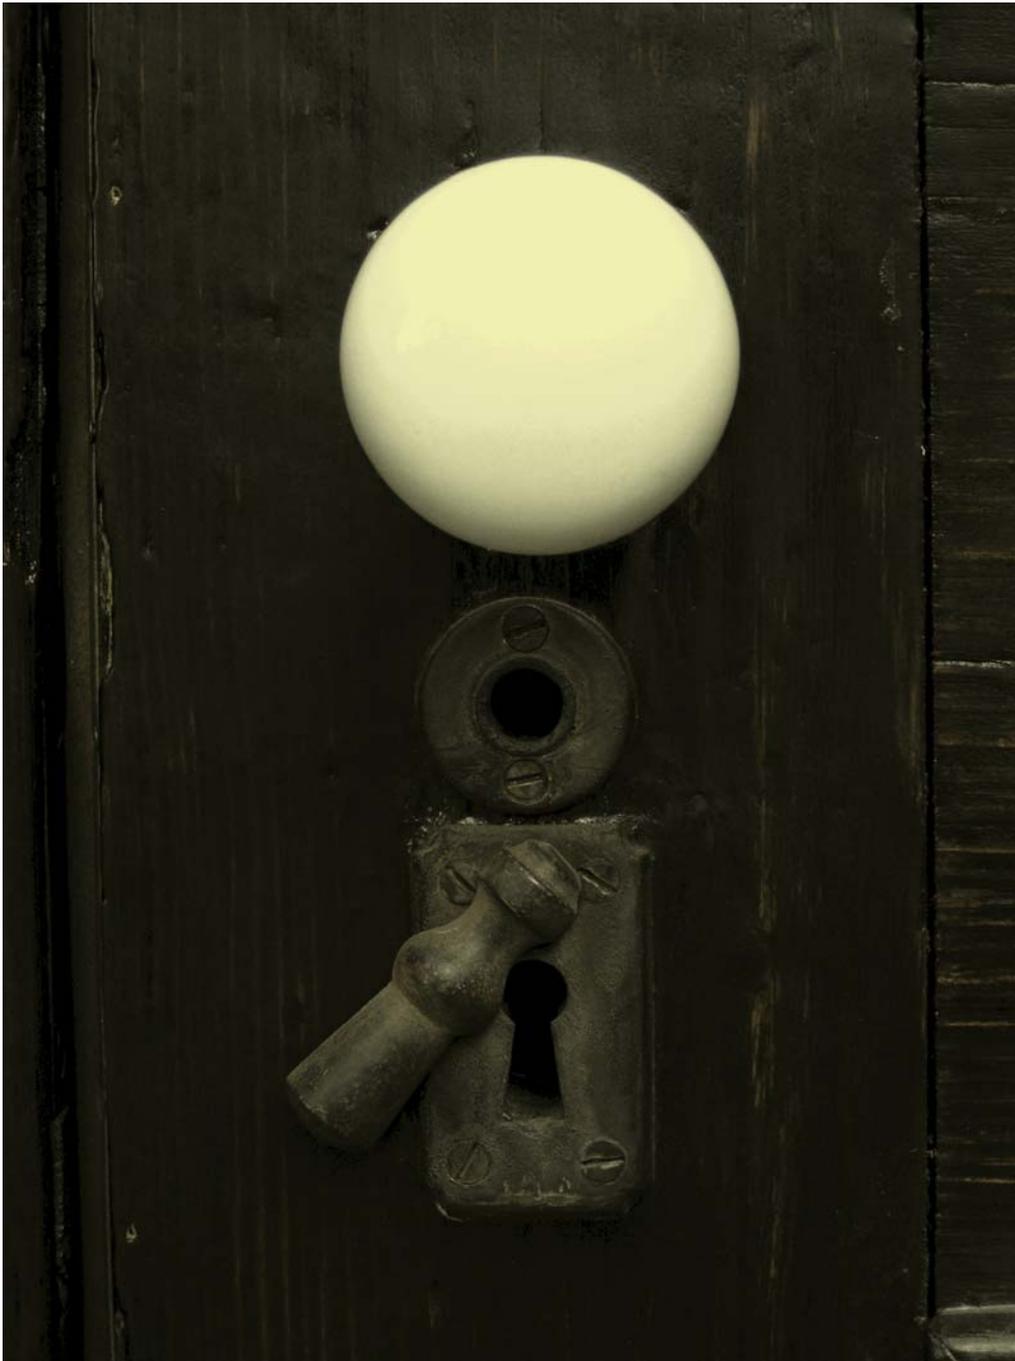
Plate 1

Front entrance hardware of the LeDuc House. The double doors are made of white pine and outfitted with white porcelain doorknobs. Each door is attached to the jamb with four inch, plain cast iron hinges. Although the doors were recently rehabilitated, the hardware is original and unaltered. This image portrays a detailed close up of the white porcelain knob, entrance cast iron key plate, and a small cast iron rosette once surrounding a small handle that controlled the latch and bolt of the mortise lock. Fortunately the key plate's swinging cover is intact—in many cases these covers were broken off or missing altogether.

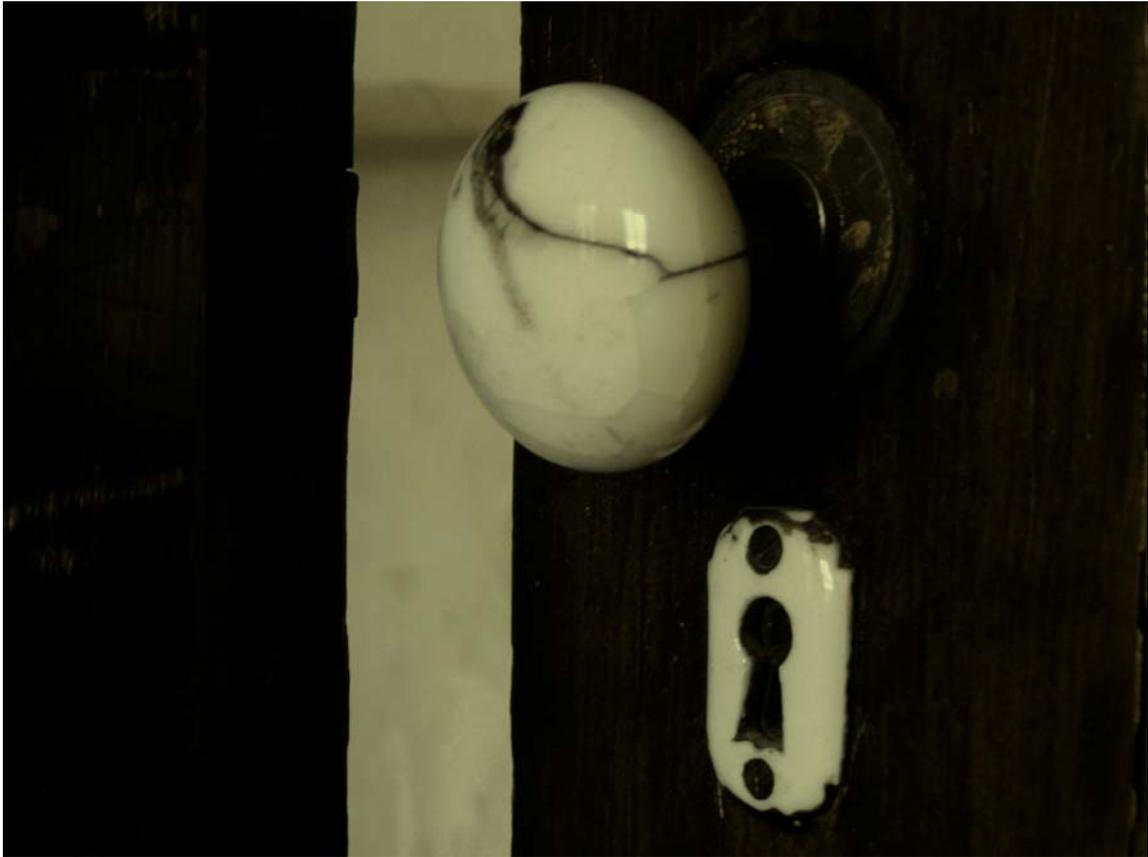
Plate 2

Due to limitations in picture transference, the story here is partially obscured. Even so, the white porcelain knob exhibits the classic crazing in the glaze that happens over time. However, the large marking on the top of the knob is actually a section that was broken off and then reattached at some later point. Some accumulating grime has accentuated the cracked portion. This knob, like the remainder found throughout the house is white porcelain with straight cast brass shanks, and backed by a plain cast iron rosette. The only variation that deviates from this scheme is the key plate which comes in different shapes, sizes, and overall appearance.

Additionally, the majority of door rosettes are white porcelain, and not cast iron. Nearly every passage door has the reversible latch mortise locks with a brass face plate, and complimentary cast brass strike plate. All of the doors are native white pine, and were recently refinished.

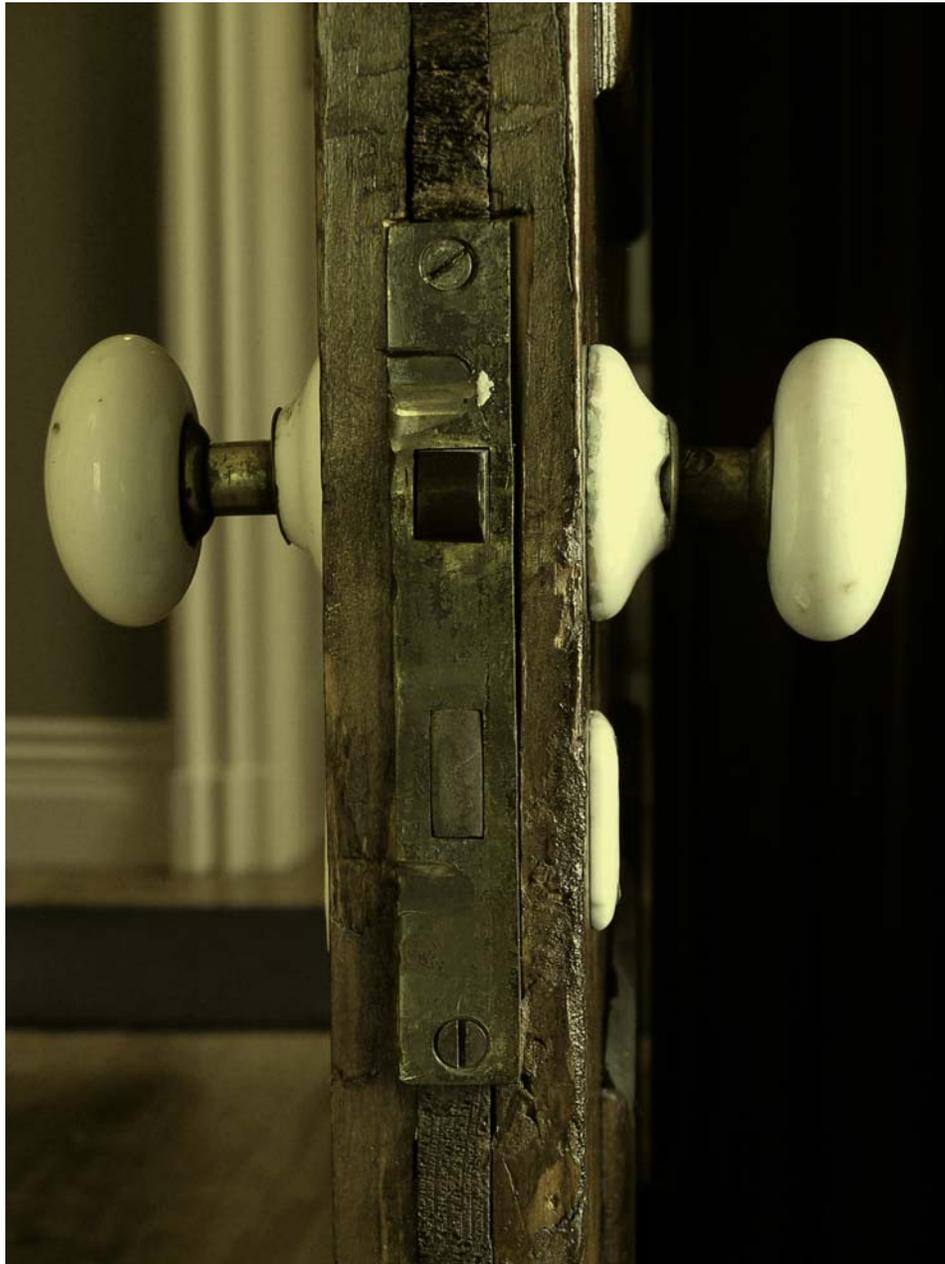
Plate 3

Cross sectional view of the hardware on a typical white pine passage door. Featured is the nicely aged cast brass mortise face plate, along with porcelain knobs and rosettes. Amazingly, there were no major chips or breaks among the vast majority of porcelain rosettes—which always seem to undergo major abuse. Every porcelain knob is mounted to brass shanks, and affixed to the spindle with brass set screws.

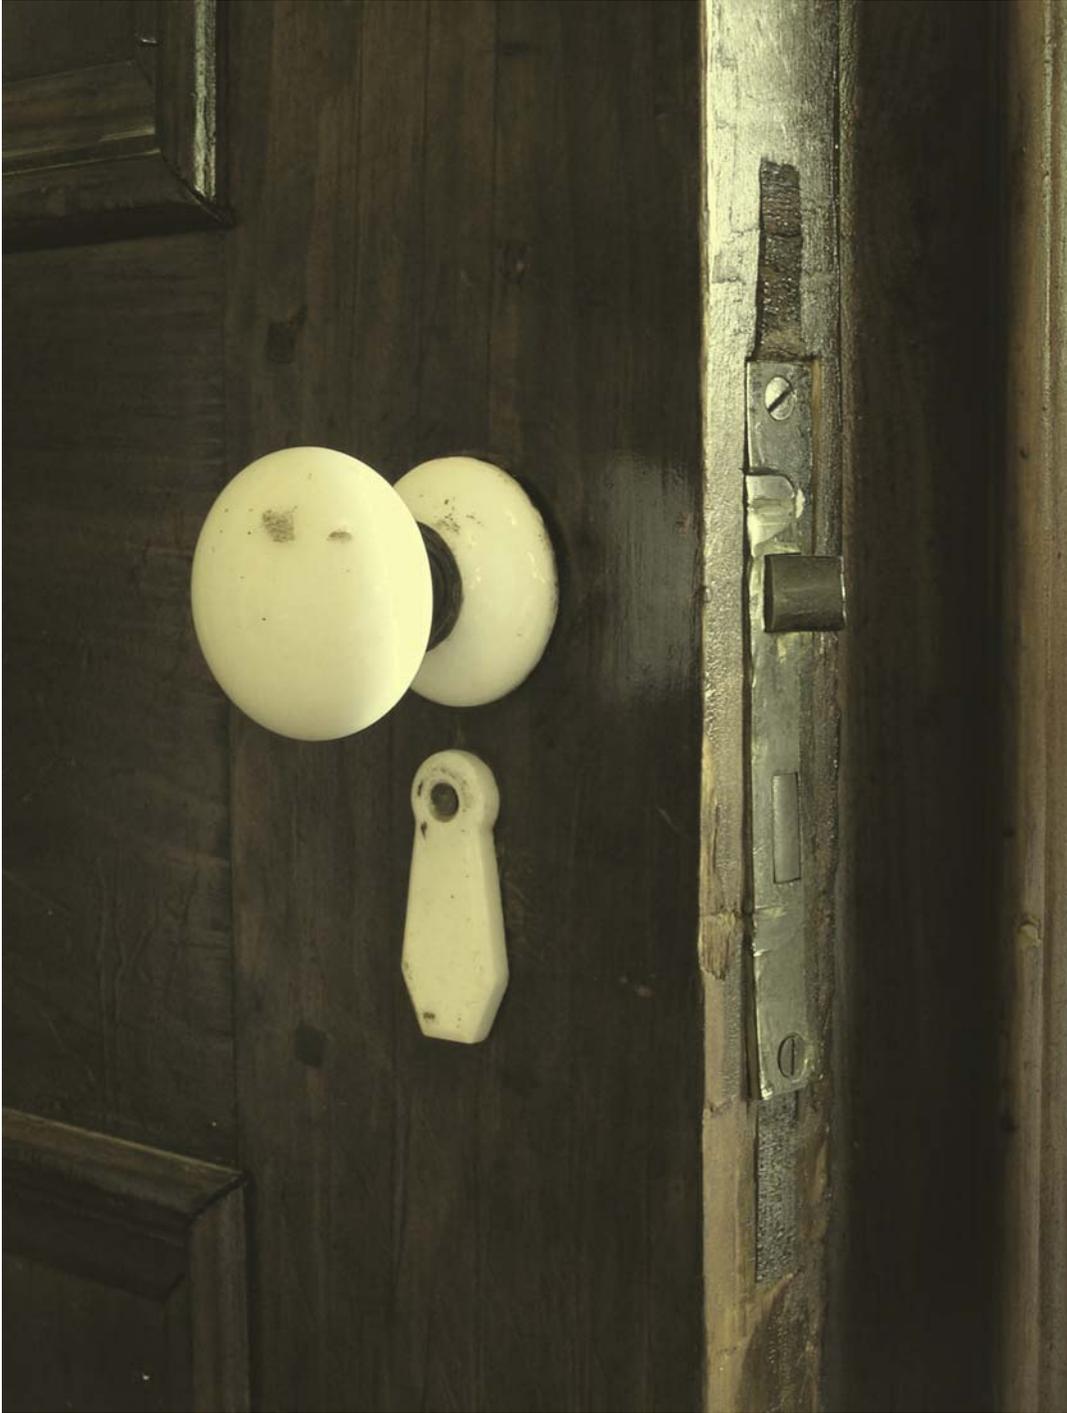
Plate 4

Another passage door only in this case, the key plate is actually the rotating cover only, nailed directly over the key hole. This is a rather unusual, if not crude alternative to the other porcelain key plates found on other passage doors.

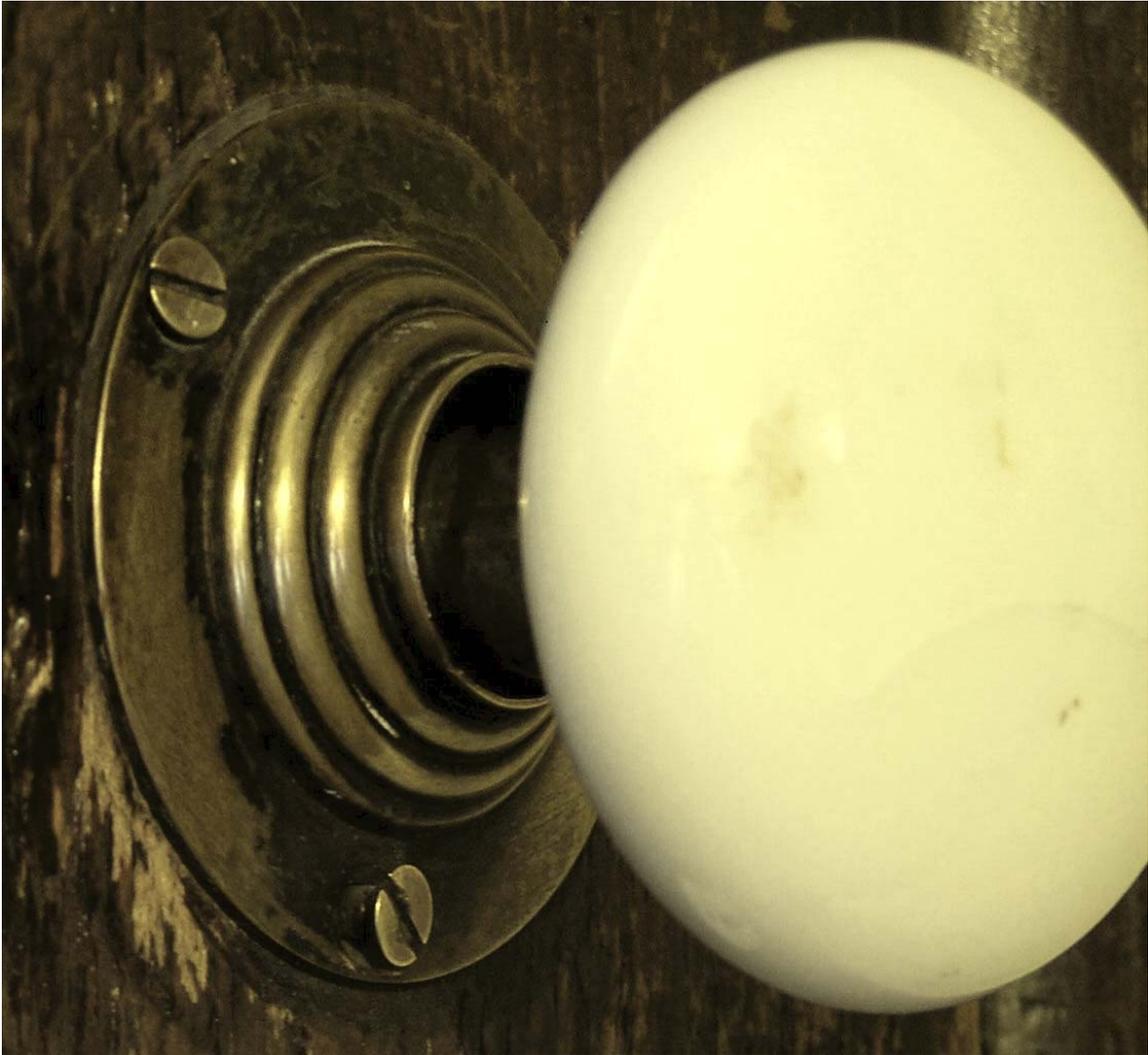
Plate 5

Detailed close up of an atypical cast brass, tapered back door rosette. This type or design is located on the rear entrance door, and is the only one of its kind located throughout the remainder of the house. I did not inspect the backside for markings, though I presume it to be R & E. This door has received substantial abuse in the form of scratch marks, slight gouges, etc., which are thought to have been made by family pets.

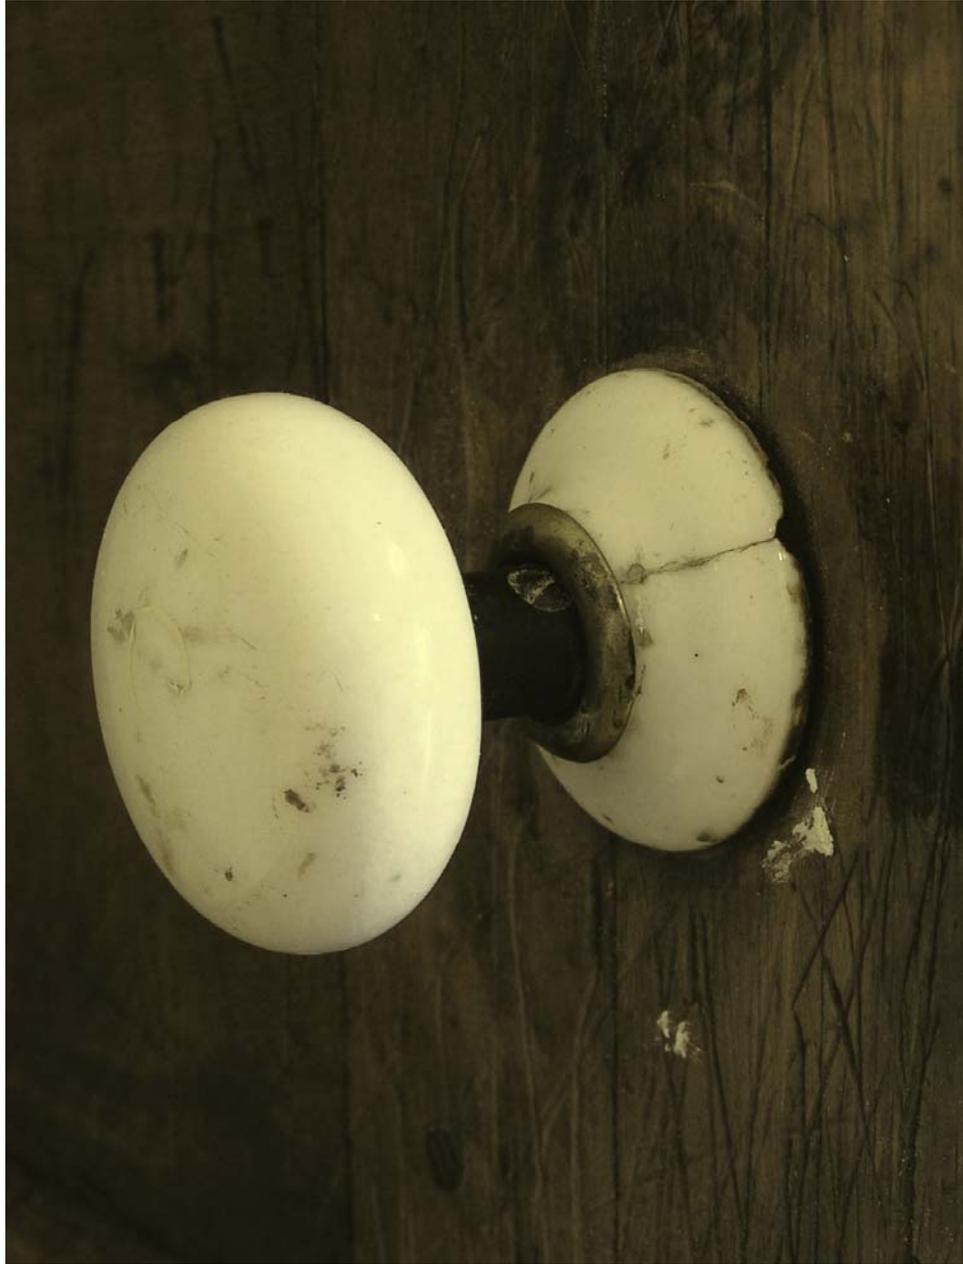
Plate 6

Side view of yet another white porcelain passage knob. In this case, the porcelain rosette has sustained a slight crack on the right side. The knob happens to have a cast iron shank surrounded by the brass collar or “thimble” housed within the porcelain rosette. The brass collar is actually a part of the plate that attaches the porcelain rosette to the door. Said another way, this rosette is actually two pieces attached by wood screws hidden underneath the porcelain rosette. Notice the deep scratch marks running perpendicular to the hardware.

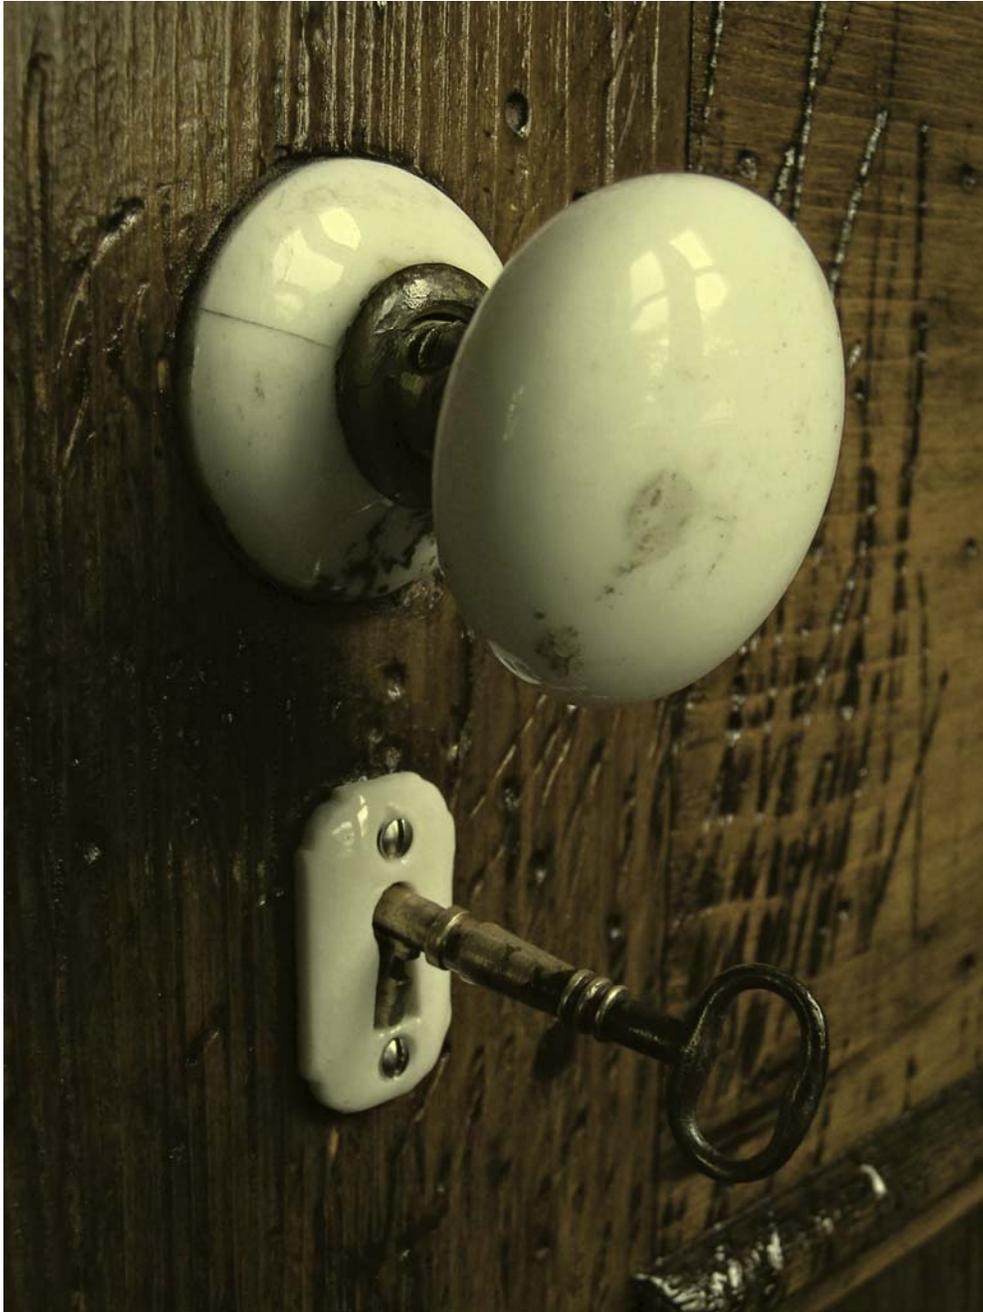
Plate 7

An upstairs passage door with the original brass key left in the lock. Again, more scratches found around the hardware, along with unique-to-each-knob markings evident on the rosette and knob. The key plate looks like it has been cleaned or replaced.

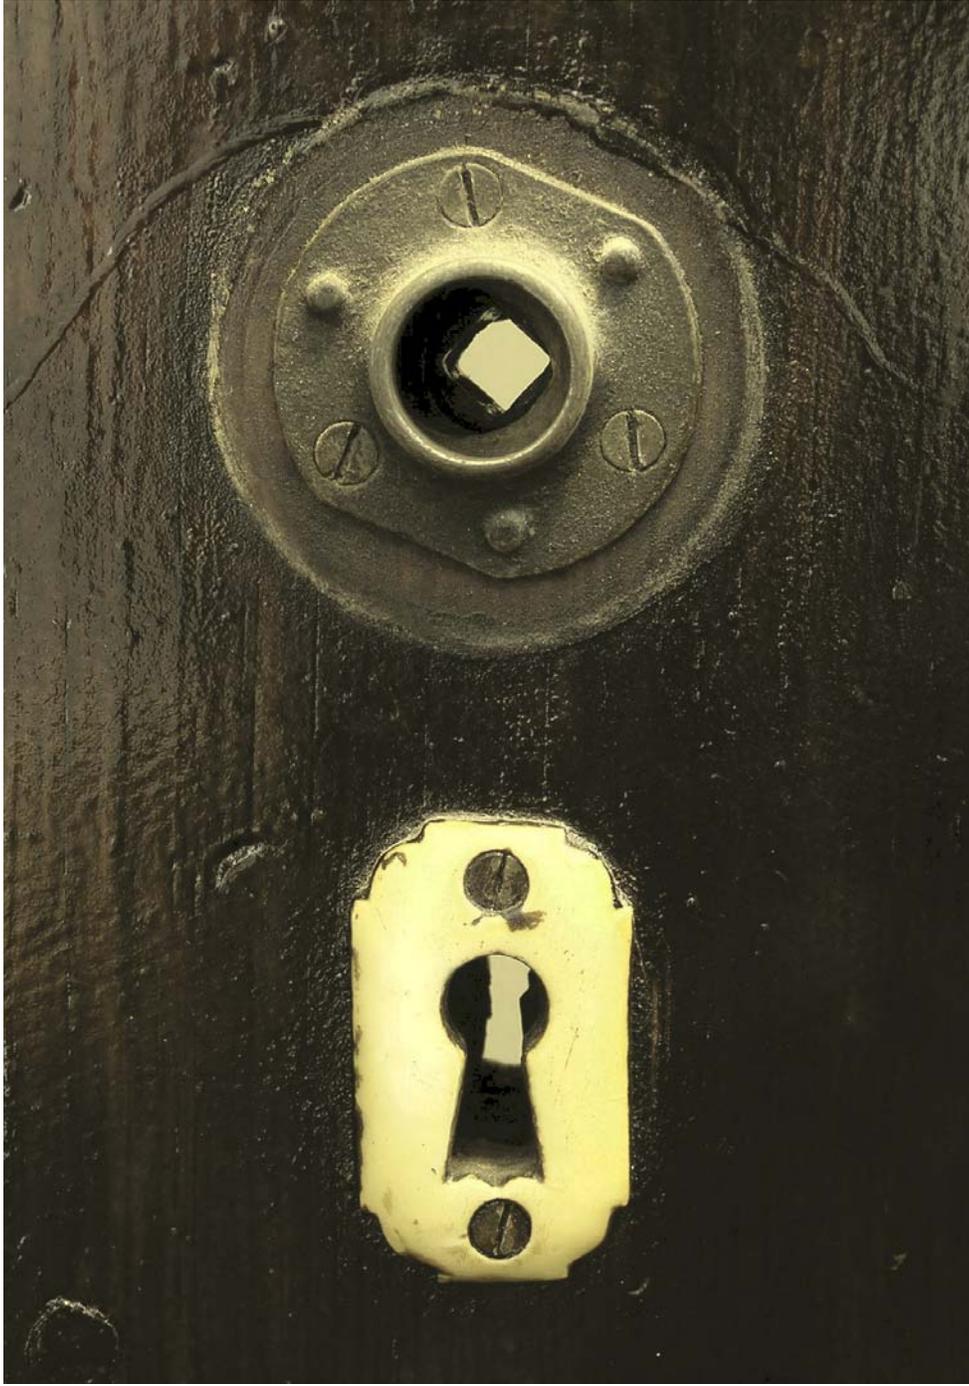
Plate 8

The porcelain rosette has been removed to expose the mounting plate that attaches it the door with three wood screws. The profile of the porcelain rosette is apparent. The porcelain key plate appears yellow because shellac was unintentionally swiped over the plate presumably, while the doors were being refinished.

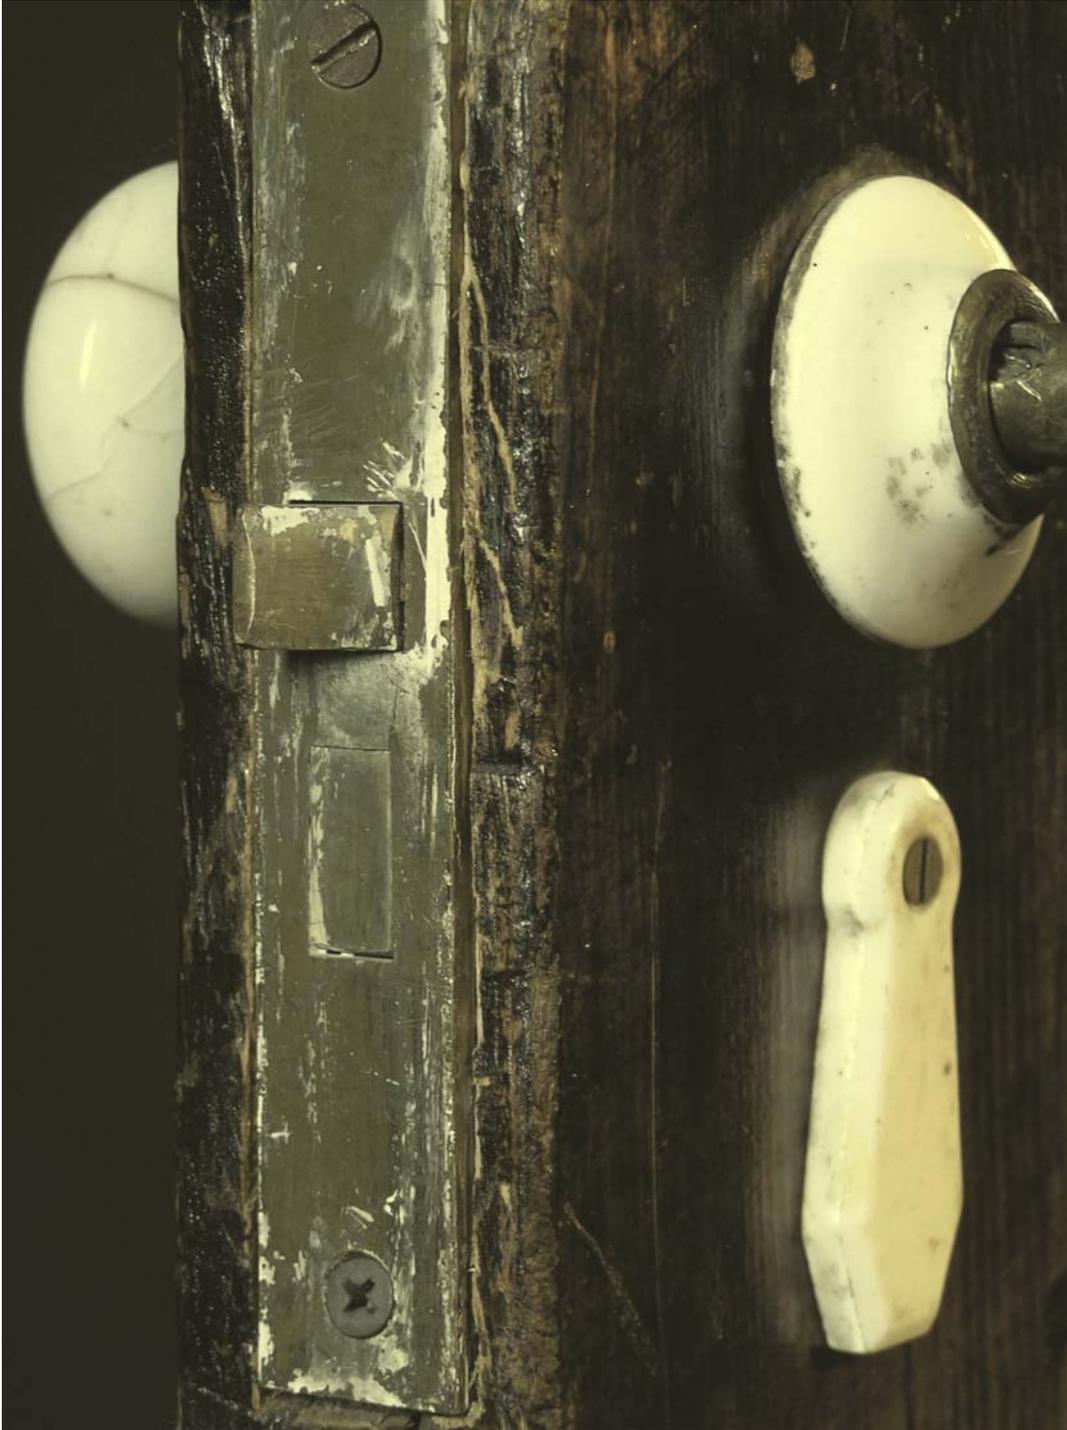
Plate 9

Another view of the brass face plate revealing major wear (i.e., markings, bends, etc.) that is a common find on all of the locks—these doors have been in use since the early 1860's with little if any changes (upkeep or otherwise) made.

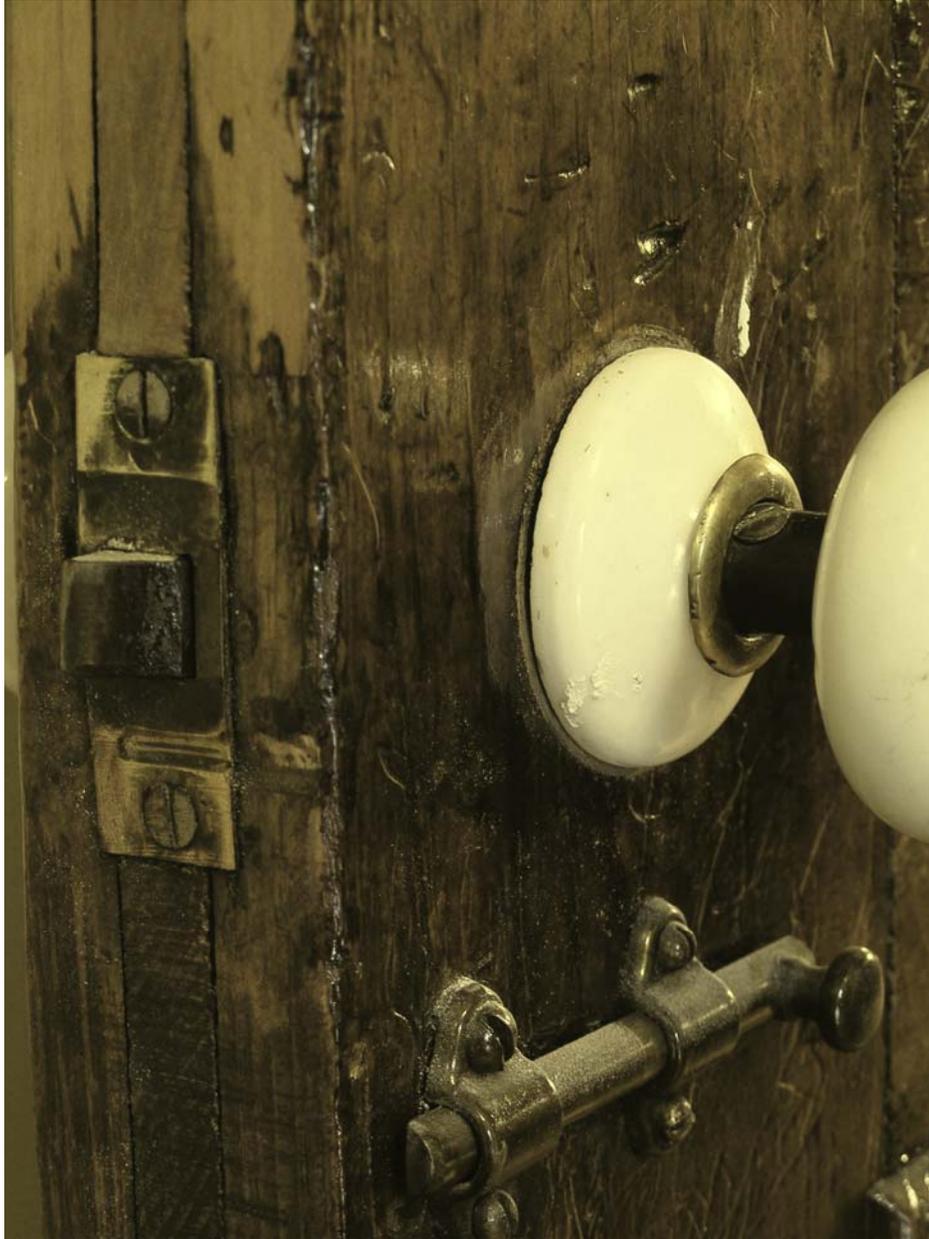
Plate 10

Although each and every door possesses the same type of hardware, there are nonetheless subtle changes or configuration differences that most be noted--and that was the primary challenge of this project; to reveal the understated differences (while at the same time make it interesting) among otherwise repetitive and identical hardware. In this case, the mortise lock (displaying no markings) is much smaller than all the other locks. There is nothing unique about this particular door (purpose or otherwise) so the choice behind this small lock remains a mystery. This door also includes a flush mount, sliding bolt made of brass which will be discussed further in a later section.

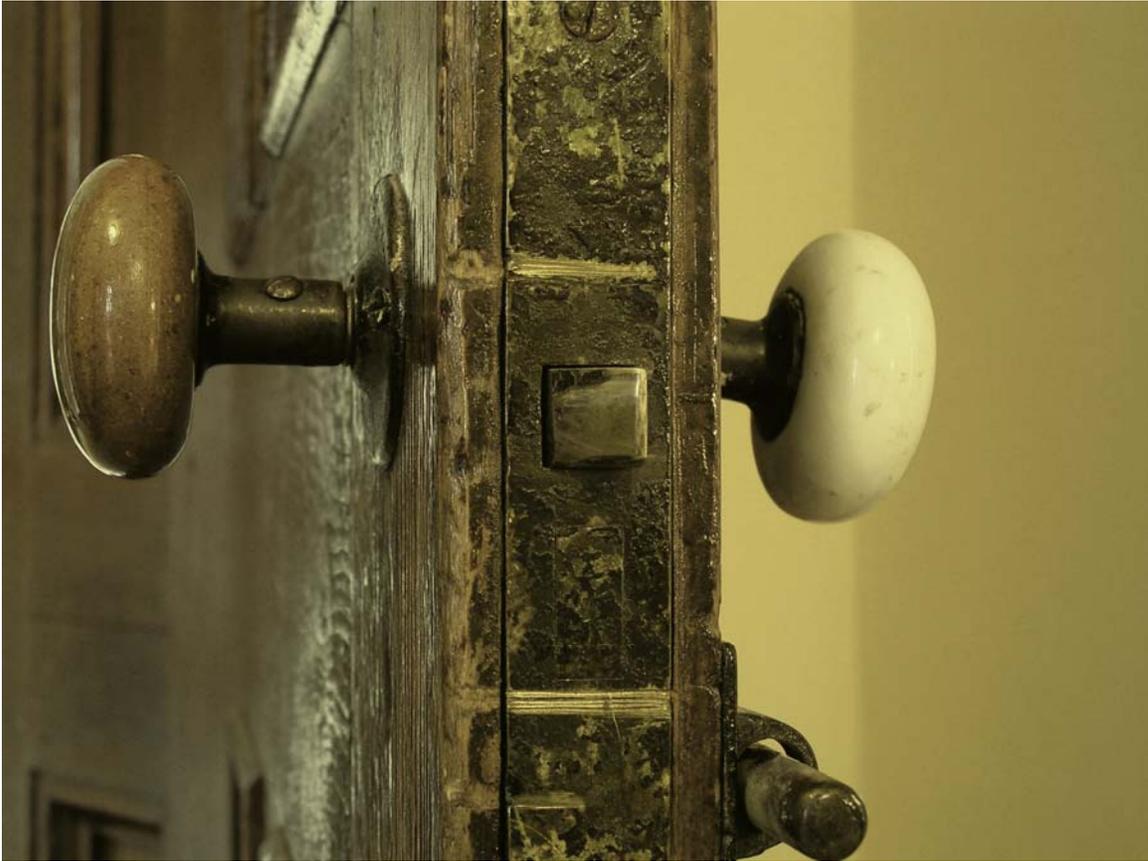
Plate 11

Another oddball hardware arrangement on a door located in the rear of the house within the summer kitchen. Over the years, knobs may be lost or broken resulting in mismatched replacements similar to the one shown here. In this illustration, there is a white porcelain knob and a “bennington-like” knob that may have been borrowed from the 3rd floor, which is where the mineral knobs and rimlocks are exclusively located. This is the only door that has jappaned-finish (baked on black paint) cast iron door rosettes located on the 1st or 2nd floors.

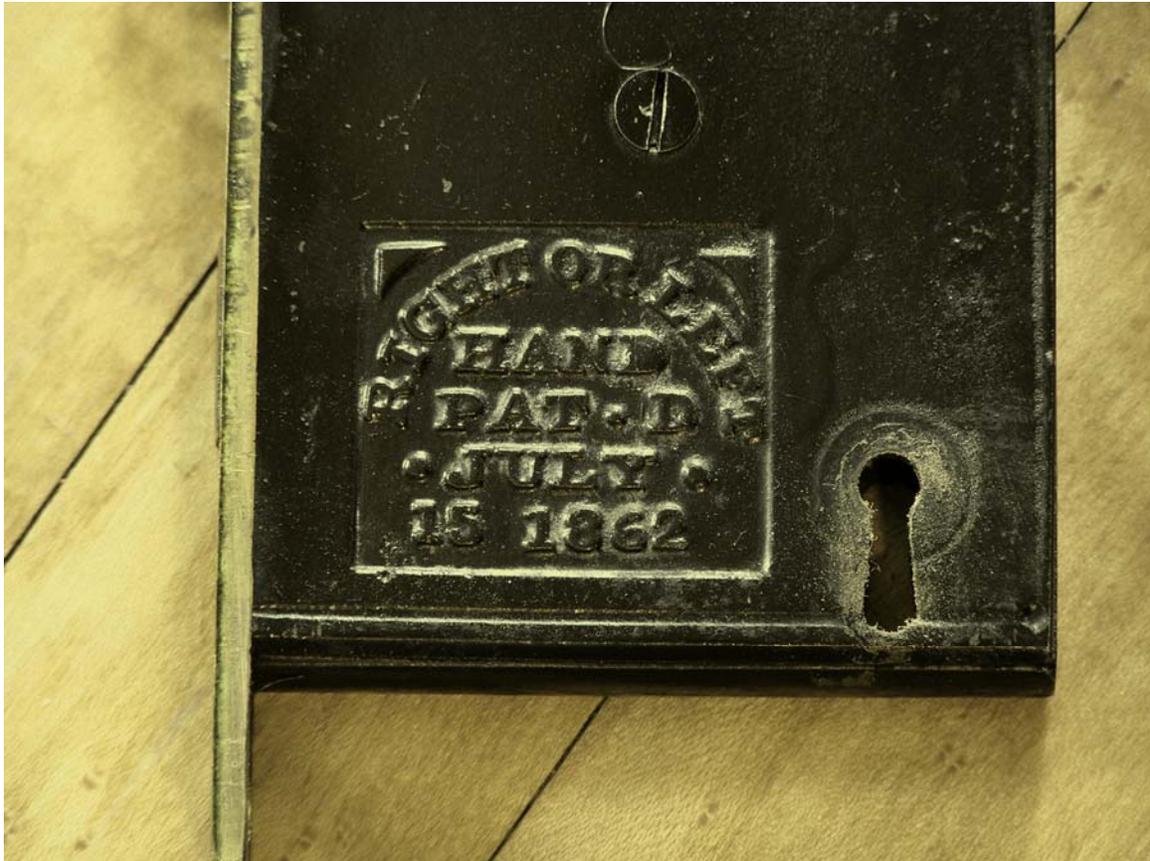
Plate 12

Virtually all mortise locks found within the passage doors possess the reversible latch bolt. Further information about this mechanism is provided in the next few plates in the form of patent description and illustration. Essentially, the purpose of this latch was twofold; to save time and especially money, one could install the mortise into either a left or right hand door by situating the bolt in the appropriate position—simply remove the plate of the lock box and flip the bolt in the opposite direction—quick and easy. The patent for this particular lock was secured by Lucius Woodruff, assignor to the Russell & Erwin Co. in 1862.

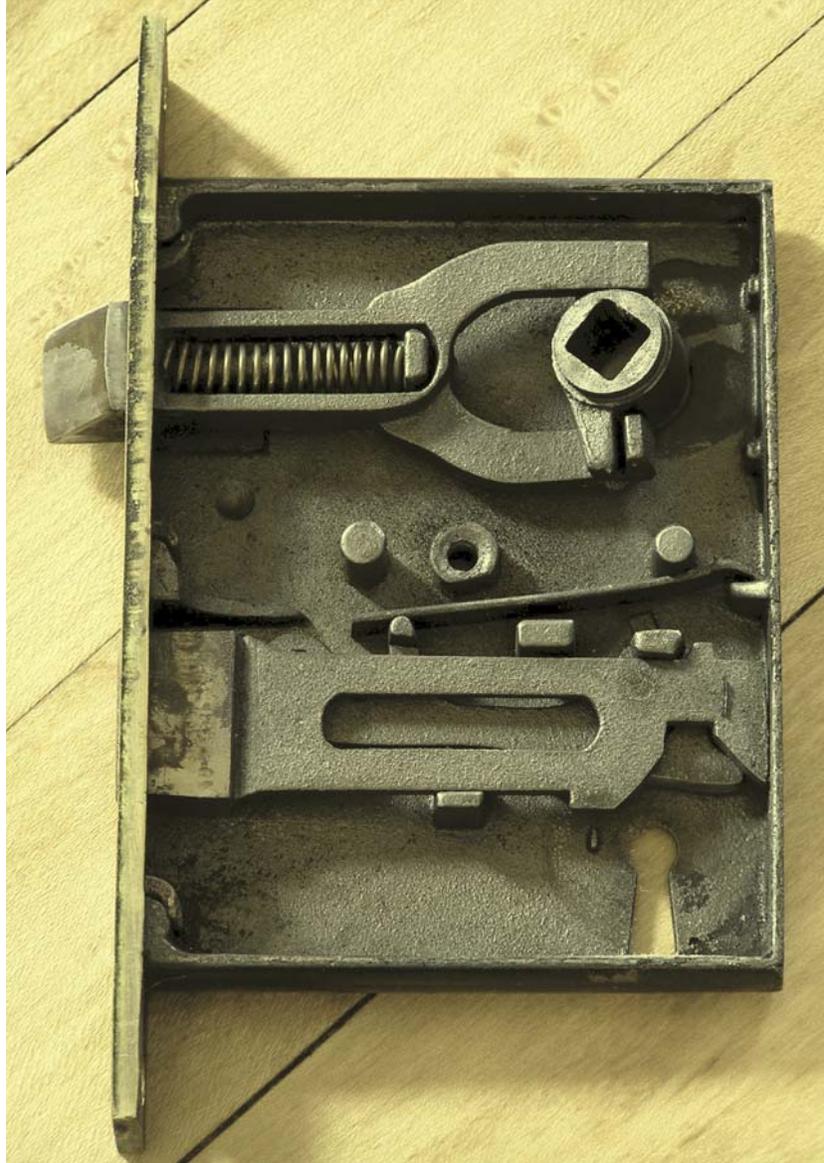
Plate 13

The patent plates found on the next few pages will provide much more depth on the internal workings of this particular mortise lock. Regardless, it seemed necessary to provide an actual photographic depiction of the “guts” to compliment the patent schematic. All the parts were cast in iron, with the exception of the brass face plate and the return spring. To reverse the direction of the bolt, one would have to remove the plate screwed onto the mortise box, followed by taking out the hub--this allows the reversible latch bolt to be pulled out, flipped over and reinserted.

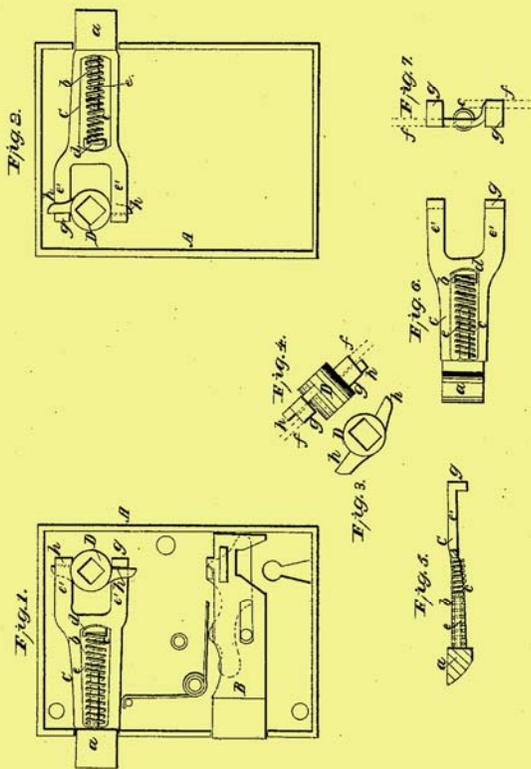
Reversible Latch Schematic, Pat. July 15th, 1868 by L. Woodruff

Figure 1 is an internal view of a lock with my improvement applied to it. Fig. 2 is also an internal view of the same, viewed at the side opposite to that shown in Fig. 1; Figs. 3 and 4, detached views of the hub of the catch or latch bolt; Fig. 5, a detached horizontal section of the catch or latch bolt. Fig. 6 is a side view of the same. Fig. 7 is an end view of the same.

C is the latch or catch bolt, which is provided, as usual, with an outer beveled end, *a*, as shown clearly in Fig. 5. The latch or catch bolt is provided with a longitudinal slot, *b*, in which a spiral spring, *c*, is fitted, the outer end of said spring bearing against the front edge of the slot *b*, and the inner end bearing against a stump, *d*, in the case A. The spring is fitted on a guide-rod, *e*, in the slot *b*, and has a tendency to keep the latch or catch bolt C forced out from the case A as far as it is designed to move. The back part of the latch or catch bolt C has two parallel arms, *e' e'*, which are out of line with each other or in different planes, as will be seen by referring to Figs. 4 and 7, in which the planes are indicated by dotted lines *f f*. The ends of the arms *e' e'* are each provided with a projection, *g*. These projections *g g* are at right angles with the arms *e' e'*, the projections of one arm extending in an opposite direction to that of the other.

D is the hub in which the arbor of the knob is fitted. This knob is provided with two lugs, *h h*, which project from it at opposite points in two different planes, as shown in Figs. 1, 2, and 4, the dotted lines *f f* indicating said planes. The lugs *h h* are about at equal distances from the ends of the hub D—that is to say, one lug is just as far from the end of the hub which is nearest to it as the other lug is from the opposite end of the hub. The lugs *h* bear against the projections *g*, which are in line with them, and when the knob is turned the latch or catch bolt will be operated thereby.

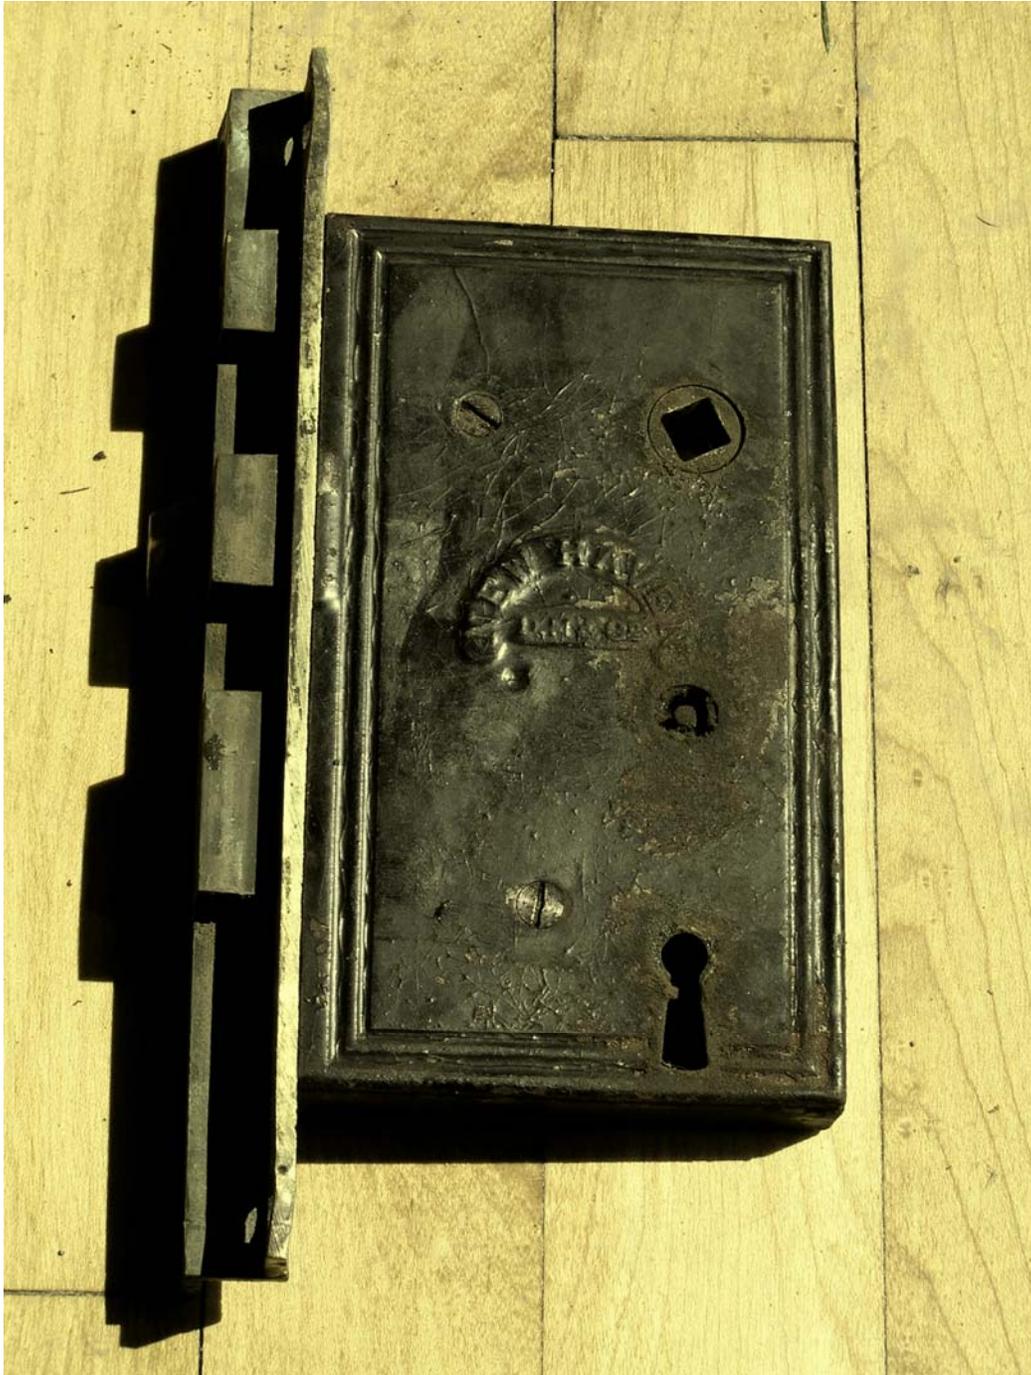
Plate 14

The mammoth front entrance door mortise lock made by the Russell & Erwin Co. The semi-circle marking points to the company's origin of operation. The box retains its original japanned finish, with only a little rust around areas being somewhat exposed to external elements (a rather common event). The cast brass face plate is partially recessed--being designed for use with double door enclosures.

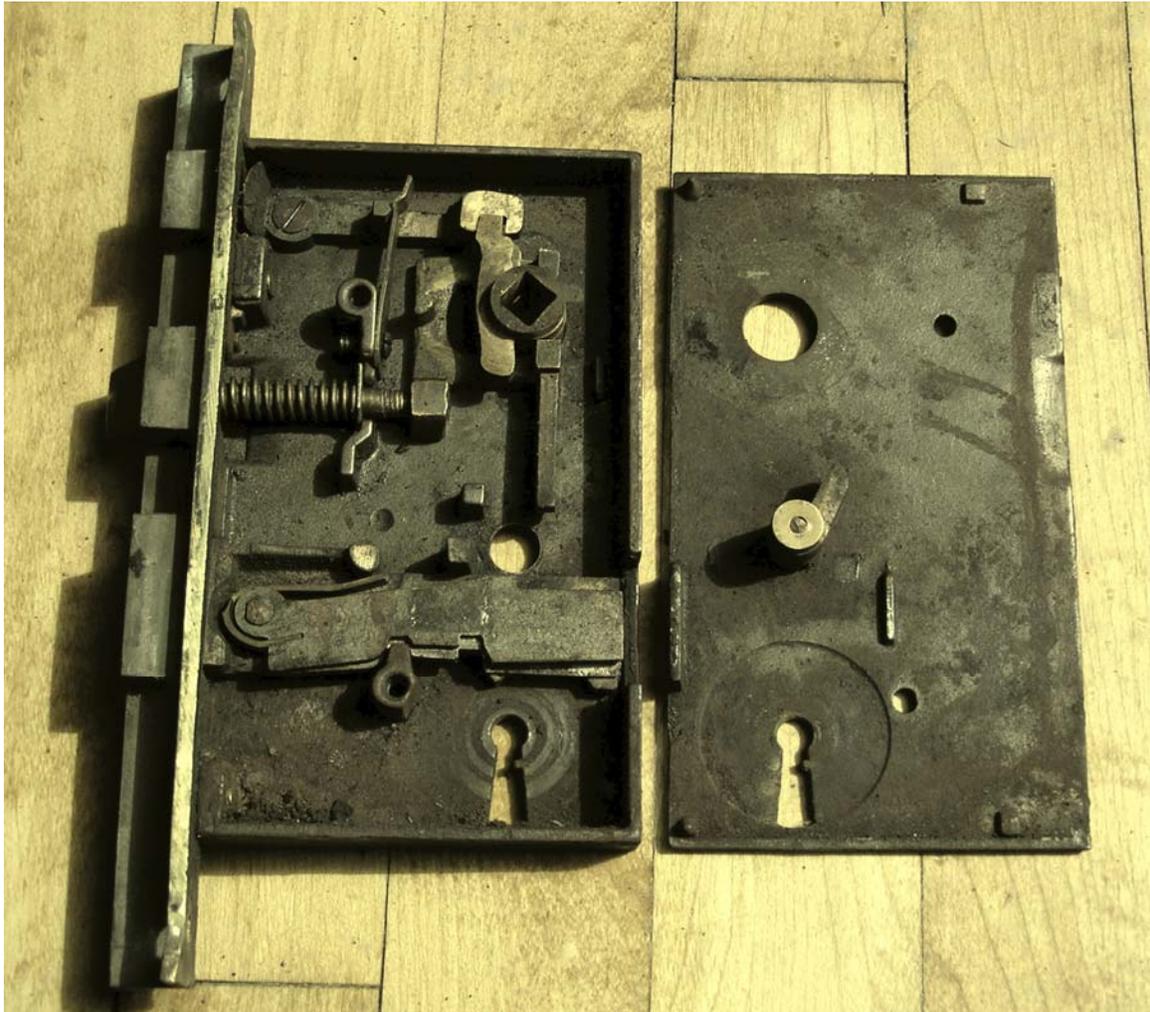
Plate 15

Removing the cover plate from the lock box reveals a rather complicated arrangement of parts involved in the operation of this lock. The major components include the dead bolt (above the key hole) which serves to lock the doors when used with the skeleton key. Above the dead bolt is the coil spring-loaded latch bolt which with the turn of the knob, opens and closes the door. Lastly, there is a small sliding vertical latch found within the face plate serving to bypass the function of the knob, thereby allowing for the latch bolt to remain in a fixed inward or outward position. Nearly all of the smaller components inside the box are cast in brass for the purpose of avoiding rust accumulation and thus, the prevention of any functional hindrance. On the flipside however, the continued use (friction) of the brass components will inevitably cause significant wear, leading to a similar fate that the use of cast iron shares.

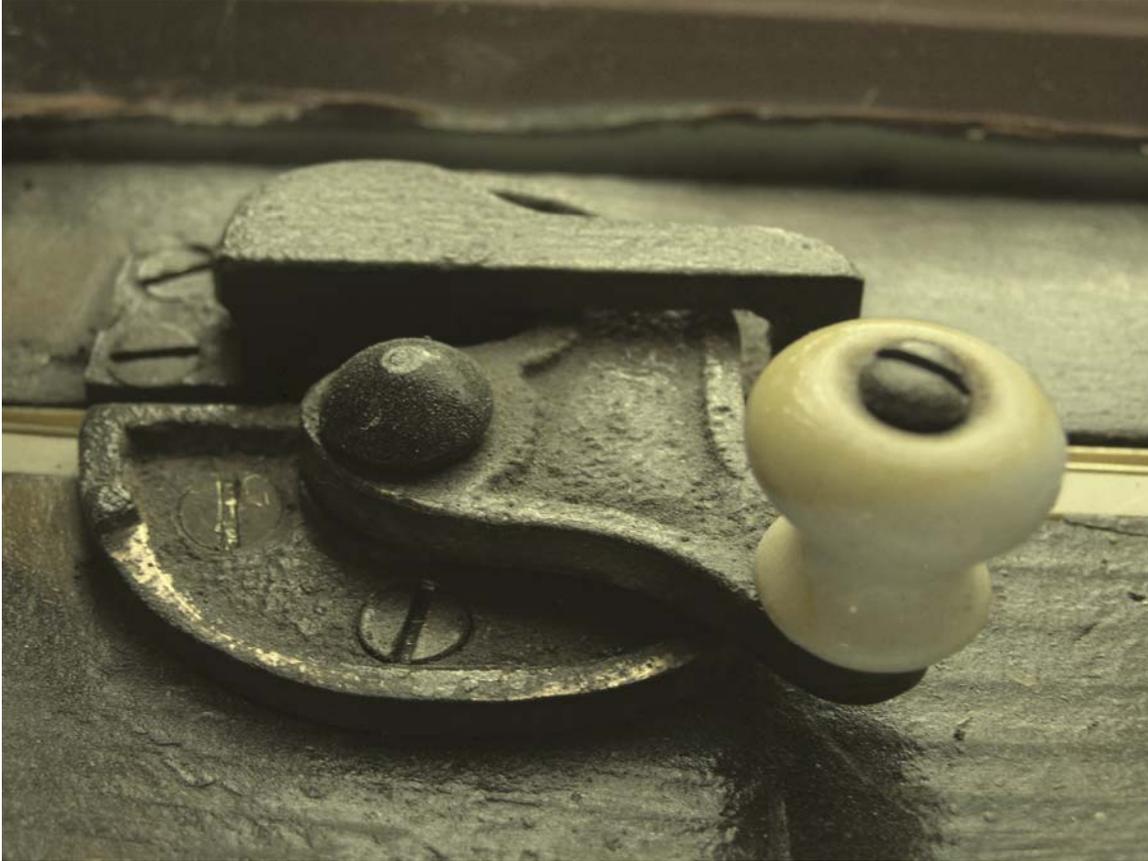
Plate 16

The sash lock depicted above, is found on every floor throughout the house—no variation whatsoever. In accordance with the utilitarian theme, these locks are plain cast bronze, with removable porcelain knobs that are affixed to the lock with a simple flat head screw. During removal of this sash lock for further examination, a spring action was found under the rotating arm (wrapped around the stationary rivet)—a most unusual mechanism. Presumably, the purpose of the spring allows some flexibility when the sash frames were uneven—this way, one would avoid forcing the arm into the keeper, which inevitably leads to bending or breakage.
