**A Comprehensive Assessment of the
Architectural Hardware found at the
William LeDuc Residence in Hastings,
Minnesota**

**Documentation compiled and written by
Eric J. Nordstrom
Spring 2005**

SECTION 1
LEDUC HOUSE ARCHITECTURAL
HARDWARE

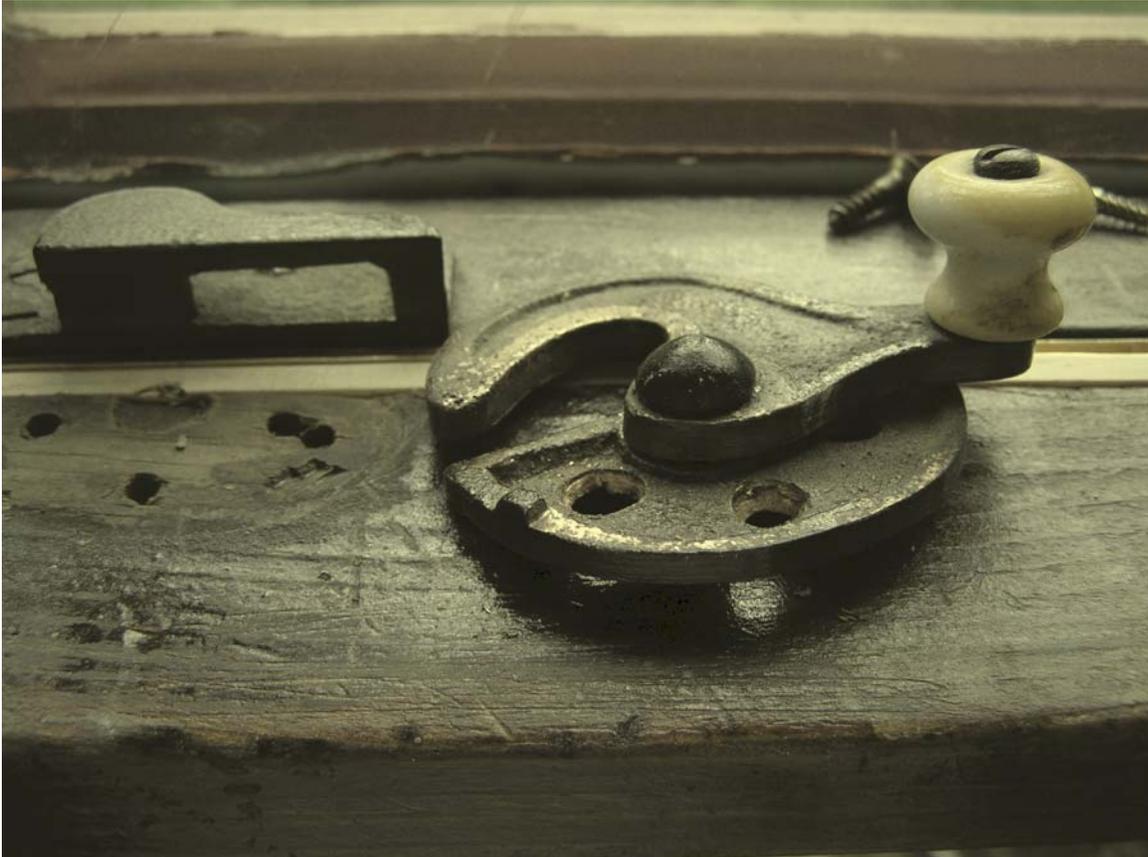
Plate 17

As of this writing, it is undetermined whether or not these sash locks were made available in the Russell & Erwin catalog of 1865. In other words, the manufacturer is unknown, although the aforementioned company is most likely the one. Security was certainly an issue because each sash lock required 6 wood screws. Nearly all sash locks within the house are functional (and surprisingly enough), retain their intact and unbroken porcelain knobs—which is a phenomenon seen often in locks of this age. Nevertheless, it appears that the locks were not removed during restoration, which meant that along with the sash frames, the locks themselves received an undeserved coat of vanish or shellac.

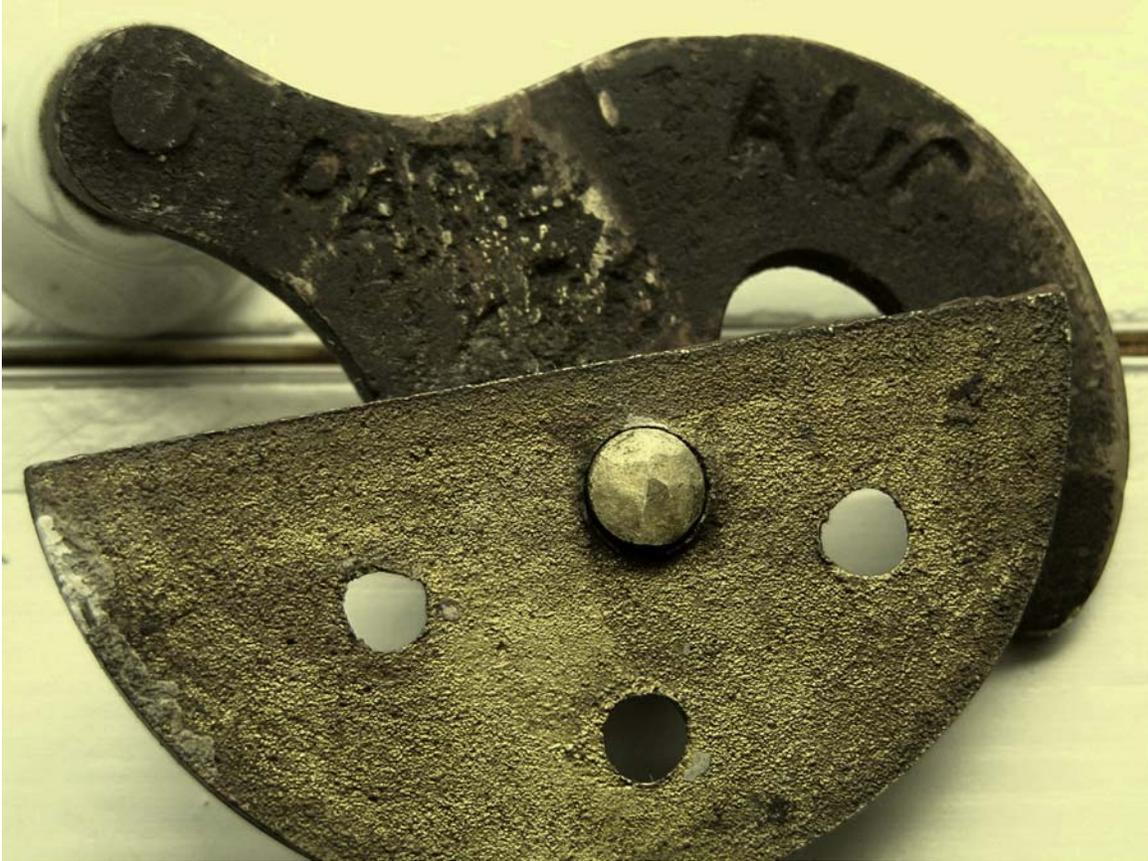
Plate 18

A passionately curious member of the LeDuc House Staff mentioned a date being located on the underside of the window sash locks, which had gone unnoticed after examination for this report (at least in the earlier stages). Although at least one sash lock was removed and examined, there was no markings found; as it turns out, some of the locks have the Aug, 1858 pat. date, while others do not. Unfortunately, because of time constraints, the author was unable to locate the actual patent (among 100's of online files for that month alone), but nonetheless, the sash lock was most likely made by the Russell & Erwin Co. and found in their 1865 hardware catalog.

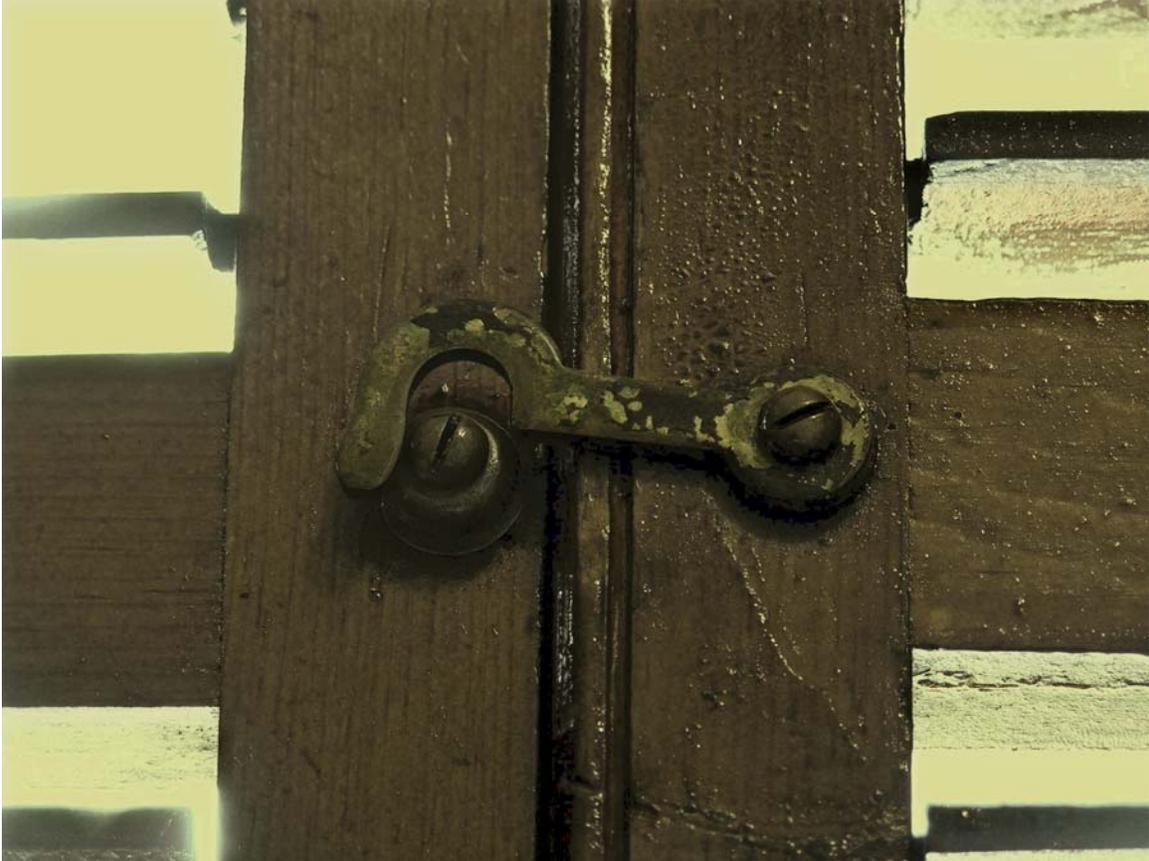
Plate 19

The white pine shutters of the LeDuc house were crafted on site by a gifted local carpenter. These shutters are found on windows located on the 1st and 2nd floor. Each shutter set was treated with the “Ohio Pattern” cast brass shutter bars, and plain cast brass hinges (not shown). Most are intact and retain their original finish and/or condition.

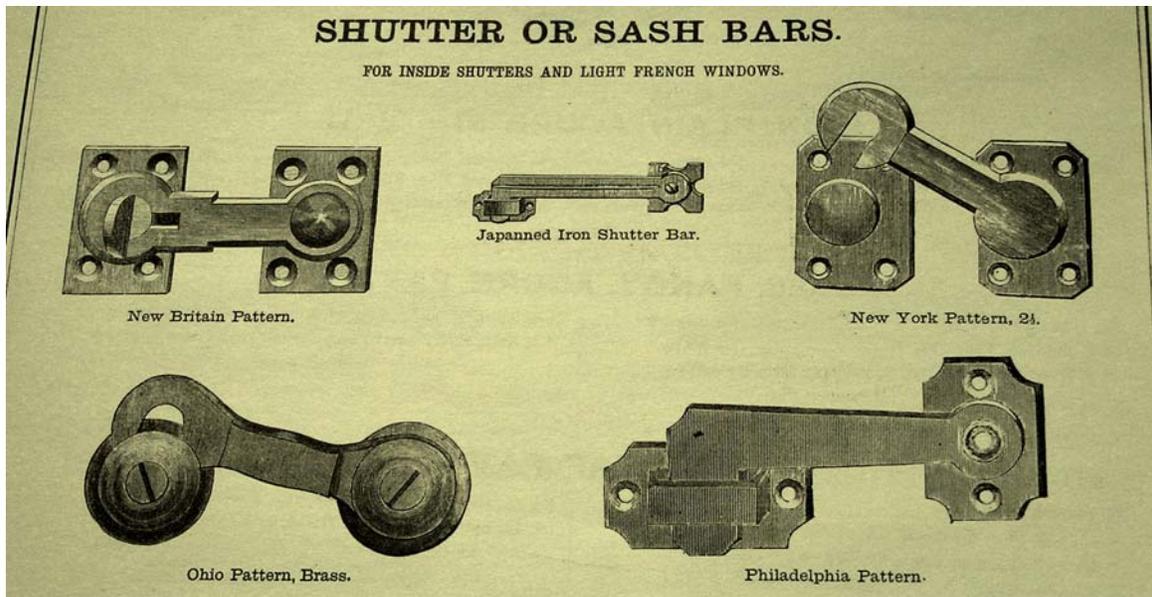
The shutter bars depicted here were available in the mammoth Russell & Erwin Catalog of 1865. As one can see, the LeDuc family (or perhaps their carpenter) chose the “Ohio Pattern.” Among the patterns, there was only one size and 3 finishes to choose from. The LeDuc house went with the solid brass shutter bars. The different patterns identified and differentiated by locale is rather interesting.

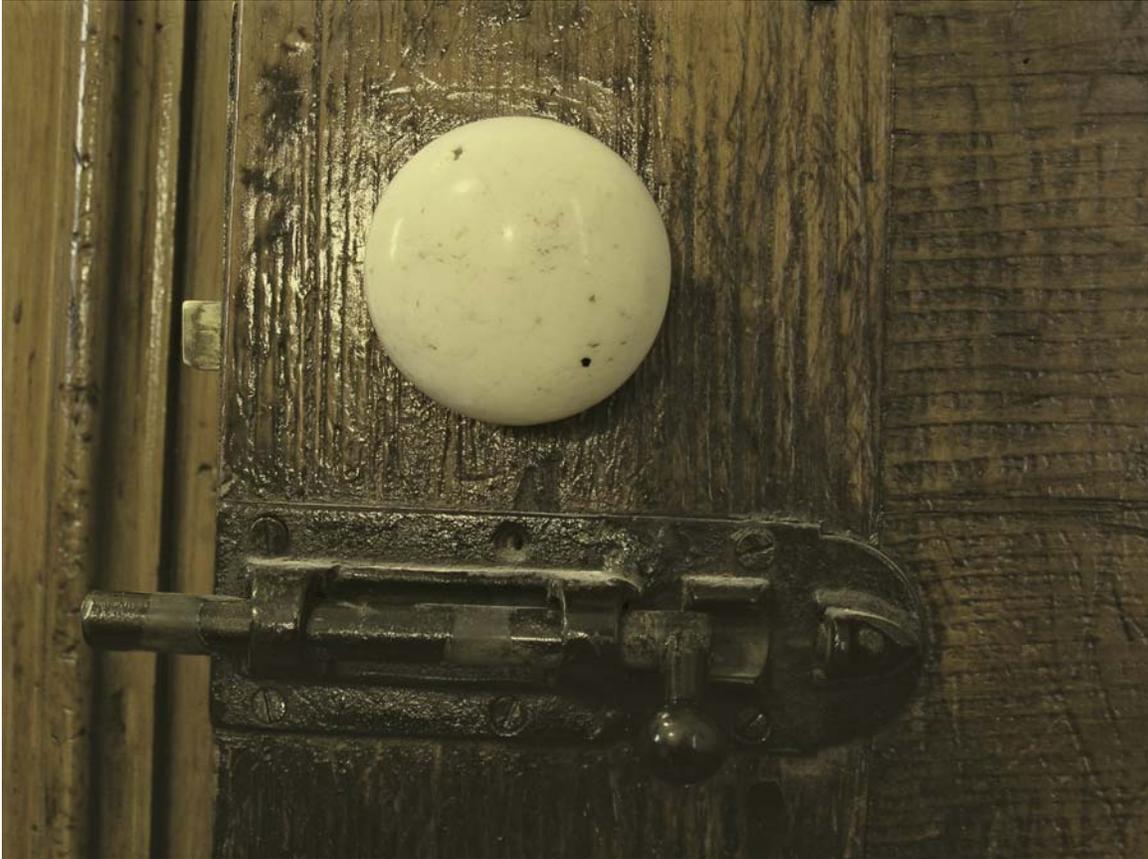
Plate 20

This wrought iron flush mount door bolt is similar to the “cottage bolt” variety as seen in the 1865 Russell & Erwin Catalog. Oddly, these bolts are found on quite a few doors within the house. They are presumed to be original to the house. This particular bolt is found on the door leading down to the basement.

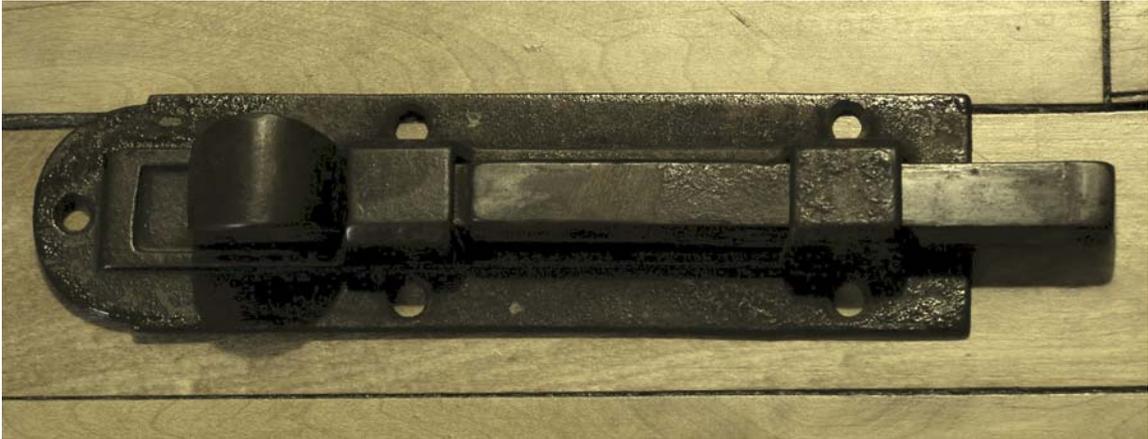
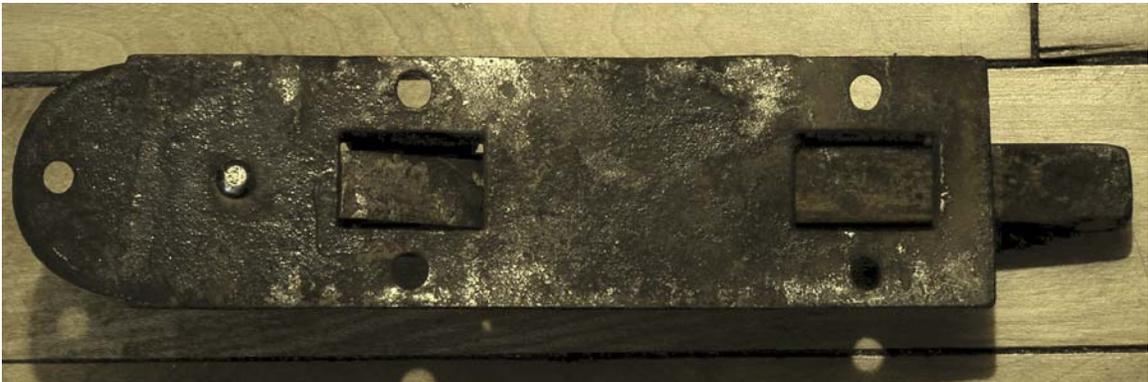
Plates 21-22

This bolt being located on the 1st floor was removed for closer inspection to determine if there was any markings indicating a maker and whether or not the bolt casings were affixed to the base plate with rivets. As one can see, there are no markings, and only one rivet was hammered in to reinforce the casing. 5 screws were needed to securely anchor this bolt into a door.

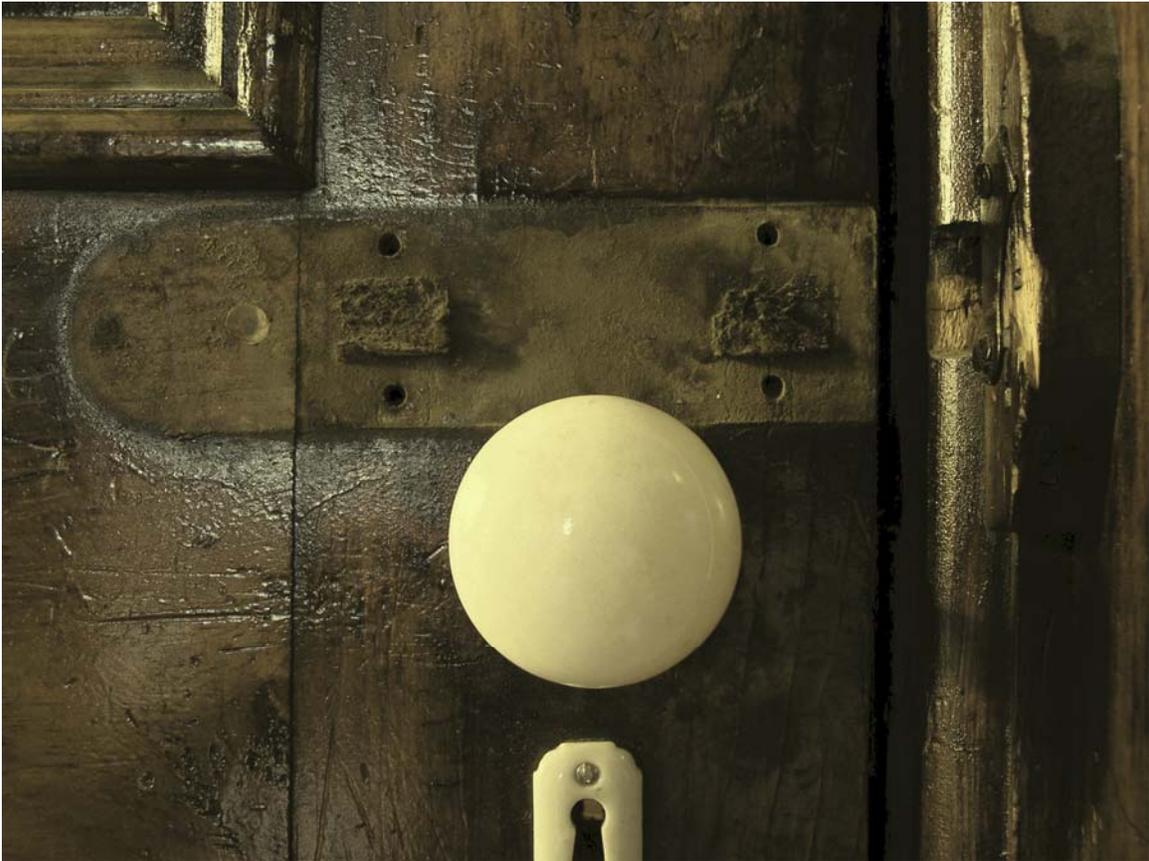
Plate 23

Door Bolt removed to reveal unfinished area of door. Accumulation of dirt, dust or insect debris was found in the recessed regions of the underside of the bolt. Keeper was missing during documentation. This door leads to the basement.

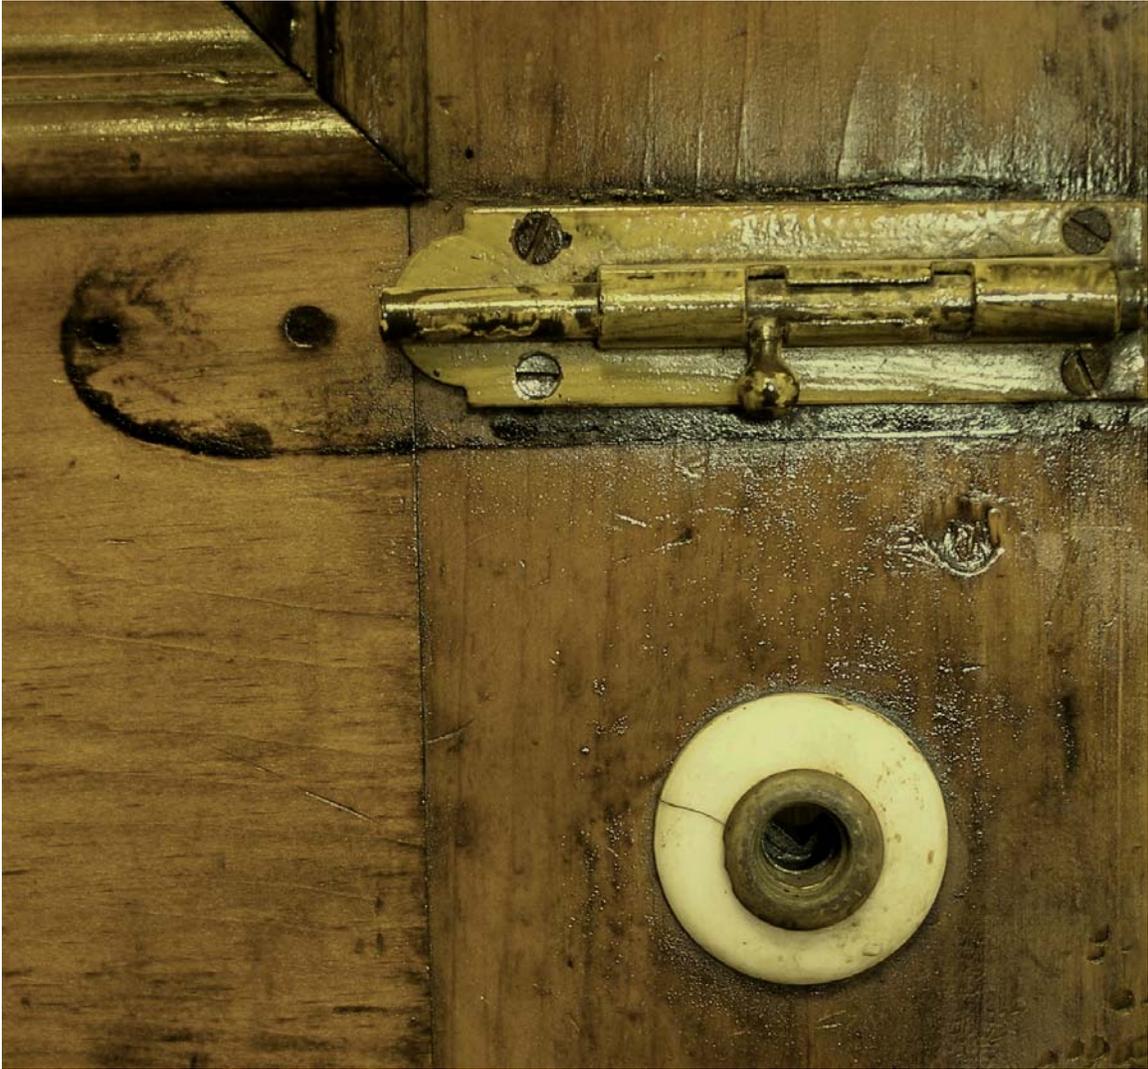
Plate 24

This bolt is undoubtedly a later replacement for the presumably original and obviously larger bolt seen only in the form of a shadow. The knob and rosette have undergone some abuse, which may lead one to believe that this particular door received frequent traffic or abuse. Fortunately, every other passage door retains their original door bolt (that is, if it had one at all).

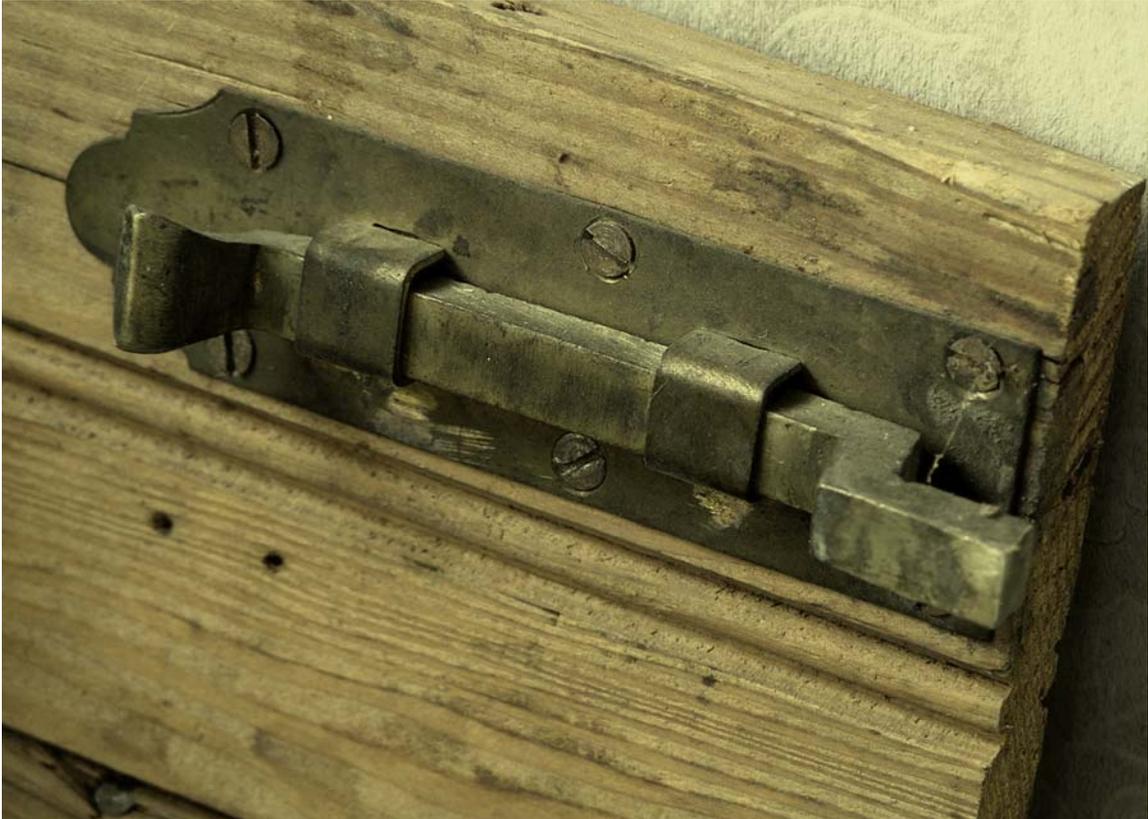
Plate 25

Brass flush mount sliding door bolt found on a cabinet door resting upon a wall on the 3rd floor. Not exactly sure where this door was originally used, and a matching keeper was not found anywhere in the attic. Nonetheless, this bolt merits attention for being the only cast brass bolt found in the house

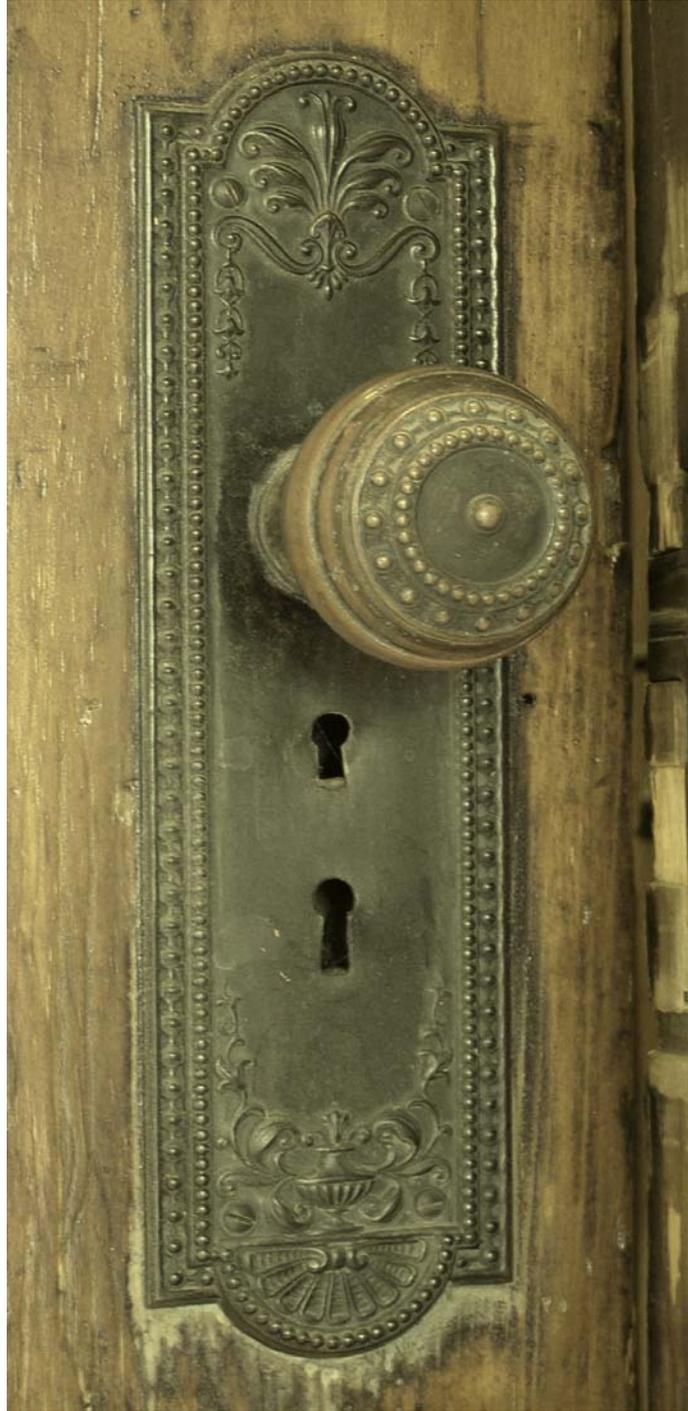
Plate 26

This hardware is located on the side entrance door, and was obviously a later addition—most likely during the 1915 house upgrade, brought about by some additional money Mr. LeDuc received shortly before his death. The knob and plate are identified as the “Como” pattern, which was one of many patterns or styles offered by the Corbin Co.

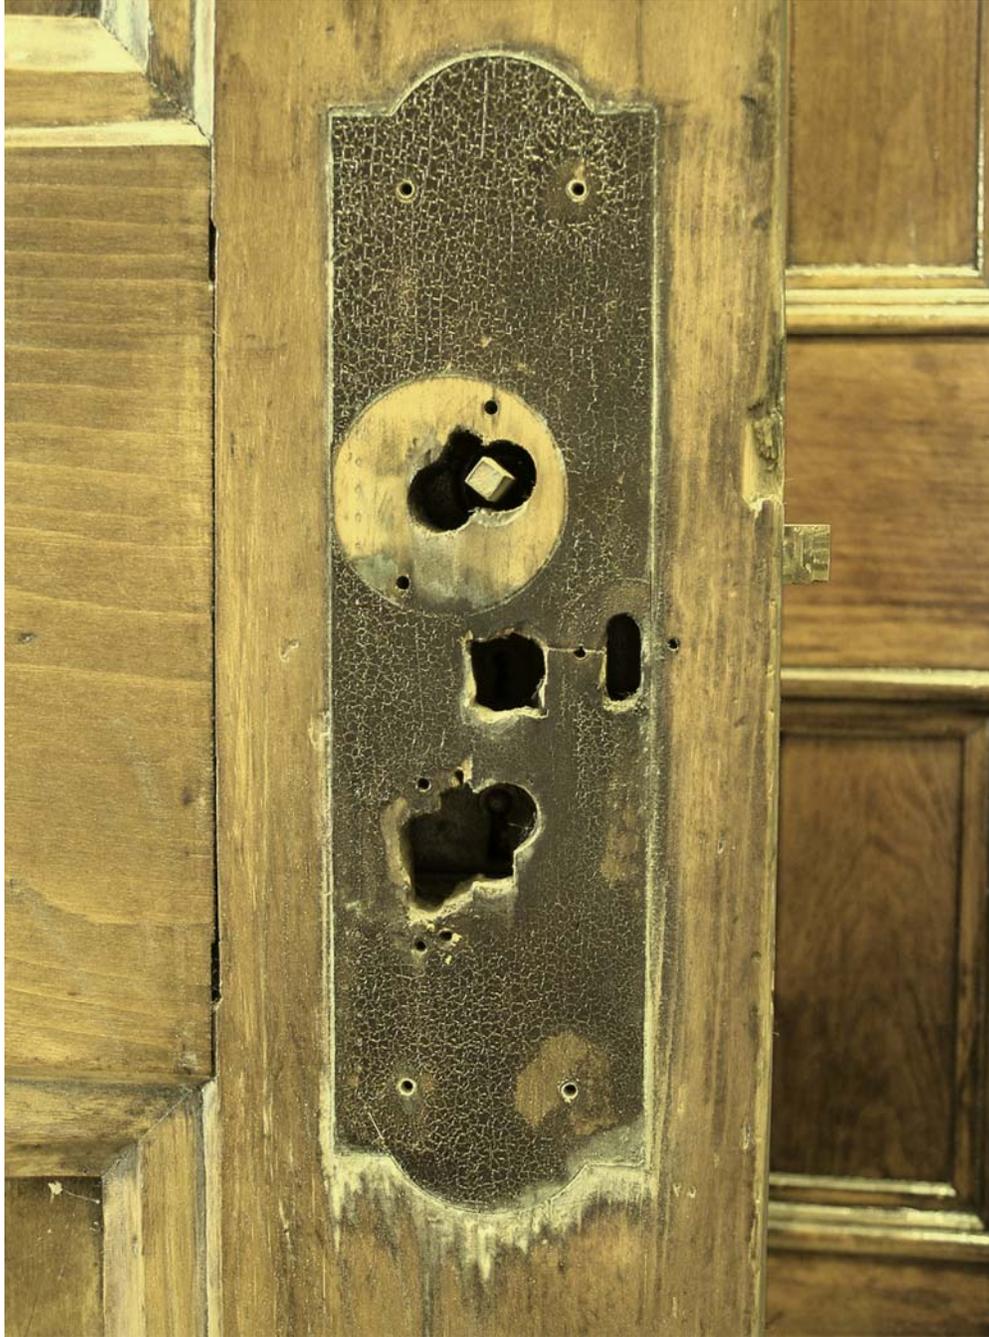
Plate 27

After removing the 1915 hardware upgrade, there was clear evidence indicating that the original hardware (most likely installed in the early 1860's) was identical to the hardware found on any of the passage doors—that being a circular porcelain rosette, porcelain key plate, porcelain doorknobs, and the interesting little cast iron rosette that manipulated the inner workings of the mortise lock. The whereabouts of that hardware is not known (though presumably it was discarded).

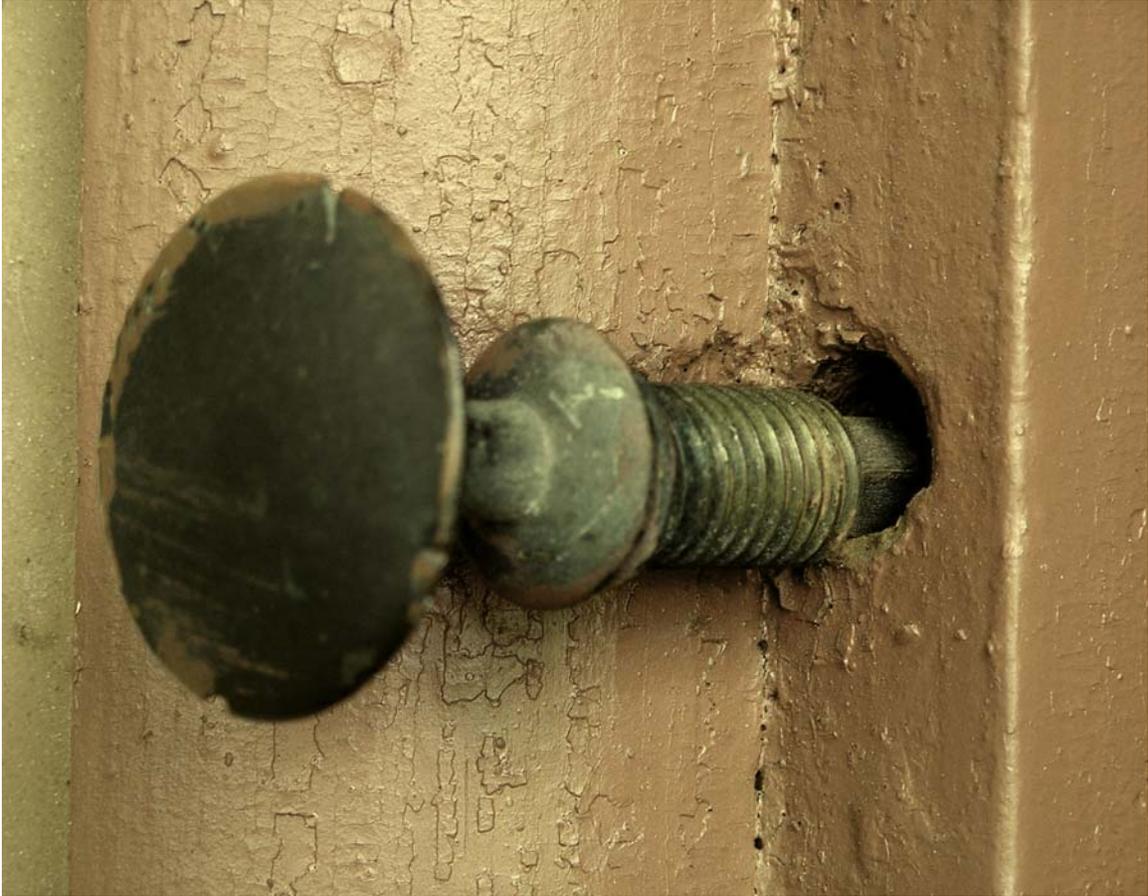
Plate 28

Plain cast bronze doorbell pull with a mushroom style base. The threaded portion would normally be hidden within the molding or wall. In fact, the pull was almost certainly screwed into place with the threaded region reinforcing the installation. The existence of this pull presents somewhat of a problem because the door itself shows evidence of a doorbell crank or knob (see other plates). If indeed there was a bell mechanism on the door, than it is uncertain as to which would be the original installation. Aside from that, it should be noted how the pull (as seen above) actually operates to ring the bell. Basically, one simply grasps and pulls the knob toward oneself, wherein a metal wire is attached running through the wall and along the door on the inside where the bell is located. The force exerted by pulling the knob results in a mechanism within the bell to trip the hammer, causing it to strike the bell.

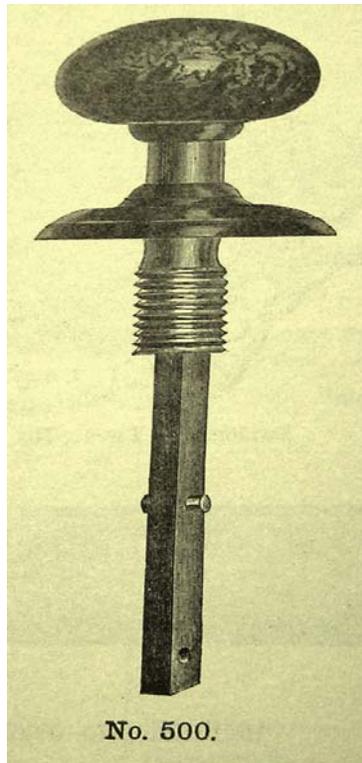
Mineral knob door bell pull offered in the 1865 Russell & Erwin hardware catalog, which with the exception of the knob, is similar to the pull found near the side entrance door. Copper wiring attached through the end of the spindle or rod was feed through the wall and along the door (in the LeDuc house) where the bell was located.

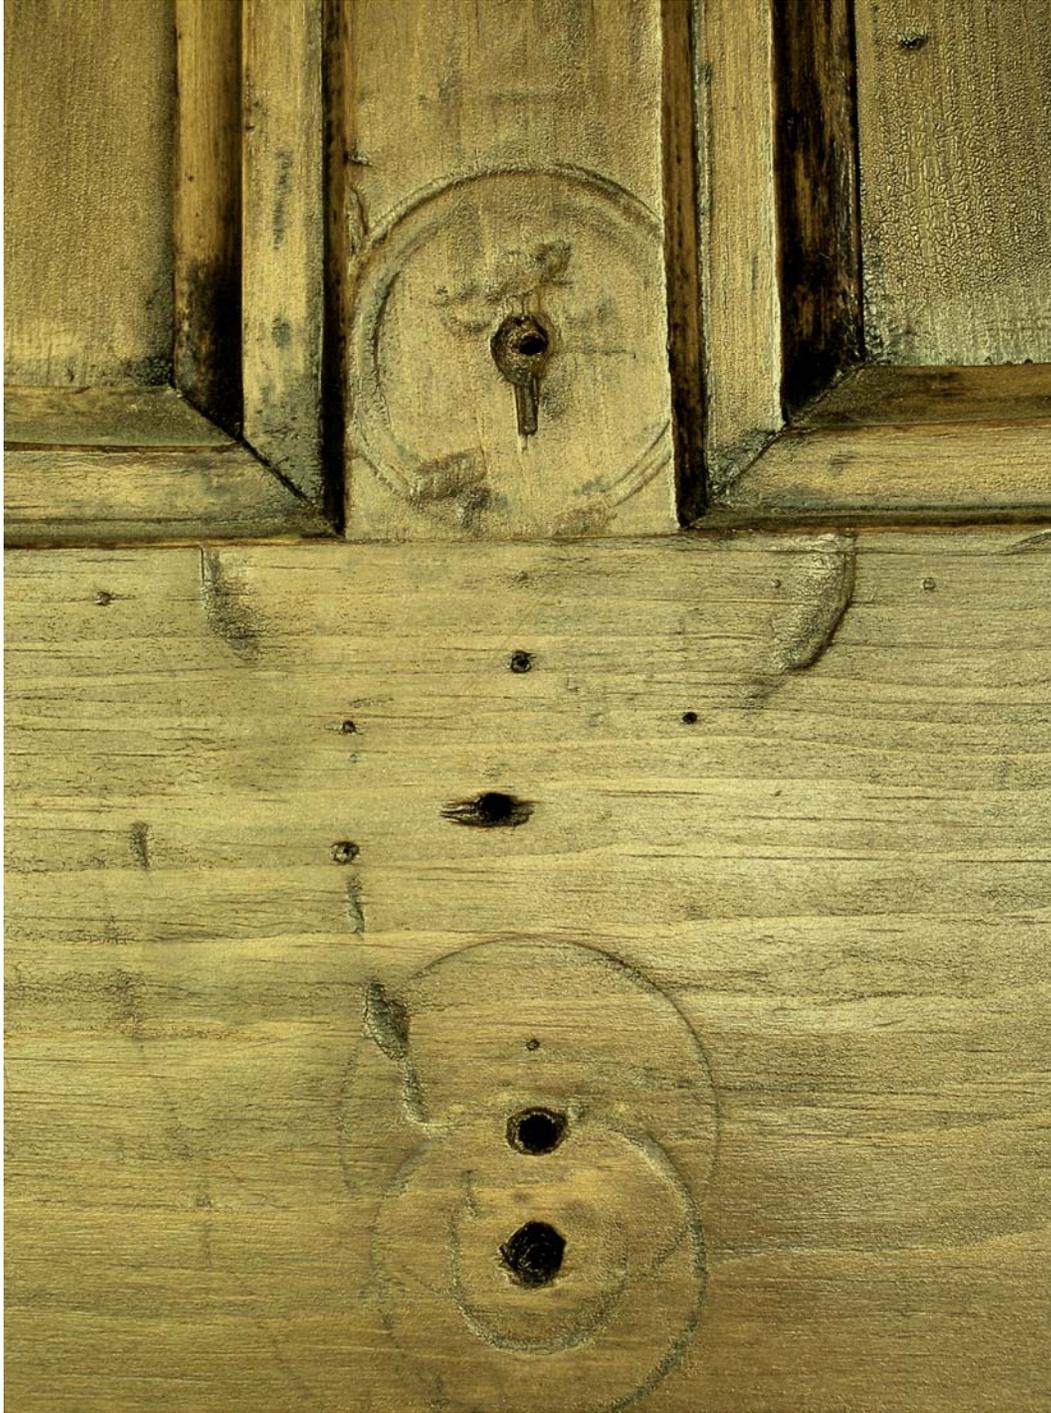
Plate 29

Mysterious markings, indentations and holes are apparent on the stile and rail of the side entrance door. The circular grooves are suggestive of a decorative mounting plate that sits behind a bell crank handle, or something along those lines. Why there are *multiple* circular patterns is really anyone's best guess.

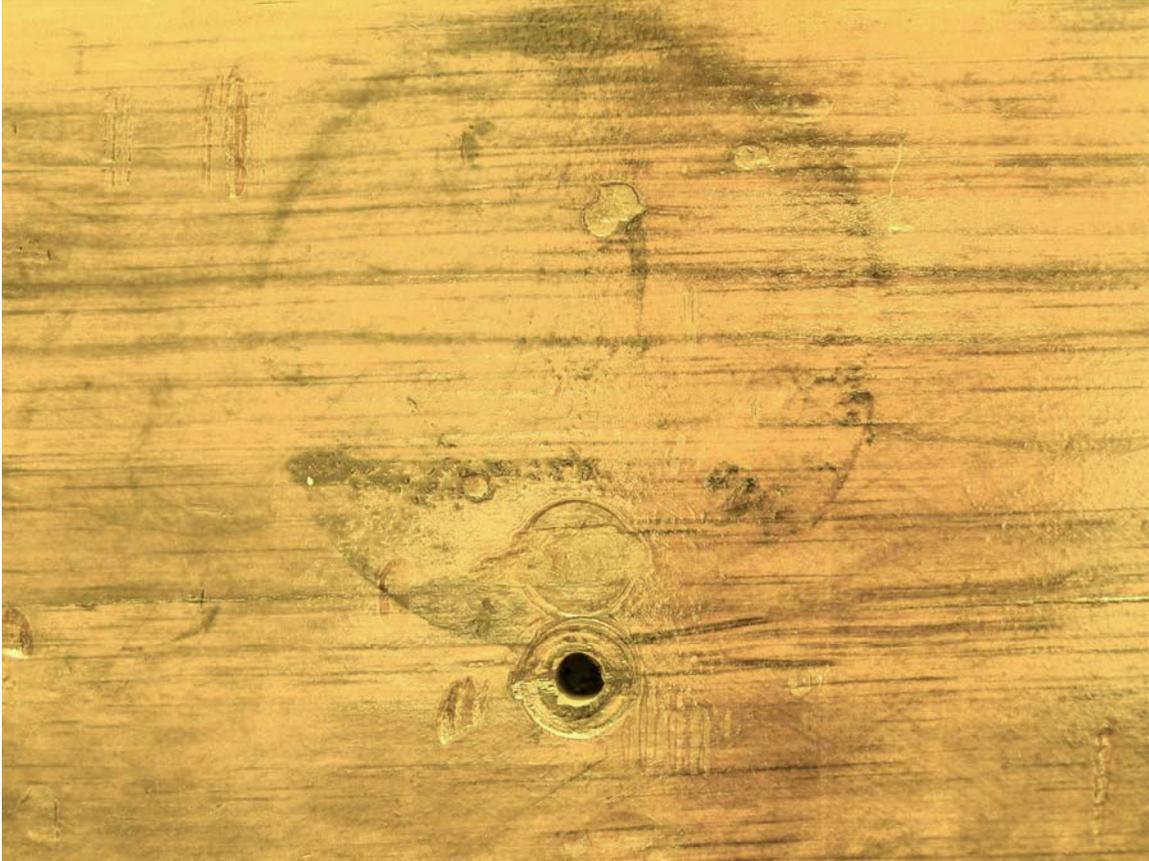
Plate 30

A silhouette of the doorbell mount, along with circular holes (some filled), are the only indicators of a once-functioning doorbell located on the side entrance door. The removal and/or whereabouts of the bell was never documented—at least to the knowledge of the author. The absent doorbell would most likely have been a Taylor's or Cone Patent (see next page), which consisted of a bronze bell with a cast iron mount. The patent date and/or patentee were depicted on the face of the bell.

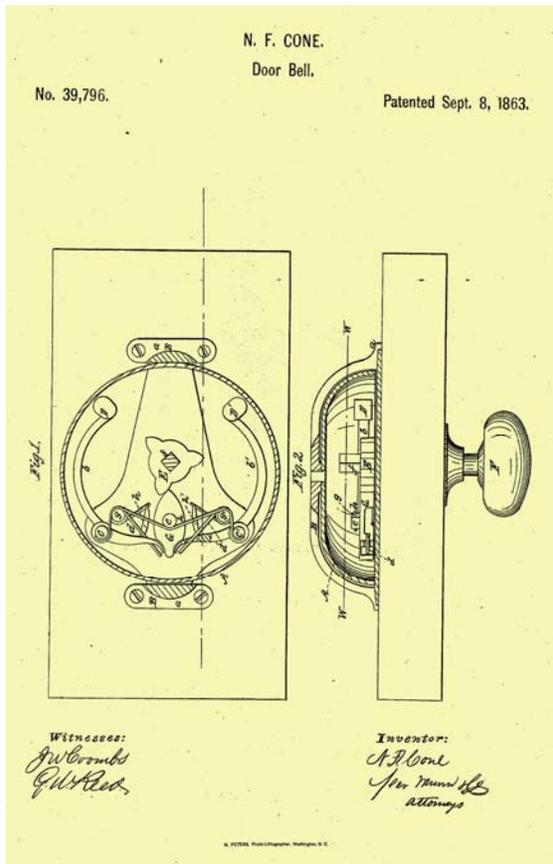
Schematic of the 1863 Nathan Cone Patent. Rotating the knob releases spring-driven hammers causing the bell to ring, over and over, so long as you twist the knob.

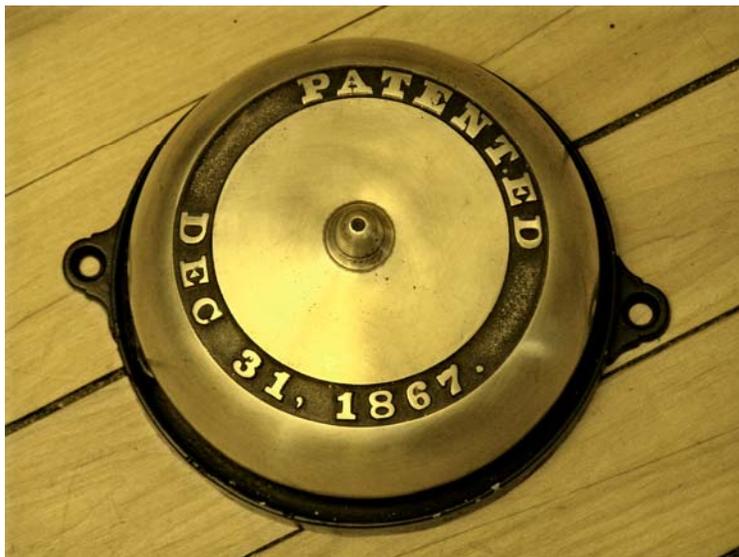
A typical door bell similar to the one shown in Cone's Patent, and most likely used on the side entrance door of the LeDuc house. (Bell is a part of the author's collection).

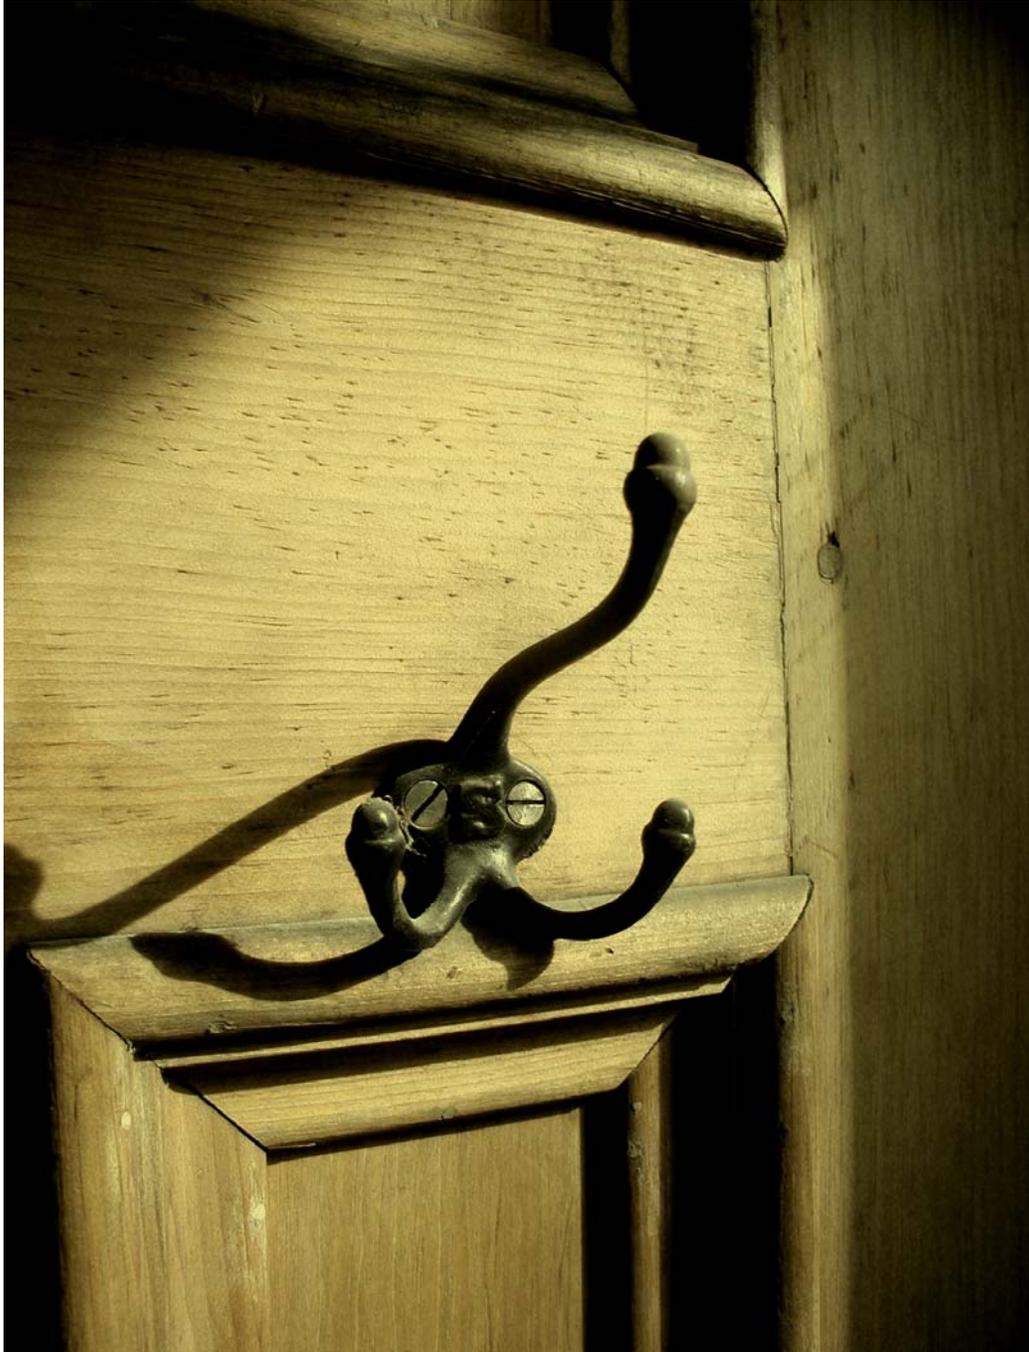
Plate 31

Passage door hook with the letter “S” found on the base between the mounting screws. Presumably the “S” identifies the manufacturer, although it is unclear at the time of writing. This particular hook is primarily found only in the passage room/closet on the 2nd floor—a small area with oddly placed hooks found almost everywhere. The utilitarian hooks are complimented with acorn-shaped tips which aside from the “S”, is the dominating trend throughout the remainder of the house.

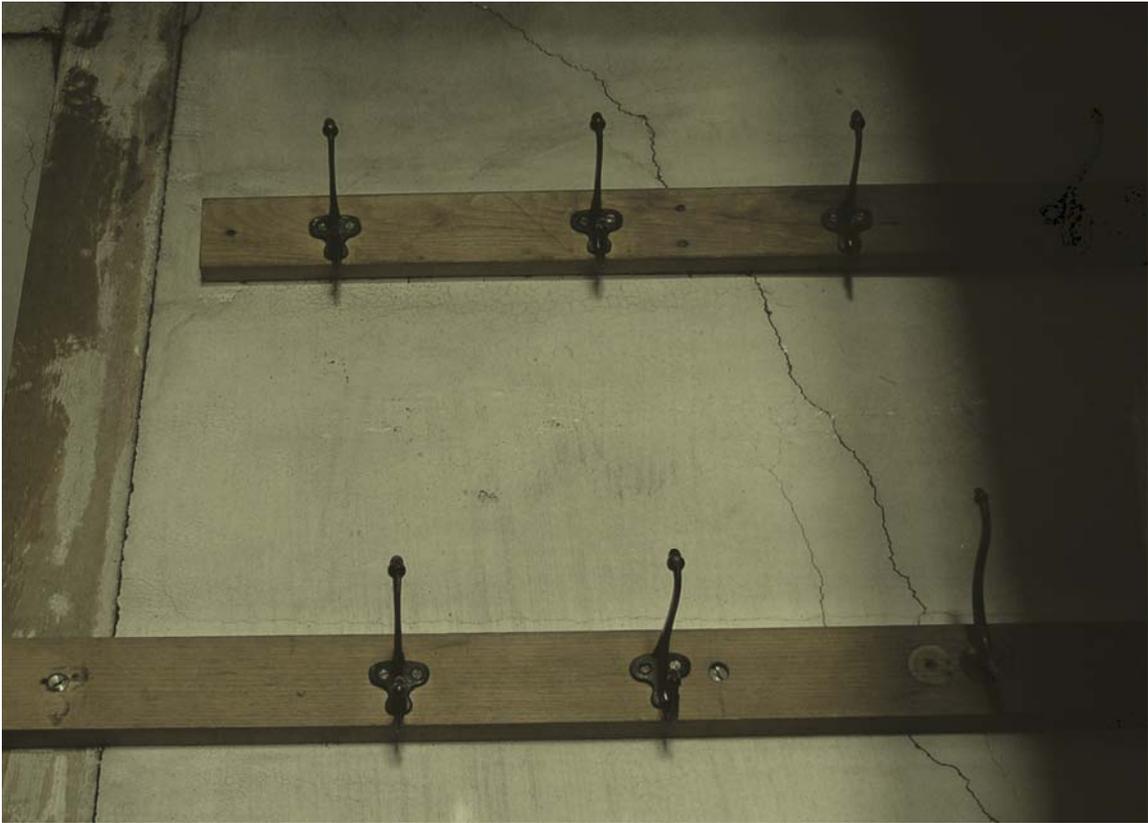
Plate 32

Most of the closets have japanned finish, cast iron hooks with acorn tips. Some are broken or missing altogether. Even so, the hooks are all mounted to a plain pine or fir board that was anchored directly into the plaster wall. It is certainly common for hooks to be broken or missing which was caused by the wear and tear over the years.

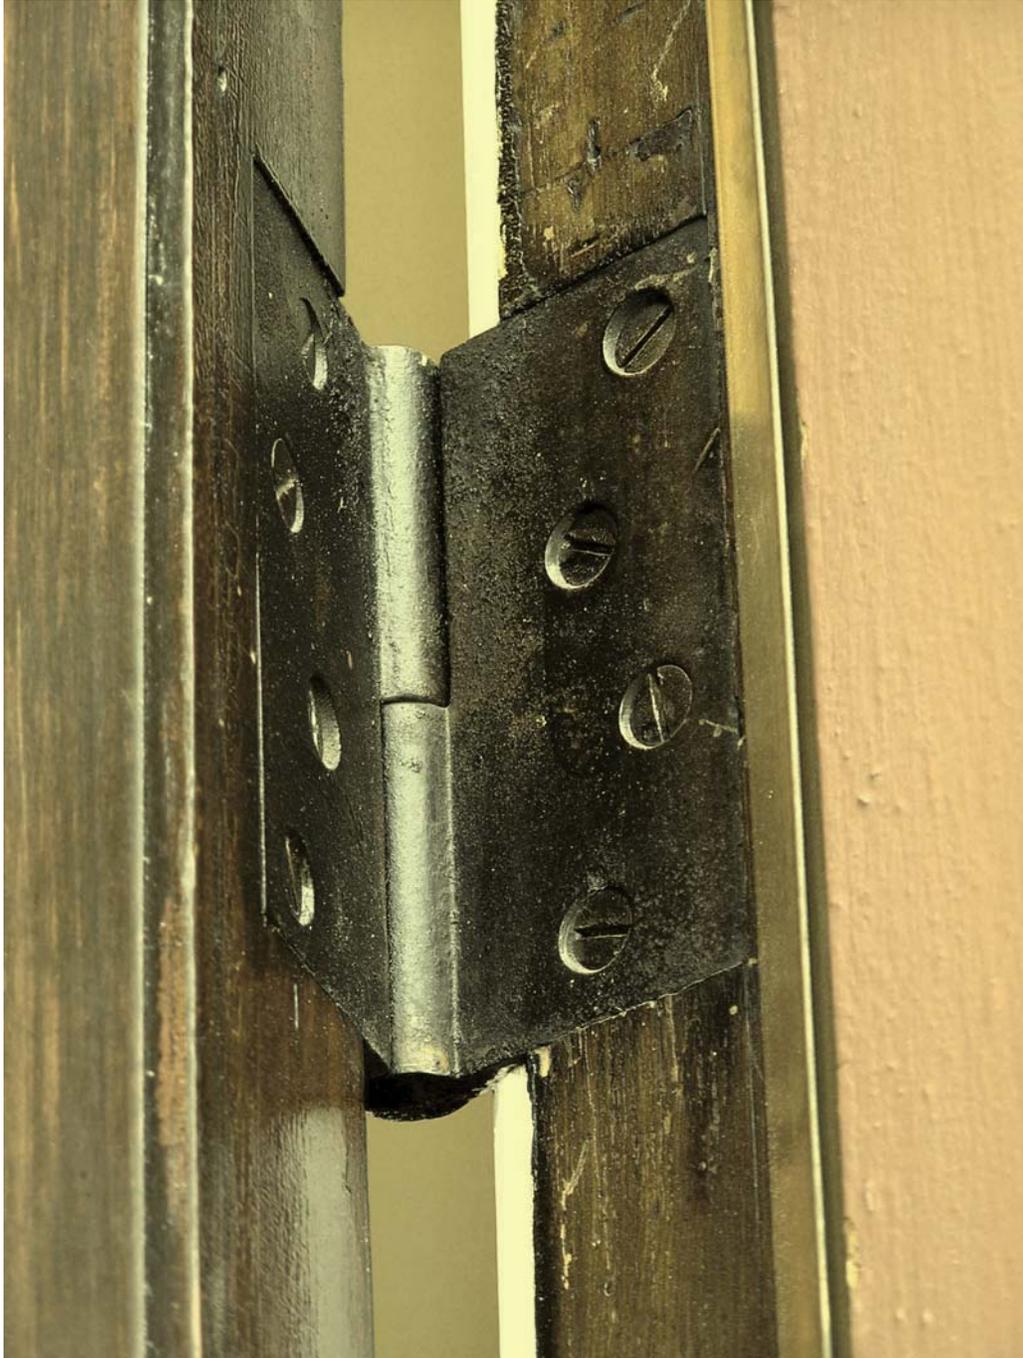
Plate 33

The hinges throughout the house (with the exception of the 3rd floor) are identical to the one depicted here—both in size, finish and style. Very simple and utilitarian...made of cast iron with original japanned finish. The hinge consists of 2 sections or leaves; whereby, one leaf has the fixed pin, while the other leaf has a hollow barrel or “knuckle” to receive the pin and link the hinge leafs into a single pivoting hinge.

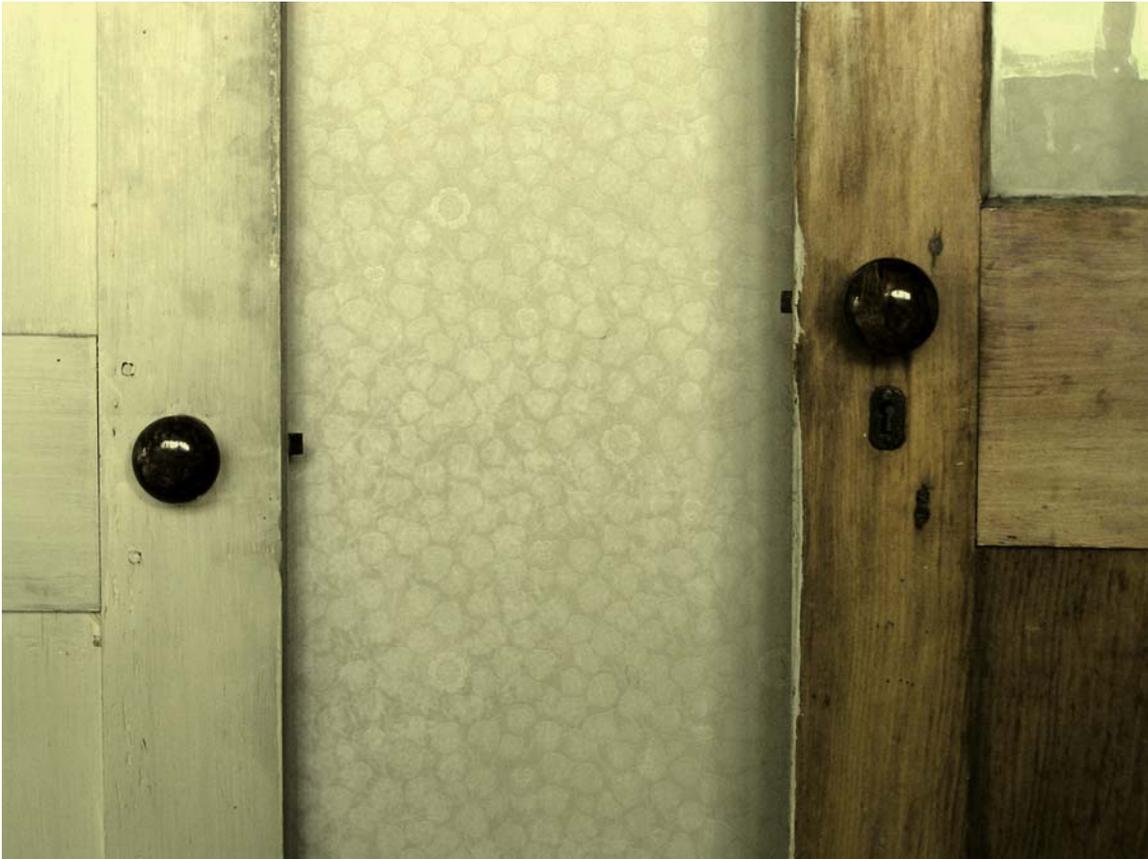
Plate 34

The door to the right contains rectangular glass panes with original wavy glass. Some of the doors are painted, while others are missing key plates. Overall however, these attic doors are largely intact and in good condition. The cast iron hinges for these doors are plain 3 ½ inch with a japanned finish. All of the doors on the 3rd floor seem unusually small—as if they were meant for wandering children.
