**A Comprehensive Assessment of the
Architectural Hardware found at the
William LeDuc Residence in Hastings,
Minnesota**

**Documentation compiled and written by
Eric J. Nordstrom
Spring 2005**

SECTION 1
LEDUC HOUSE ARCHITECTURAL
HARDWARE

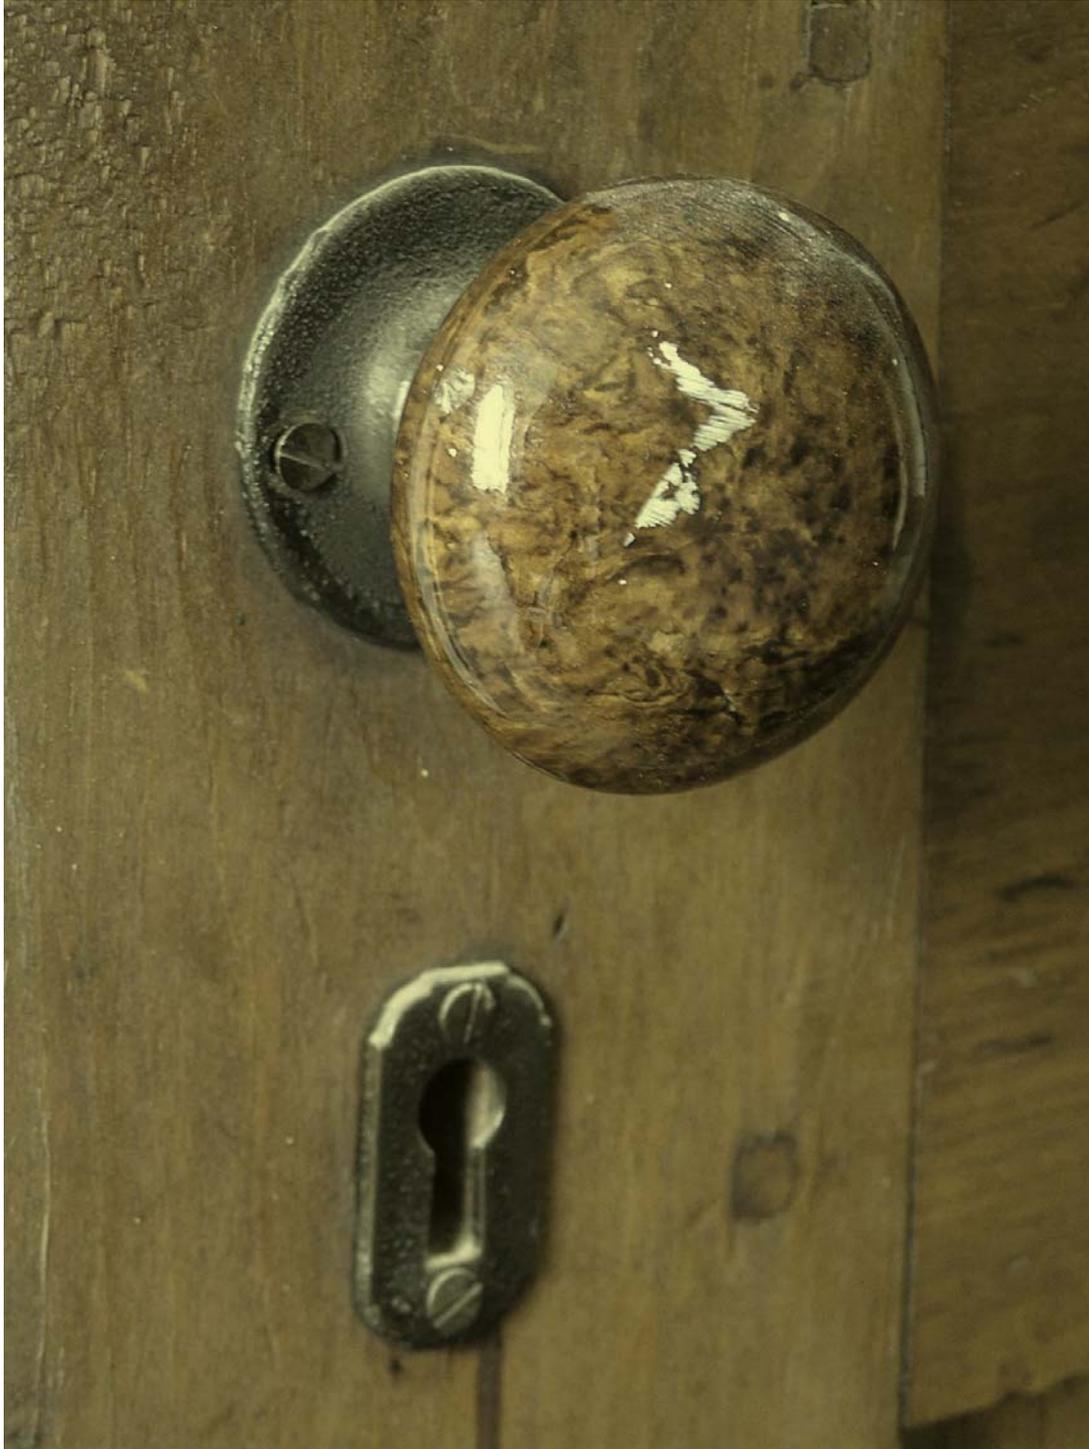
Plate 35

Detailed portrayal of a typical 3rd floor mineral knob. All of these knobs were backed by a japanned finish cast iron rosette and key plate. Along with the rimlocks, the knobs show very few signs of wear.

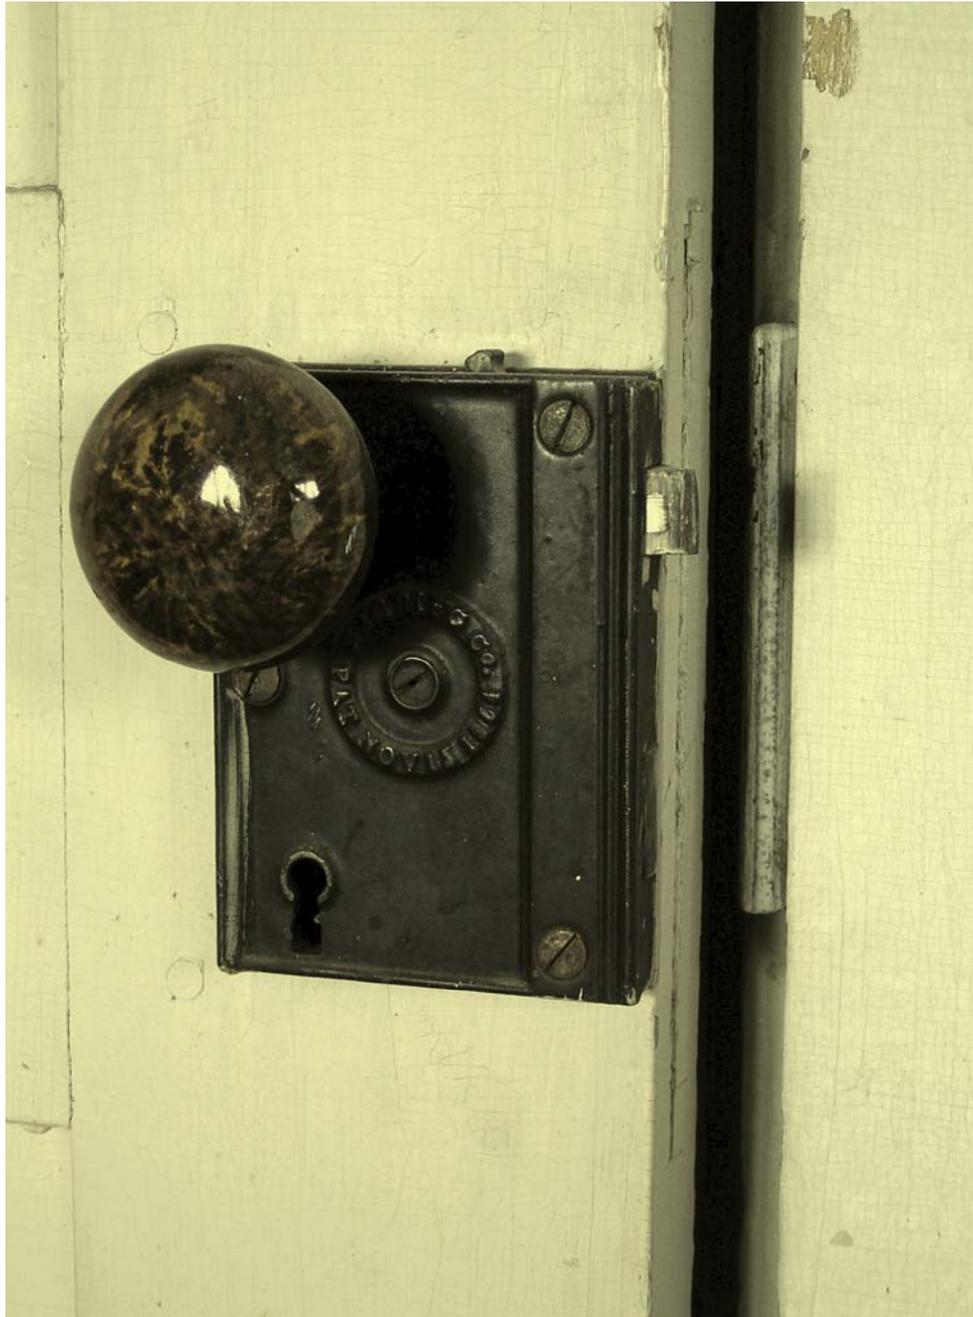
Plate 36

Japanned rimlock and mineral knob located on all the passage doors throughout the 3rd floor only. The lock has a patent date of Nov. 15, 1862. The keeper is somewhat hidden because it has been painted. All of the 3rd floor rimlocks are in surprisingly good working order.

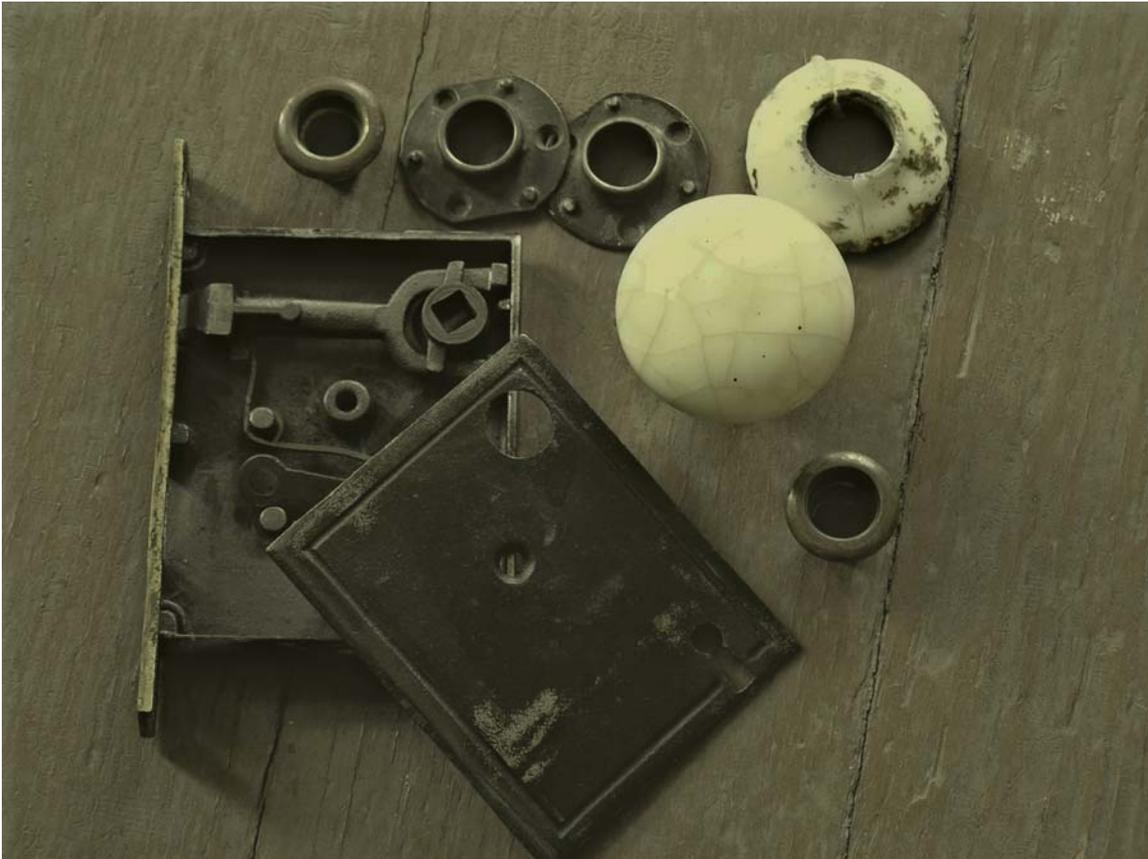
Plate 38

These hardware parts were found on a shelf in the 2nd floor passage room and/or closet between bedrooms. Presumably, the hardware was removed for repair because the mortise lock is missing springs and the dead bolt. The rosettes are in pieces. The knob has a fabulous crackle pattern. The lock box has no markings indicating a manufacturer.

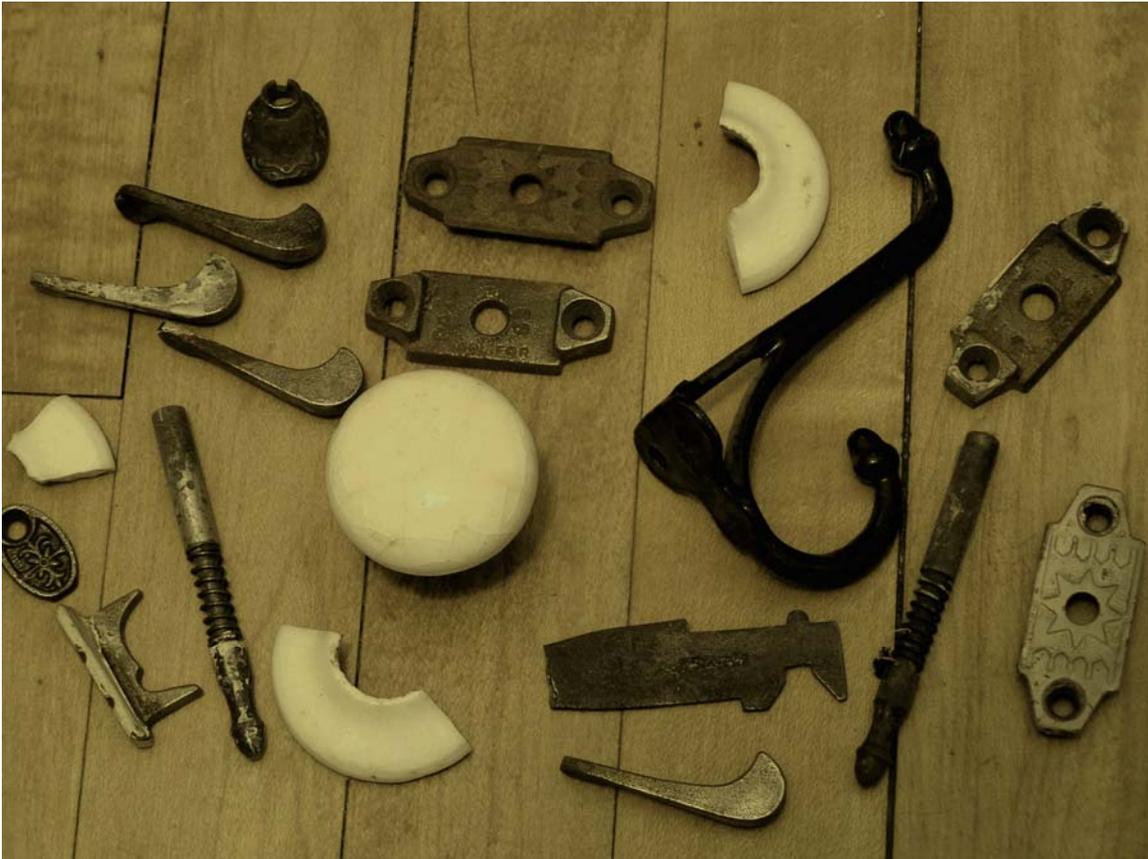
Plate 39

Defunct hardware parts found in an old gallon milk container. An extra hook, broken rosette fragments, sash hardware, and so on. It was at first presumed that hardware items no longer serving a purpose were simply discarded. Thankfully, that presumption was wrong because of instances where items like the lot found above tend to surface, when sought after. Accordingly, these stashed away lots may invoke hardware placement conundrums (that are always exciting to solve), or at the very least, serve as replacements for broken or missing hardware items still found or used throughout the house.

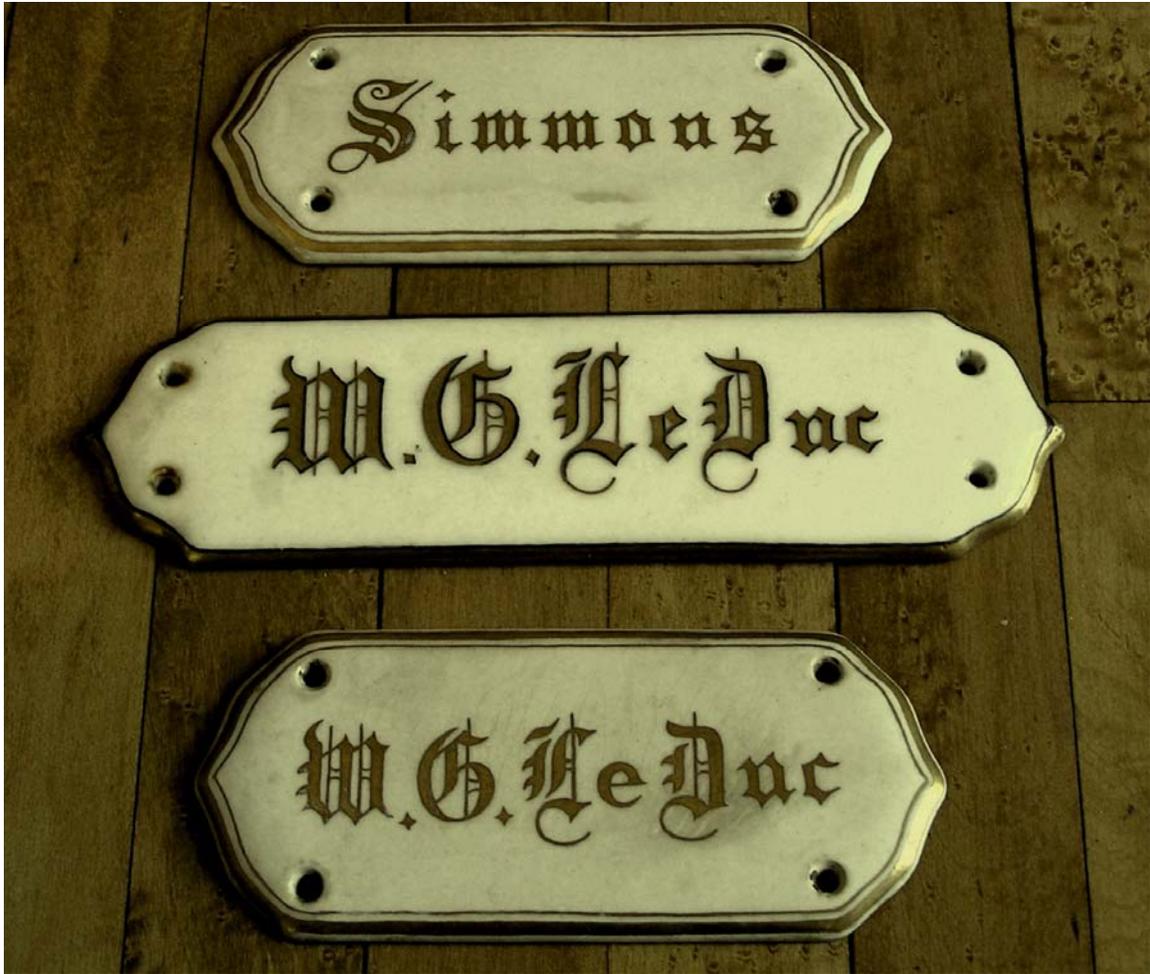
Plate 40

This history (or lack thereof) of these name plates is rather interesting. The author was convinced of their authenticity—that is, being original pieces from the time of construction. Of all the hardware in and around the house, these plates were the focal point; mainly, since nothing like this was ever seen before. In addition, the plates complimented the other porcelain hardware so nicely. More to the point, these plates never existed during construction—in fact, they never existed in Mr. LeDuc's lifetime. It turns out that these plates were made by the antique dealer (Carroll Simmons) who took the home over from LeDuc family descendants. In actuality, the plates are only 50 or so years old. After reviewing the picture, one may think it is obvious that these plates are not original—the dead give away being the plate with Simmons name on it. During the original assessment, the author failed to recall the existence of the Simmons plate because these plates were removed during restoration. Nonetheless, the possibility that the Simmons plate was made after the already existing LeDuc plates (as a means to be recognized with the history of the house) cannot be excluded entirely. The driving force behind the rationale is found in the stylistic differences and varying conditions among the three plates.
