Subject: 2011 Mt. Morris Dam Inspection
Rattlesnake Creek, Waushara County
Field File # 69.04, Key Sequence # 93

**MT. MORRIS DAM
RATTLESNAKE CREEK, WAUSHARA COUNTY**

**2011 DAM SAFETY INSPECTION REPORT
DAM INSPECTION CHECKLIST
PHOTO DOCUMENTATION**

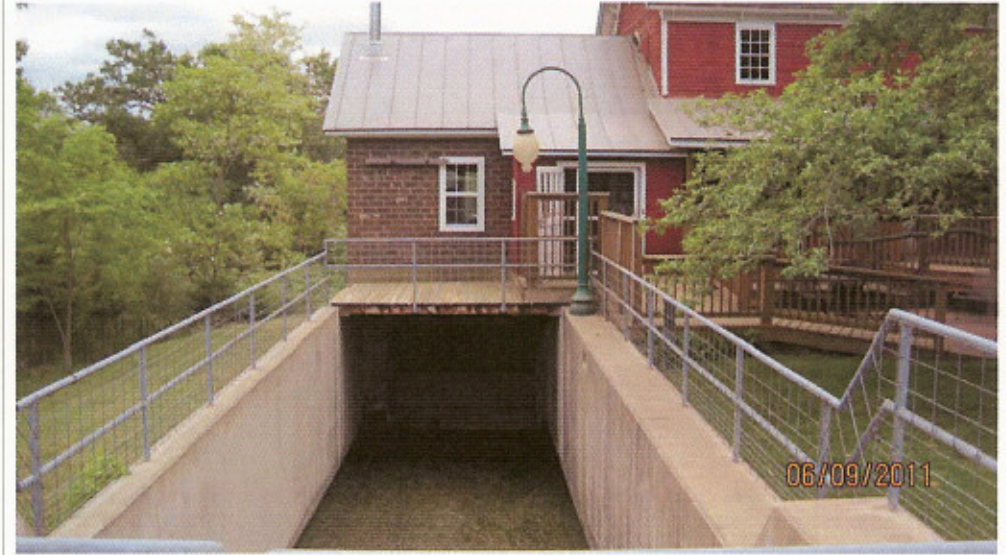
Powerhouse / Flume (0009300609201120)

The rear powerhouse foundation wall and bulkheads have some concrete deterioration above the flume. The 1995 flume reconstruction was designed to be independent of the powerhouse. Concrete repairs should made to the powerhouse foundation walls and support structures should hydroelectric generation ever be reconsidered.

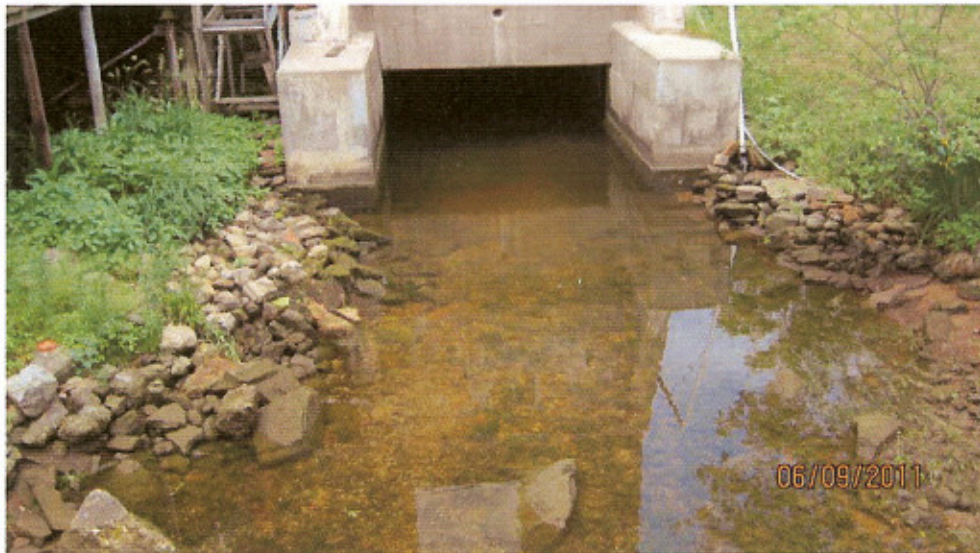
Tailwater (0009300609201136)

Flow was briefly shut off during the inspection to allow examination of the outlet area. The tailwater slab within the powerhouse appears to prevent outlet erosion under normal flow conditions. No scour or undermining of the slab was observed during the inspection.
