Initial Seismic Vulnerability Assessment of Trashigang District Hospital Trashigang, Bhutan

December 21, 2013

GEOHAZARDS

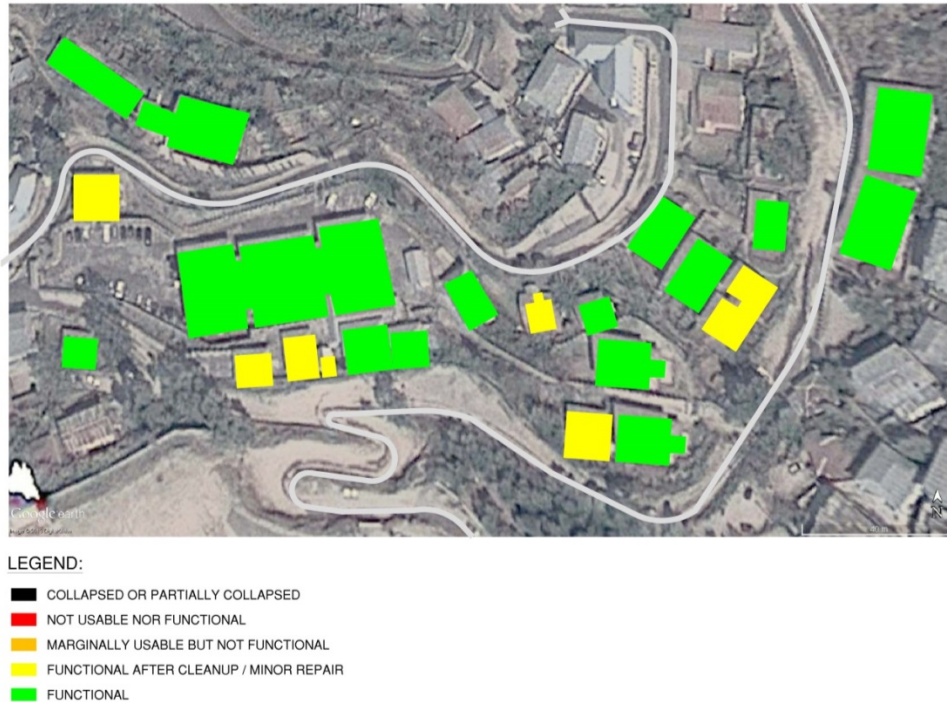
Site plan showing likely performance of hospital buildings in deep M7 hypothetical scenario earthquake

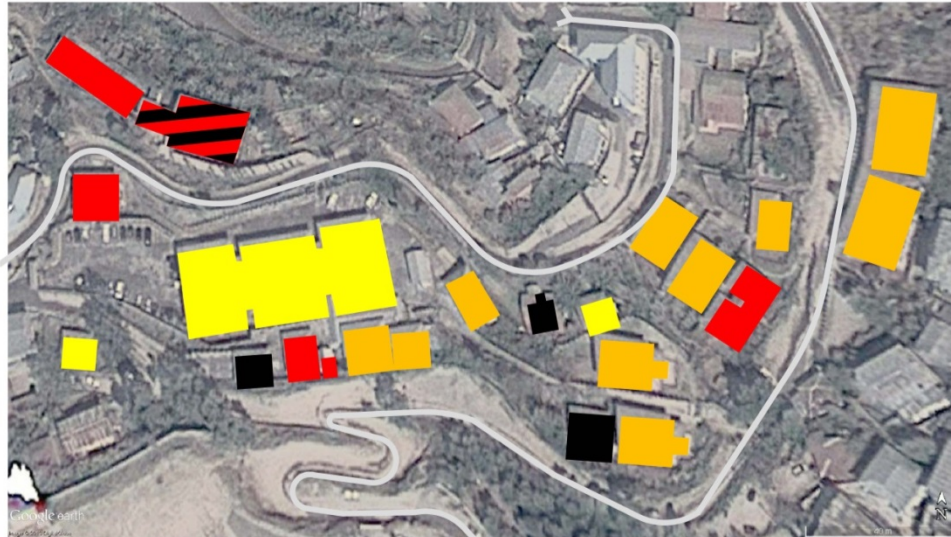
Site plan showing likely performance of hospital buildings in shallow M6.1 hypothetical scenario earthquake

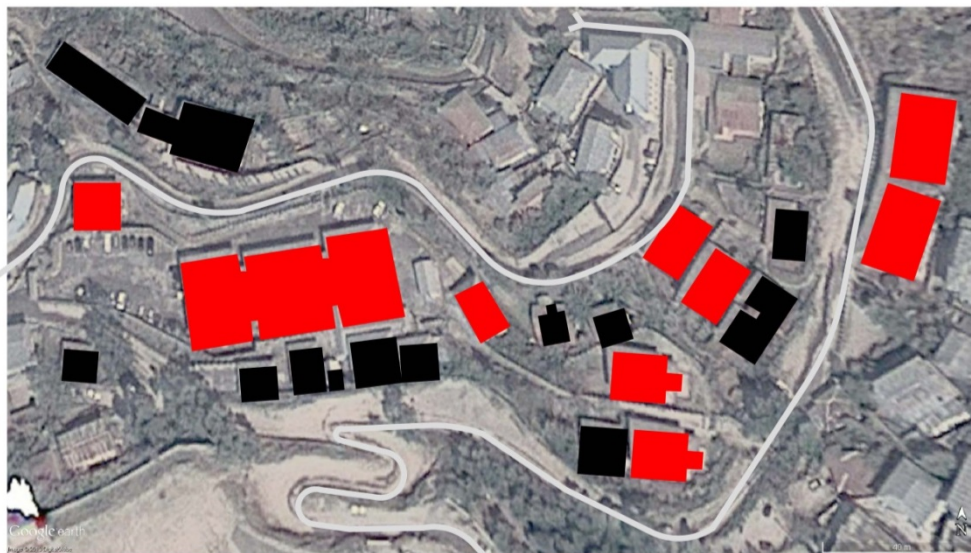
Site plan showing likely performance of hospital buildings in M8.6 hypothetical scenario earthquake

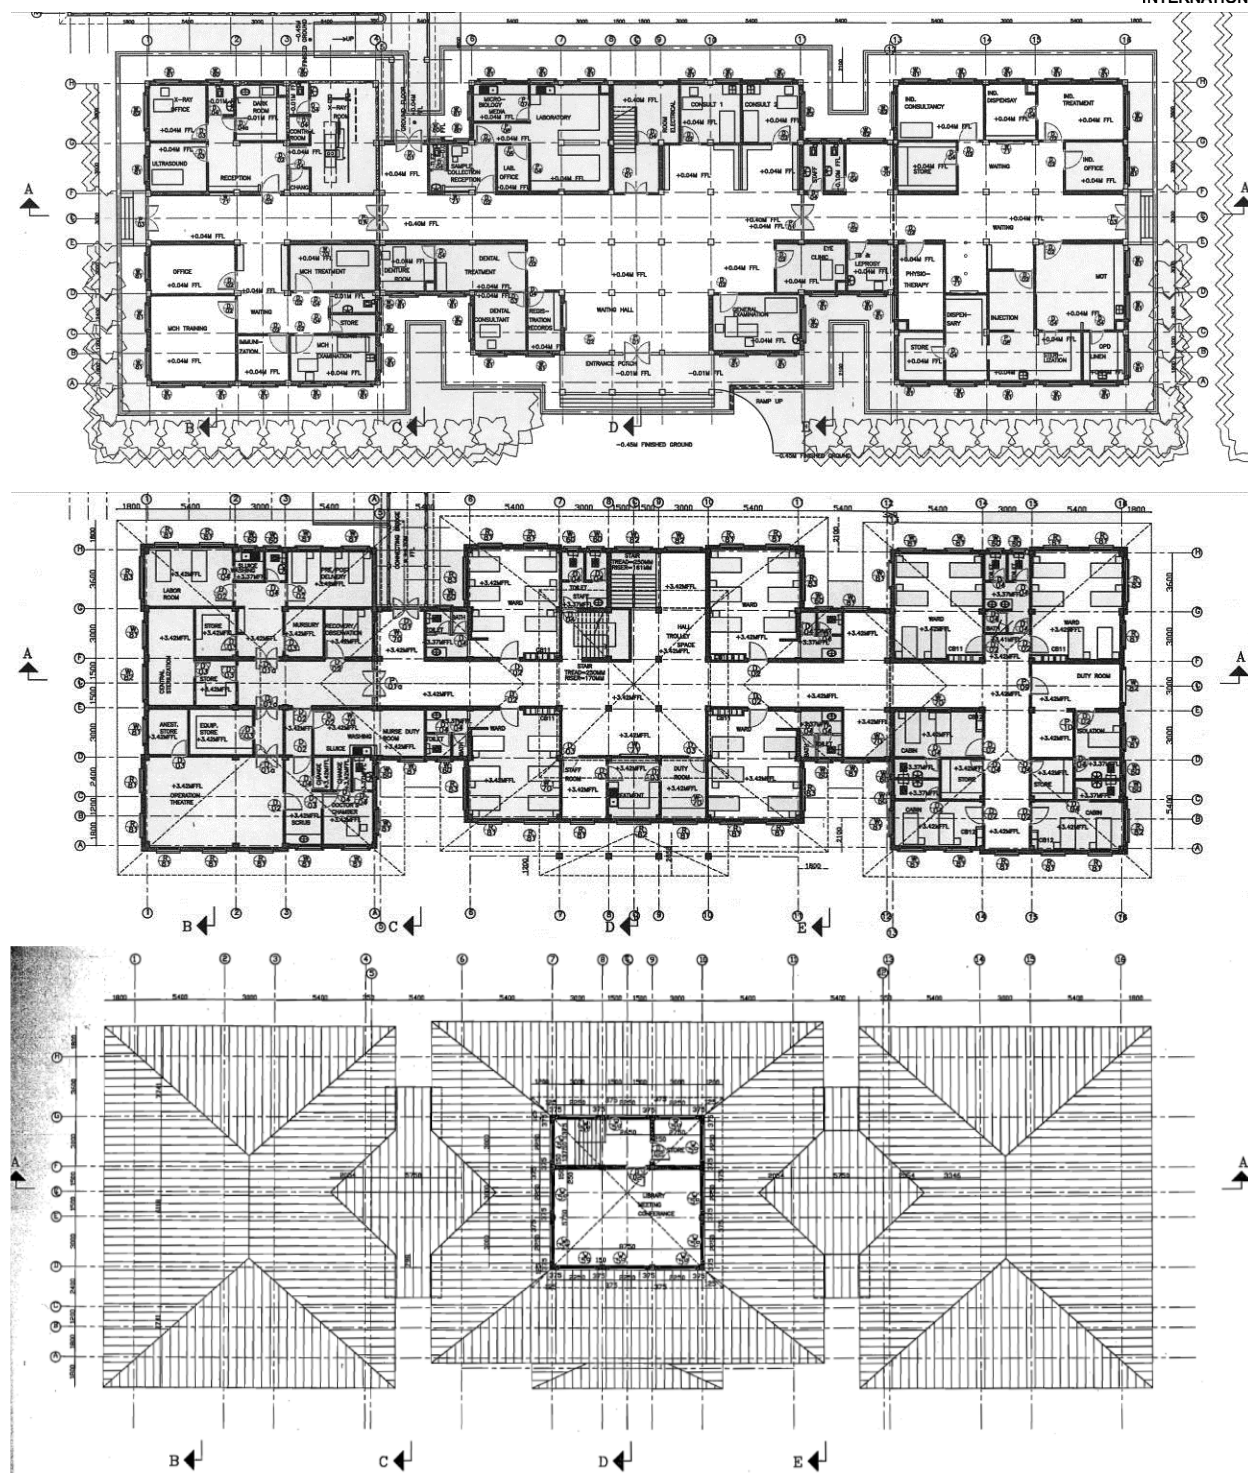
Figure 10. Ground (top), first (middle) and second (bottom) floor plans of Main Hospital building; note that second floor has very small plan area used as a conference room.

Figure 10 shows floor plans for the building. The building is ground-plus-one-storey for most of the plan area, with a small second storey containing a conference room in the central part of the building. The wings at east and west ends are separated from the central portion of the building by what appear to be code compliant seismic joints of 50 mm (25 mm per floor). The building's structural system is reinforced concrete moment-resisting frame with brick masonry infill walls, in which rigid joints between beams and columns resist lateral forces from earthquake and wind. Exterior and interior corridor brick infill walls are double wythe (250 mm), interior brick partitions are single wythe (125 mm). The building is presumed to have a steel tubular truss roof, which is covered with corrugated metal (CGI) sheets. The ceilings are plywood supported on steel and wood joists.

The building, as a whole, does not have significant vertical irregularities and appears unlikely to collapse or partially collapse in strong shaking. Damage may be greater in the second floor conference room due to dynamic amplification, with partial collapse of this upper structure possible in the very strong shaking

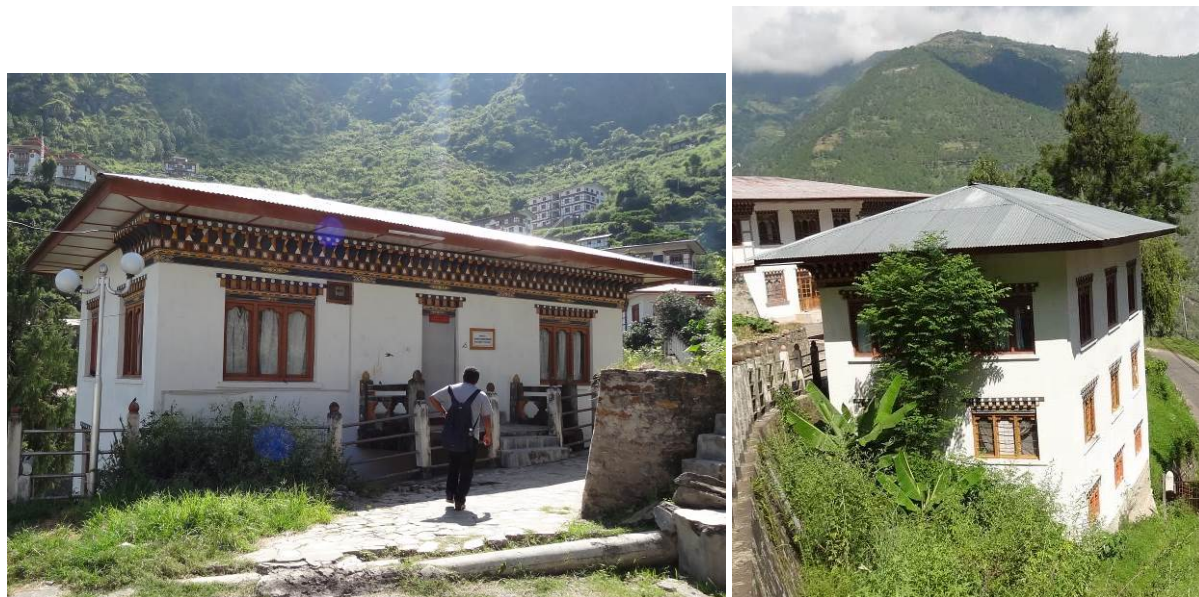
Figure 12. Front view (left) and side view (right) of the Physiotherapy Building

The Physiotherapy building, shown in Figure 12, was built at the same time as the new hospital building but with funding from Her Royal Highness Ashi Kezang Wangmo Wangchuck. The building is a ground-plus-two-storey building, with the physiotherapy department on the top floor. The assessment team understands that the two lower floors are used for storage. There are no drawings available for the building, but according to HIDD it is a reinforced concrete frame with brick masonry infill walls.

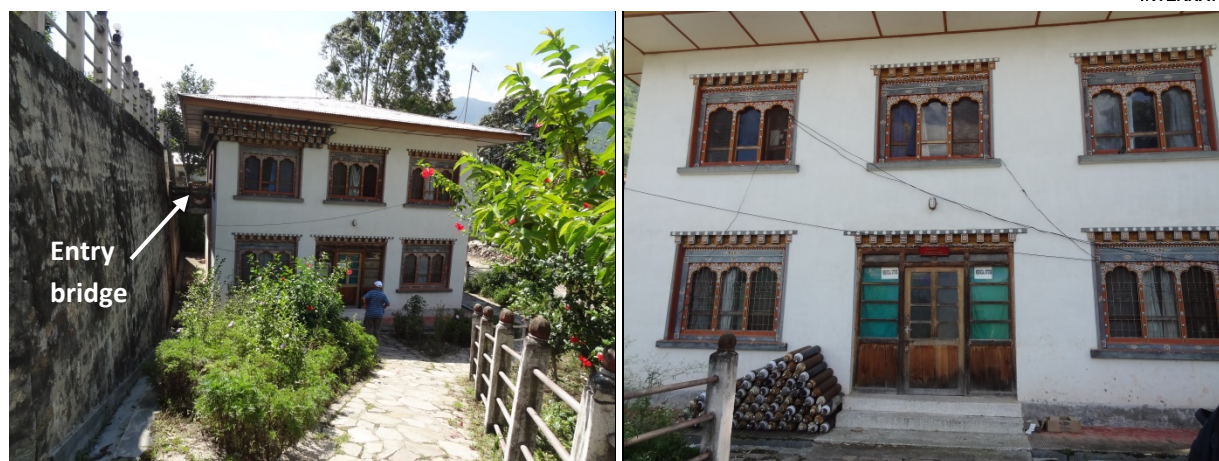
Figure 13. Side view showing entry bridge (left) and front view (right) of the Administration/Medical Store building

The Administrative/Medical Store building is a ground-plus-one-storey building, built in 2002-2004 as part of the new hospital. Shown in Figure 13, the building has a reinforced concrete frame structure with brick masonry infill walls. The offices of the District Health Officer and the administrative staff are on the first floor, and the Medical Store (where supplies and medical gas are kept) is on the ground floor. The building does not have an internal stair. An entry bridge from the parking lot above, shown at the left side of Figure 13, provides the only access to the first storey administrative offices. This entry bridge appears to be rigidly fixed to both sides, meaning that it will attract significant earthquake forces as the building tries to sway back and forth. It was probably not designed for these forces and will likely fail as a result, presenting a problem for those trying to exit (or re-enter) the first floor administrative offices.

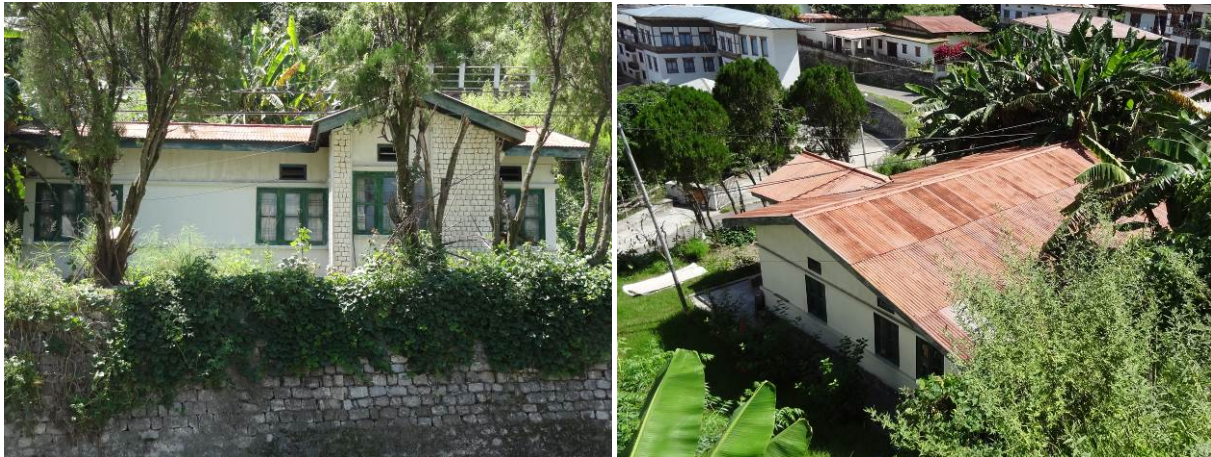
Figure 17. District Health Officer's quarters, front view (left) and side view (right)

The hospital has two bungalow type quarters for doctors and senior staff. The District Health Officer (DHO) lives in one of the staff bungalows, shown in Figure 17. The second bungalow, of a different design, is shown in Figure 18. Both of these buildings were built around the time of the original hospital complex or in the 1980s. They are unreinforced masonry, presumably without seismic bands, and as a result are highly vulnerable to earthquake damage and may collapse in strong shaking. These buildings are more vulnerable than the newly built brick masonry buildings with seismic bands. In addition, the bungalow in Figure 18 has an unreinforced masonry gable—a triangular shaped extension of the wall up to the roofline of a peaked roof. (The other bungalow does not have this feature.) Past earthquakes

have shown that unreinforced masonry gables are vulnerable to damage, and parts of them can easily fall outward during shaking.

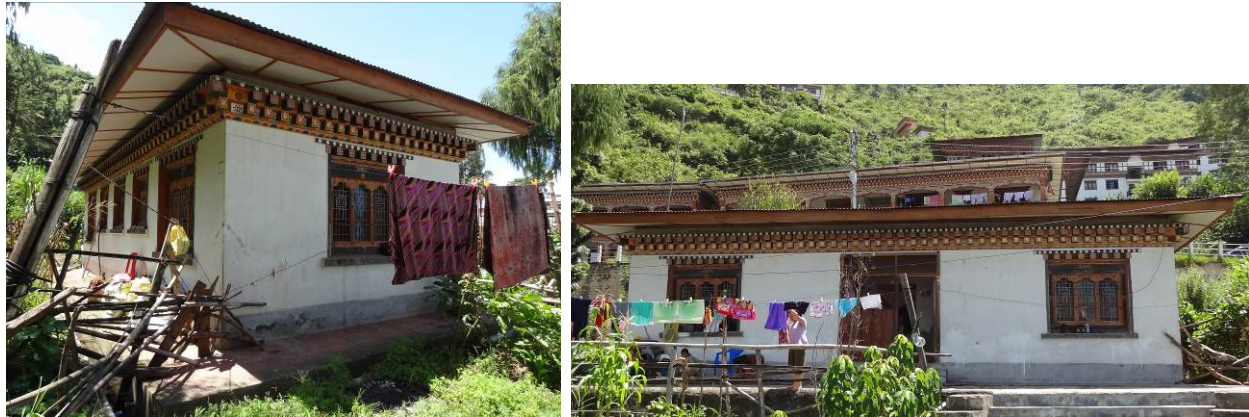
Figure 23. Front view (left) and side and back view (right) of the Attendant Guest House

Though originally built as a patient attendant guest house along with the new main hospital complex, this single storey brick building shown in Figure 23 is now being used as staff quarters. The walls are double wythe (250mm) and it has a seismic band, which will help improve its performance during shaking. However, the back side of the building has numerous windows that greatly reduce the wall area and therefore the building's strength to resist shaking. Per the drawings, the interior walls in the building's long direction are very short and cannot resist much load. The narrow brick piers between the back windows are likely to crack in strong shaking.

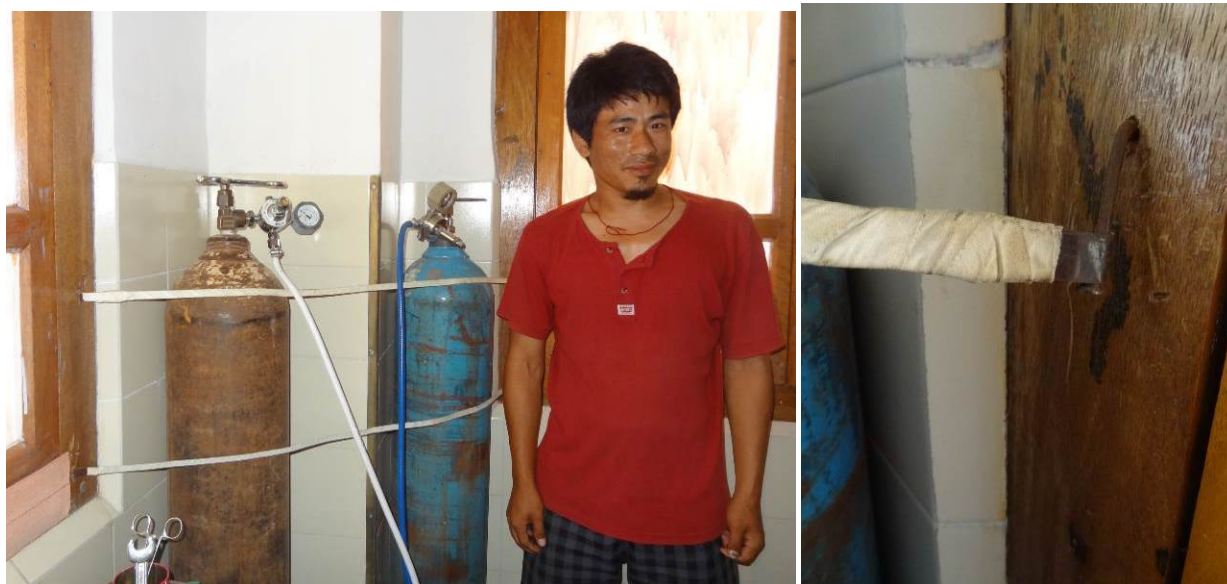
The team was very pleased to note that laboratory technician Mr. Chokey Dorji had installed simple seismic restraints on the large cylinders in the Operation Theatre to prevent them from toppling during shaking. The restraint is a simple strap with a small loop at the end that fits over a nail into the window frame. With staff creativity, such effective seismic restraints can be made out of what is available, without additional budget. Elsewhere in the hospital, cylinders are either on small trolleys or

freestanding in rooms and halls. These tall and narrow freestanding cylinders can easily topple, and they need seismic restraints.

Figure 31. Mr. Chokey Dorji with seismic restraints he installed on OT medical gas cylinders (left); simple restraint attachment (right)

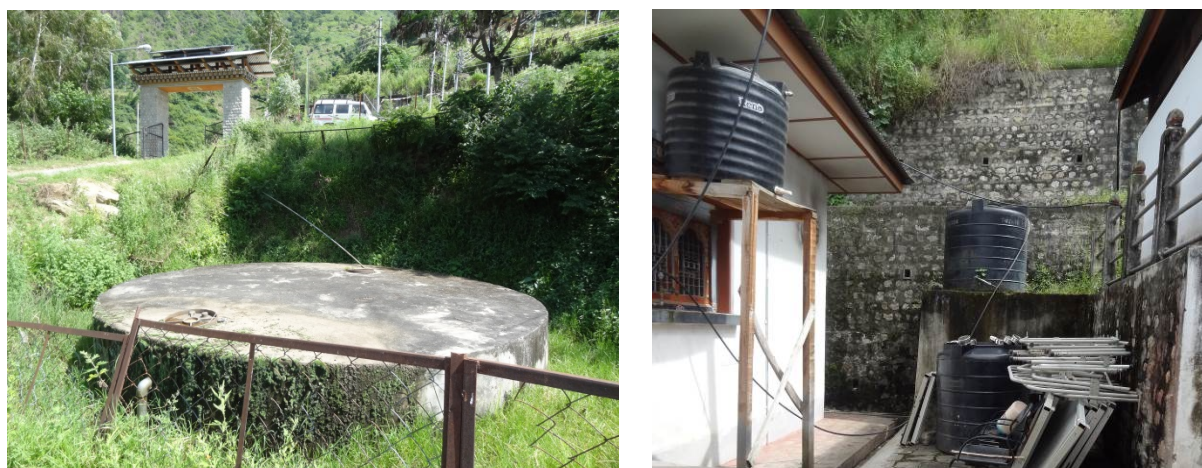
Under normal operating conditions, the hospital receives water from the city supply, which will most likely be unavailable for some time after a major earthquake. The hospital will need to function using stored water. The hospital's water storage tank is located approximately 150m uphill from the hospital, on the Trashigang Middle Secondary School premises, as Figure 4 shows. From the tank, the water flows down to the hospital through what the team was told are galvanized iron (GI) pipes with threaded couplings. Water storage down at the hospital itself is minimal, consisting of several plastic tanks holding approximately 1000L each.

Despite the tank's intended multi-day backup capacity, the supply tank was drained in less than a day during a recent city water outage caused by a landslide near the city water source (some kilometers away from the town). This indicates that either staff quarters are also being fed from the storage tank, or that the system has significant leaks. While both problems can be rectified, the hospital currently does not have adequate backup water storage capacity.

Figure 32. Main water storage tank on Trashigang Middle Secondary School grounds (left); small local tanks behind main hospital building (right)

The team recommends that the maintenance staff responsible for the tank immediately determine whether the staff quarters are being supplied by the tank. If so, the hospital maintenance staff and HIDD should begin the process of having a separate city line, which bypasses the storage tank, installed to serve the staff quarters. Smaller local tanks can provide an emergency water supply for the staff quarters. If the staff quarters are not being fed from the hospital's water storage tank, then the maintenance staff should begin investigating where leaks are occurring.

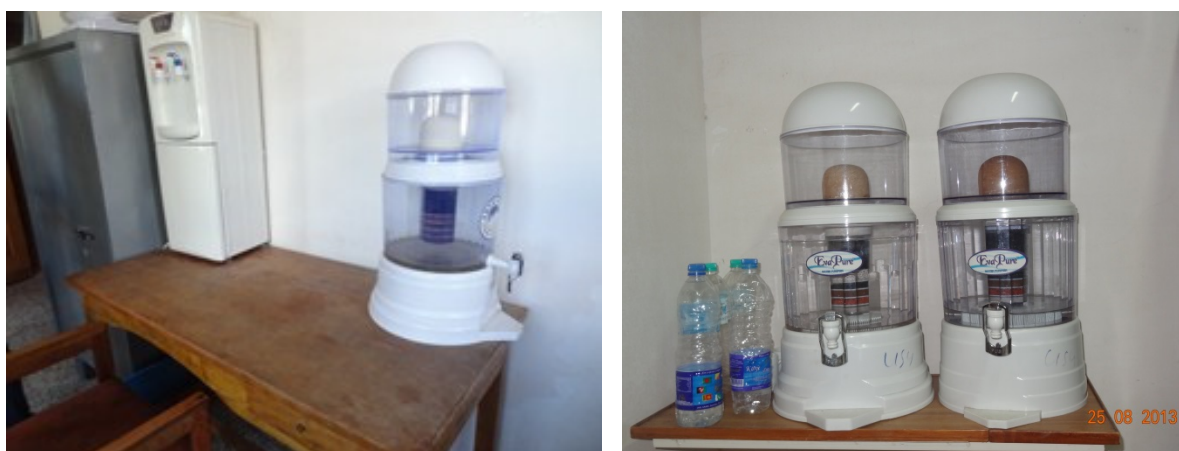
Drinking water is provided by filtering domestic water using filter units placed in wards and other areas of the hospital. The supply of drinking water is therefore dependent on the availability of domestic water and prevention of earthquake damage to the filter units. Figure 33 shows the tall and narrow filter units, meaning that during shaking they could topple from the edge of the tables where they are placed. The filters units are thin plastic and many have ceramic filters. A fall from the table top could potentially break the filter. If enough filters are damaged, the hospital will not have sufficient safe drinking water for the staff and patients.

Figure 33. Drinking water filters at the hospital

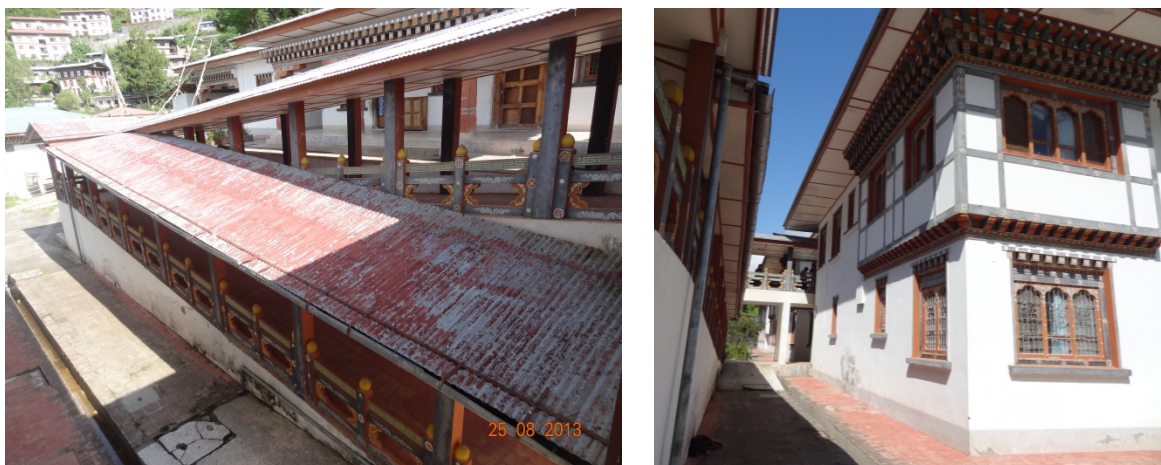
The ramp, shown in Figure 34, is on the exterior of the hospital and is separated by a seismic joint. It has reasonably spaced column ties, according to the structural drawings, and appears unlikely to suffer damage that would make it unsafe to use, until perhaps the largest scenario event.

Figure 34. Ramp behind the Main Hospital building leading to the Operation Theatre and the ward

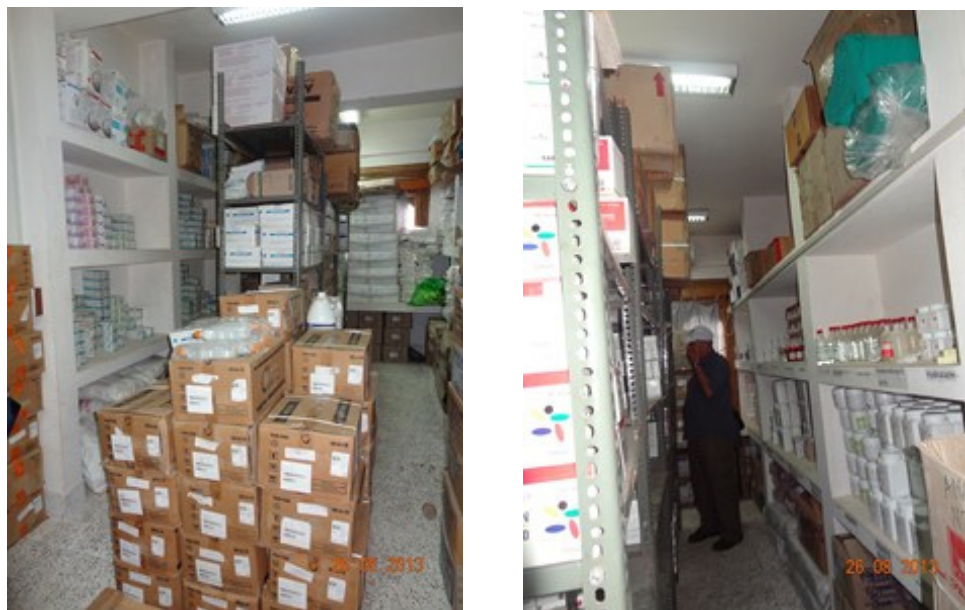
In several areas of the main hospital building and Medical Store, important items such as medicines and sterile surgical instruments are stored on unanchored shelving (Figure 38) that may topple in an earthquake. In the laboratory, dangerous chemicals are stored in glass bottles on open shelving or counters where they can easily fall, break and spill (Figure 39).

Figure 38. Supplies stacked in Medical Store

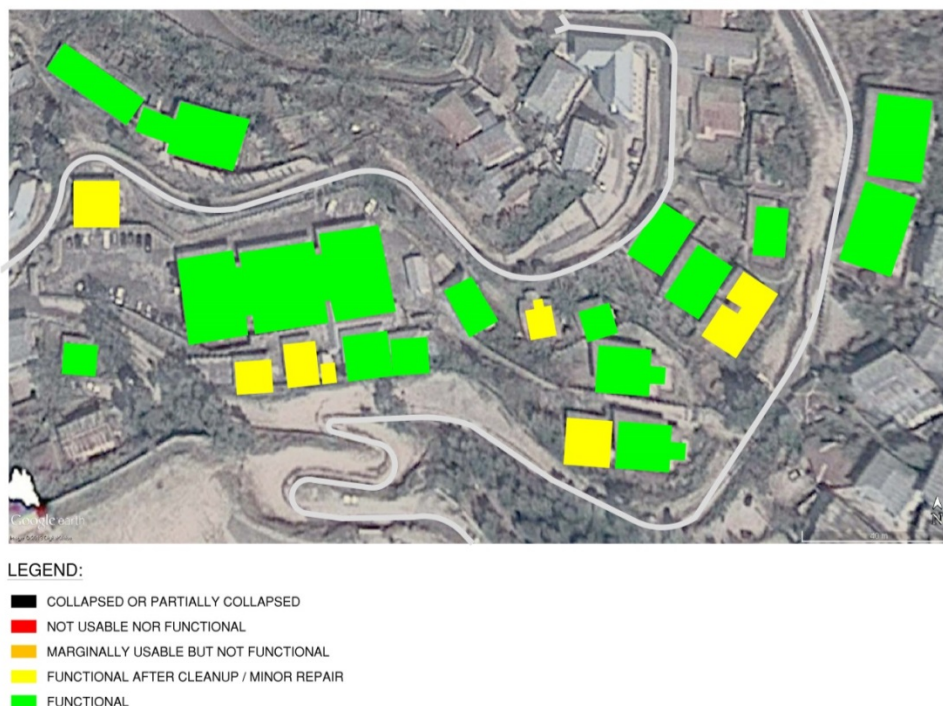
Figure 45 shows the anticipated performance of the hospital's buildings, in terms of functionality. The actual state of functionality is highly uncertain, due to uncertainty in the exact nature of ground shaking, and in the evaluation team's existing knowledge of site conditions and structural and nonstructural systems. Each building could be one performance level higher or lower than shown. The hospital is able

to maintain most essential functions and treat the injured, but the severe shortage of doctors reduces the quality of care and the ability of the hospital to treat more severe injuries.

Figure 45. Likely performance of hospital buildings in deep M7 hypothetical scenario earthquake

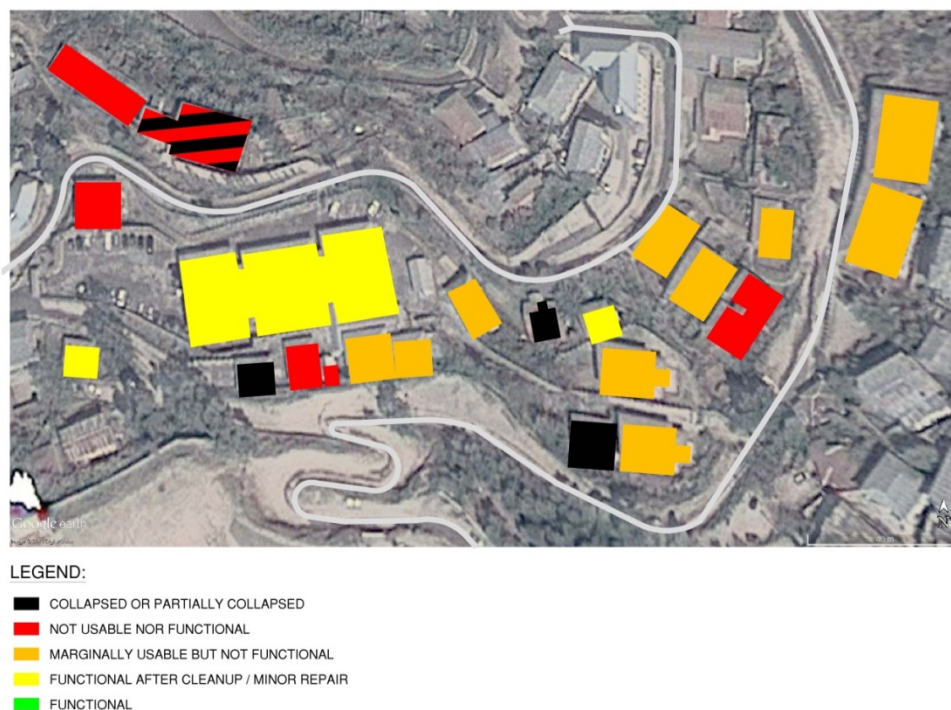
Figure 47 shows the anticipated functional performance of the hospital's buildings. The main hospital building remains functional for a short time, until fuel and water run out; improving backup capabilities would greatly increase the hospital's ability to function following moderately strong earthquakes.

Figure 47. Site plan showing performance of hospital buildings in shallow M6.1 hypothetical scenario earthquake

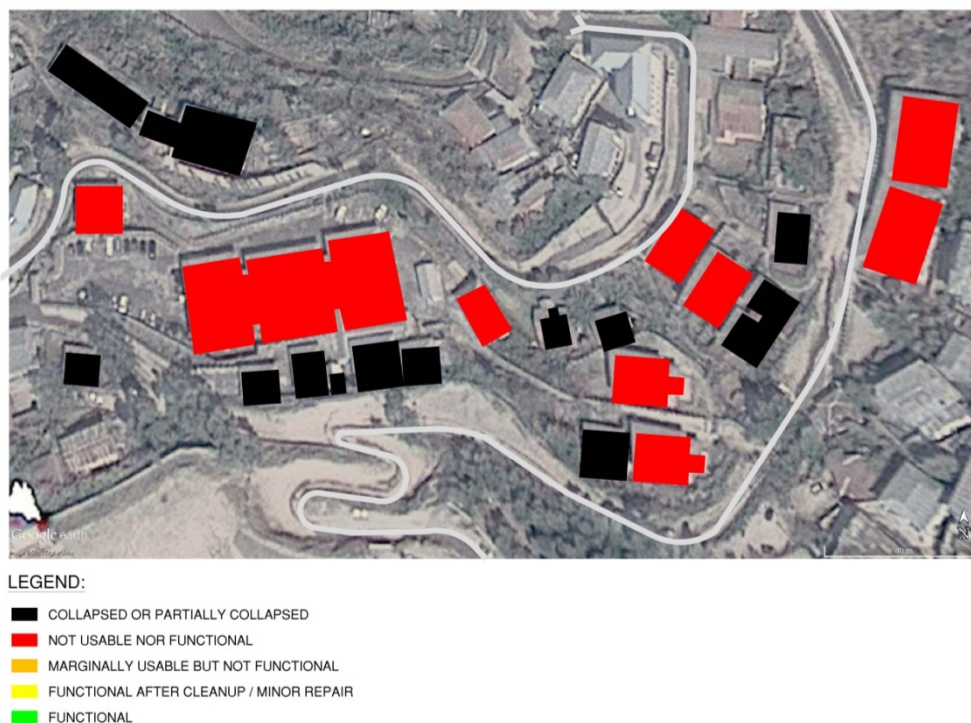
Figure 49 shows the anticipated performance of the hospital's buildings, in terms of functionality. The main hospital has not collapsed and has protected the lives of most inside, but many other buildings are badly damaged or have collapsed. The hospital is able to provide only a basic level of "austere" care in the immediate post-earthquake period, but the main building is badly damaged and is probably not repairable.

Figure 49. Likely performance of hospital buildings in M8.6 hypothetical scenario earthquake
