# Initial Seismic Vulnerability Assessment of Trashiyangtse District Hospital Trashiyangtse, Bhutan

December 24, 2013

**GEOHAZARDS**

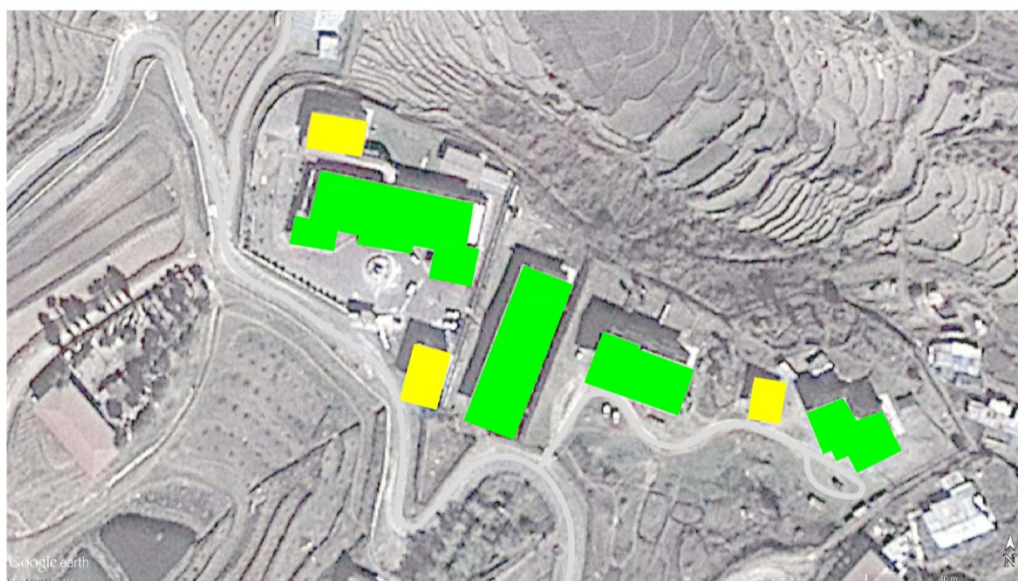
**Site plan showing likely performance of hospital buildings in deep M7 hypothetical scenario earthquake**

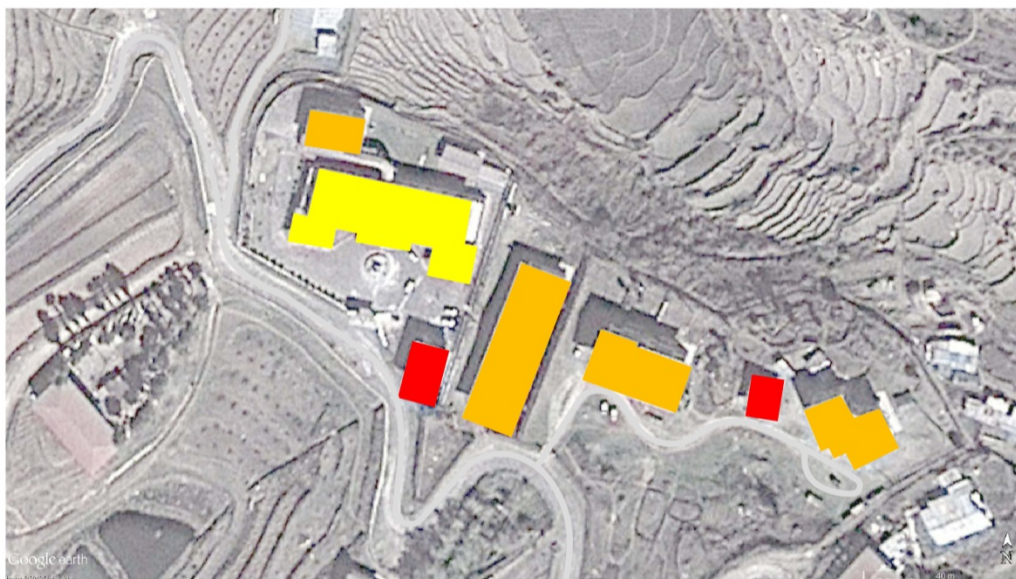
**Site plan showing likely performance of hospital buildings in shallow M6.1 hypothetical scenario earthquake**

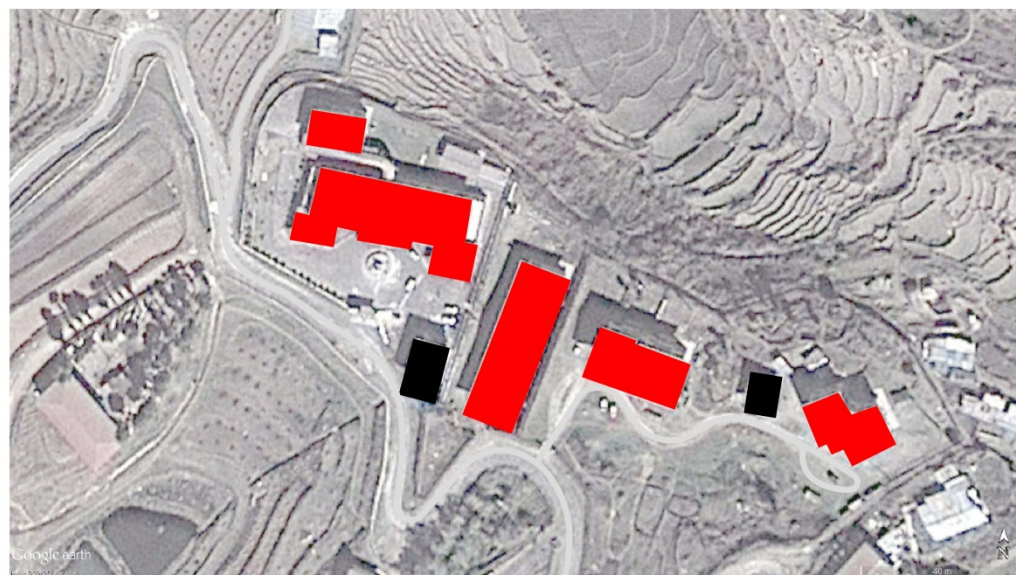
**Site plan showing likely performance of hospital buildings in M8.6 hypothetical scenario earthquake**

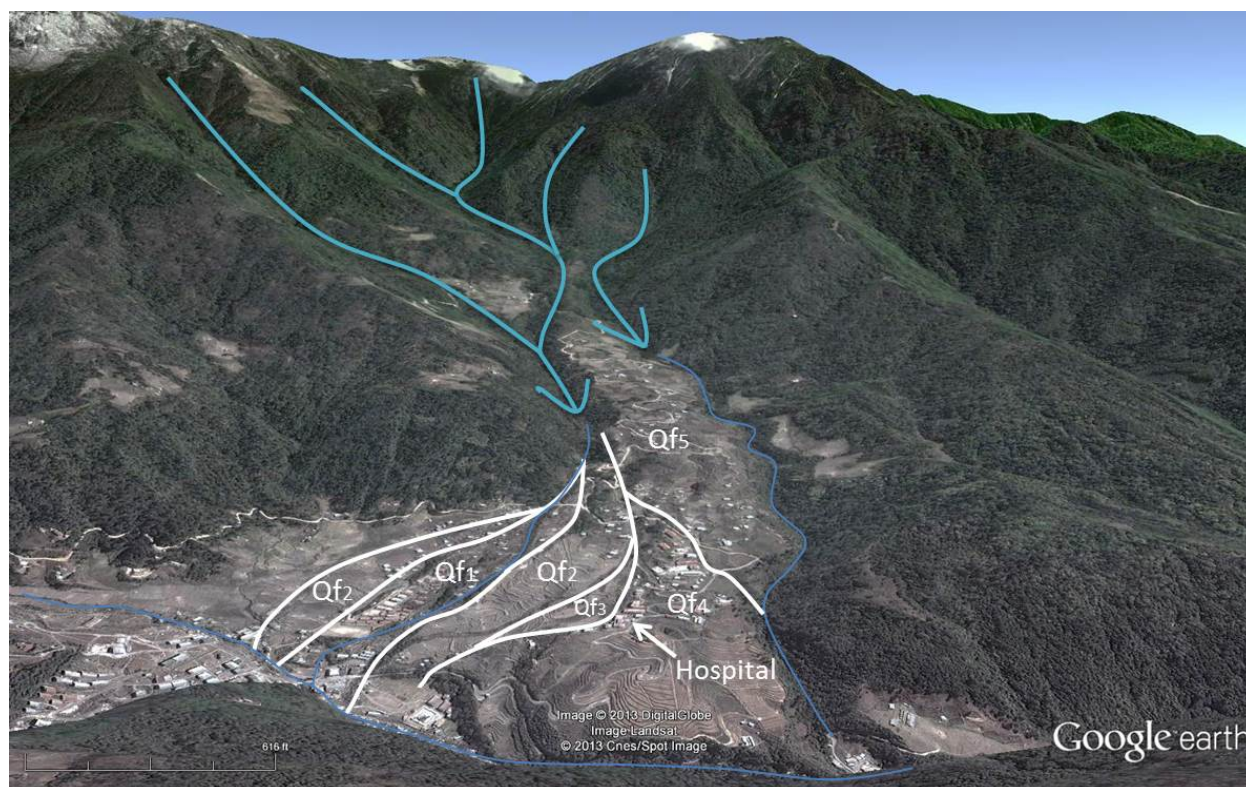
The relative age of deposits on the fan surface can be estimated by geomorphic analysis. Older fan surfaces are higher in elevation and more heavily dissected than younger fan surfaces. Older fan surfaces are often more heavily vegetated and expose fewer coarse deposits such as boulders than younger fan surfaces. Preliminary interpretations of Google Earth imagery and site photographs indicate that the Trashiyangtse Hospital is located on a relatively older fan surface, labeled Qf4 (Quaternary fan 4, where Quaternary refers to the current geologic time period) in Figure 7. The active drainage channel is bounded by the youngest and most active fan deposits (Qf1) with successively older fan surfaces stepping away from the active channel. The potential for a large debris flow to affect Trashiyangtse hospital is considered low due to the relative age of the Qf4; however, a detailed debris flow hazard study is recommended for this site.

Figure 7. Oblique view of the west facing hill slope and fan surfaces at Trashiyangtse. Preliminary interpretation of fan surfaces shown as Qf1 – Qf5 (youngest to oldest) are outlined in white, debris flow paths are shown in light blue, and active stream channels are shown in dark blue.

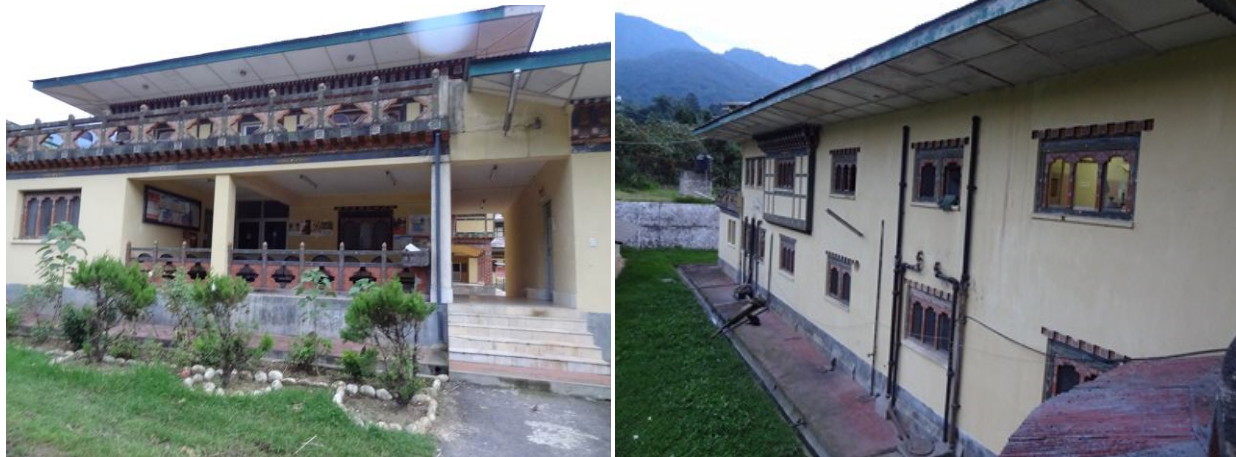
The building steps back at each end; Figure 9 shows the configuration of the ground storey with a terrace above. The back side of the main building is structurally and architecturally simpler, as the right photo in Figure 9 shows; note that plumbing runs on the outside of the buildings. Figure 10 shows an architectural ground floor plan, one of the few drawings available for the hospital.

Figure 9. Side view (left) and back view (right) of Hospital building

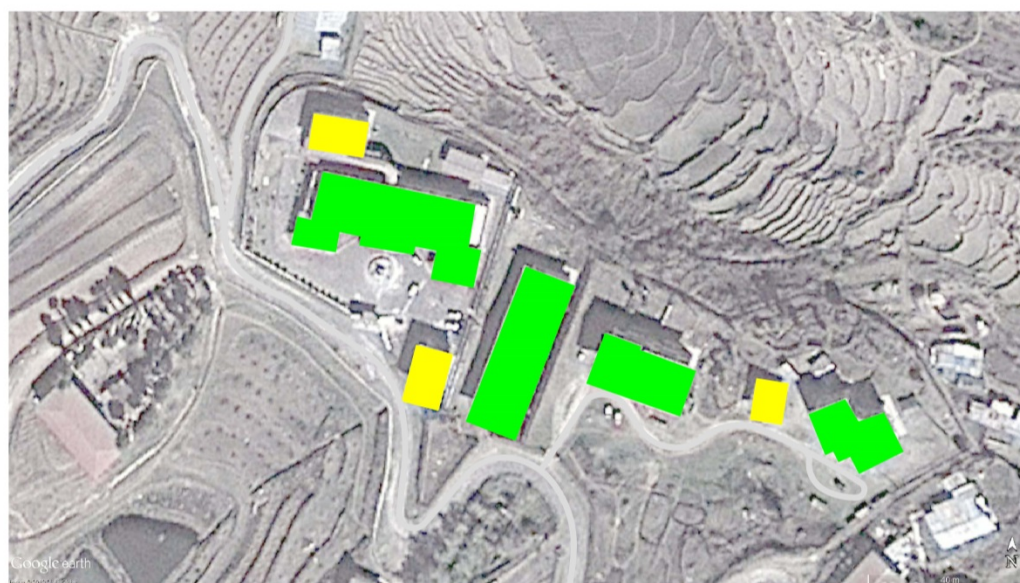
Figure 31 shows the anticipated performance of the hospital's buildings, in terms of functionality. Each building could be one performance level higher or lower than shown due to uncertainty in the nature of ground shaking, and in the team's existing knowledge of site conditions and building systems. One performance level is shown for illustrative purposes. The hospital keeps staff and patients safe, but the loss of water and supplies reduces the quality of care and the ability of the hospital to treat the injured.

Figure 31. Likely performance of hospital buildings in deep M7 hypothetical scenario earthquake

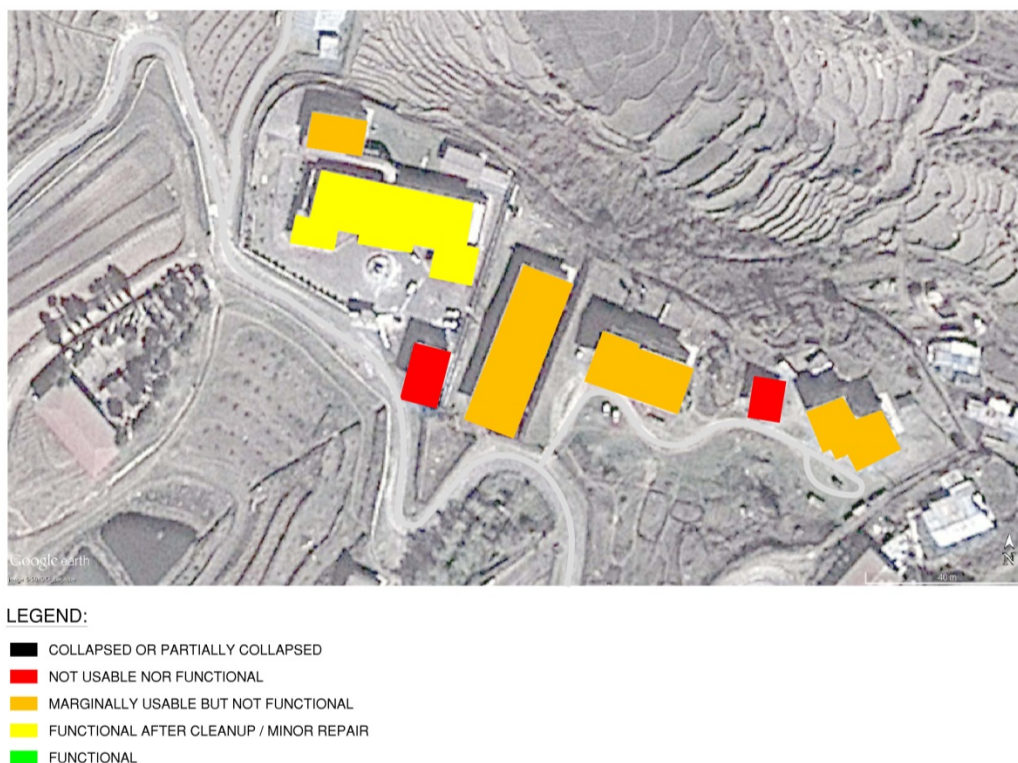
Figure 33 shows the anticipated performance of the hospital's buildings, in terms of functionality. Without a backup water supply, the hospital's functionality suffers due to the off-site water system outage. The main building is damaged but useable, but with only 20 beds, a small medical staff, and the loss of equipment and supplies, the hospital's capacity is severely taxed.

Figure 33. Site plan showing performance of hospital buildings in M6.1 hypothetical scenario earthquake

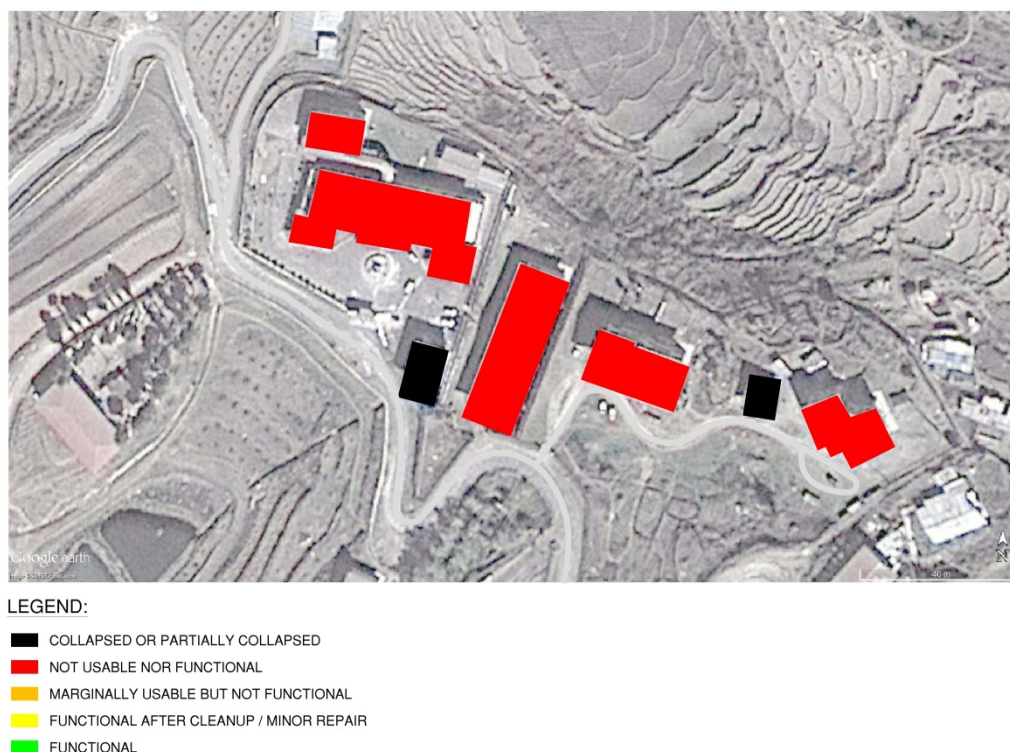
Figure 35 below shows the anticipated performance of the hospital's buildings, in terms of functionality. The hospital remains standing but is too badly damaged to be useable.

Figure 35. Likely performance of hospital buildings in M8.6 hypothetical scenario earthquake
